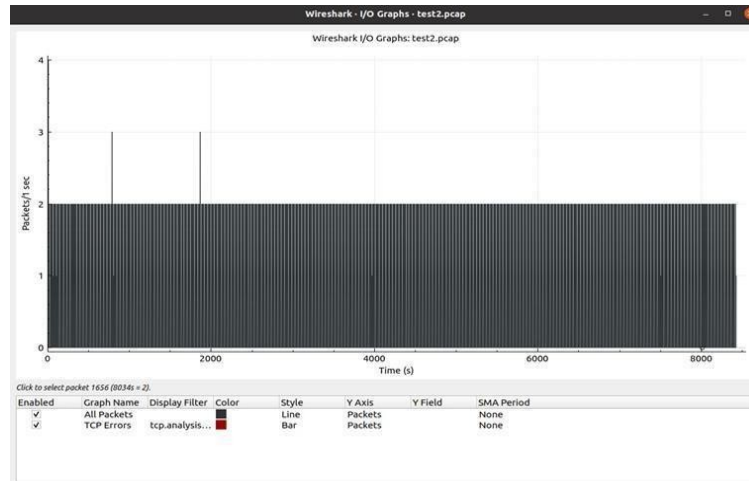
### Case 1: I/O Packet Inspection Without Detection and Mitigation Mechanism

In the below graph, it is analyzed the attacker is injecting the attack file on the network and host people is being Victim to the attacker without detection and prevention mechanisms.

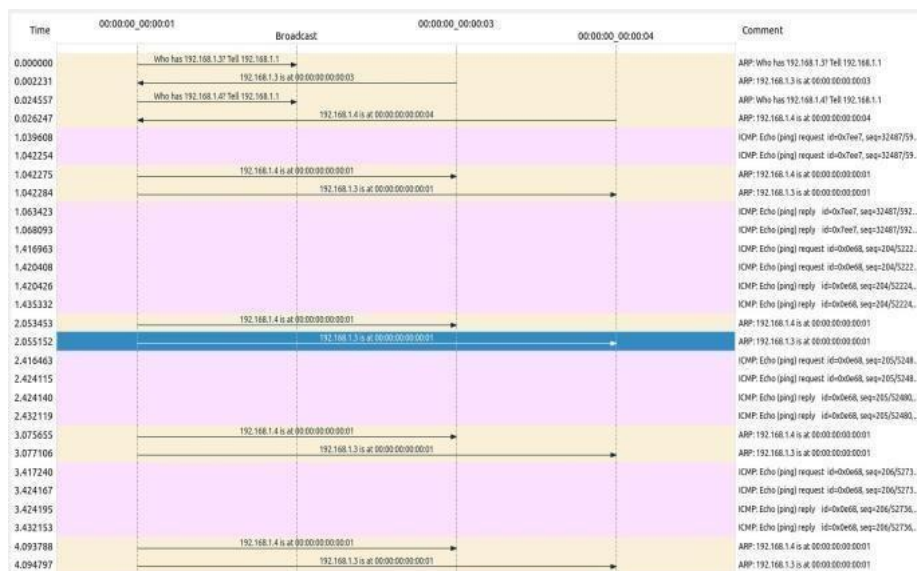
### Case 3: Flow Graph Packet Inspection with Detection and With Mitigation Mechanism:

In the below graph, the attack by the hacker is identified and it is being mitigated by the centralized Software Defined Network Controller which is indicated by the arrows having head pointing towards right side.
