TAILLIGHT DOES NOT LIGHT UP

WIRING DIAGRAM

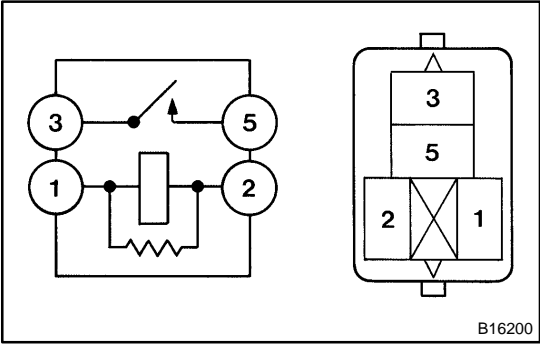
1 INSPECT TAIL LAMP RELAY

(a) Inspect relay continuity.

Condition	Tester connection	Specified condition
Constant	1 – 2	Continuity
Apply B+ between terminals 1 and 2.	3 – 5	Continuity

NG REPLACE TAIL LAMP RELAY

REPAIR OR REPLACE HARNESS AND CONNECTOR(BETWEEN INSTRUMENT PANEL J/B ASSY AND TAIL RELAY)

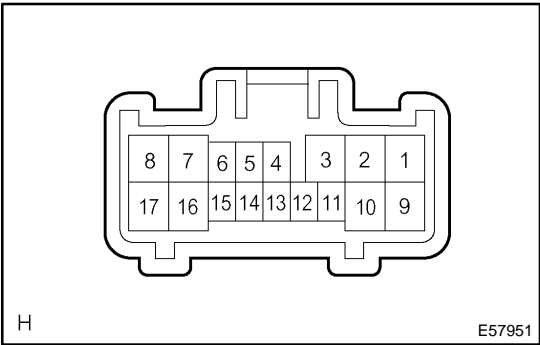
2 INSPECT HEADLAMP DIMMER SWITCH ASSY(TAIL)

(a) Inspect light control switch continuity.
(1) Check that there is continuity between terminals at each switch position as shown in the chart.

Switch operation	Tester connection	Specified condition
OFF	–	No continuity
TAIL	14 – 16	Continuity

NG REPLACE HEADLAMP DIMMER SWITCH ASSY

CHECK AND REPLACE INSTRUMENT PANEL JUNCTION BLOCK ASSY
