TORQUE CONVERTER CLUTCH AND DRIVE PLATE INSPECTION

400G5-01

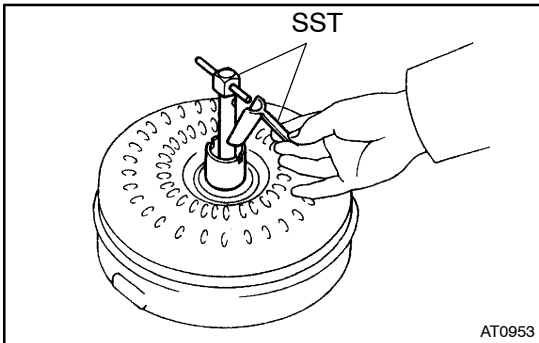
- (a) Inspect the one-way clutch.
 - (1) Set SST into the inner race of the one-way clutch.
SST 09350-32014 (09351-32010)
 - (2) Install SST so that it fits in the notch of the converter hub and outer race of the one-way clutch.
SST 09350-32014 (09351-32020)

- (3) With the torque converter clutch setting up on its side, check that the one-way clutch locks when it is turned counterclockwise, and rotates clockwise smoothly.

If necessary, clean the converter and retest the one-way clutch.

Replace the converter if the one-way clutch still fails the test.

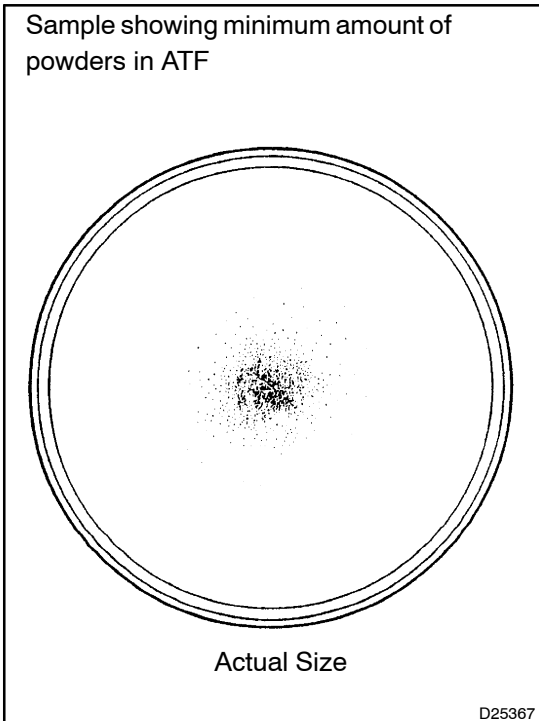
- (c) Exchange the ATF in the torque converter clutch.
 - (1) If the ATF is discolored and/or has a foul odor, completely stir the ATF in the torque converter clutch and drain the ATF with the torque converter facing to up.

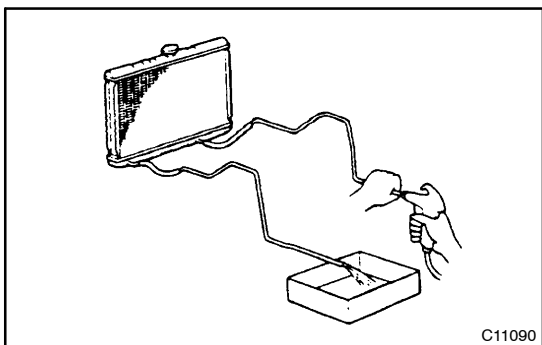
- (d) Clean and check the oil cooler and oil pipe line.
 (1) If the torque converter clutch is inspected or the ATF is exchanged, clean the oil cooler and oil pipe line.

- Spray compressed air of 196 kPa (2 kgf/cm², 28 psi) from the inlet hose.
 - If plenty of fine powders are identified in the ATF, add new ATF using a bucket pump and clean it again.
- (2) If the ATF is cloudy, inspect the oil cooler (radiator).

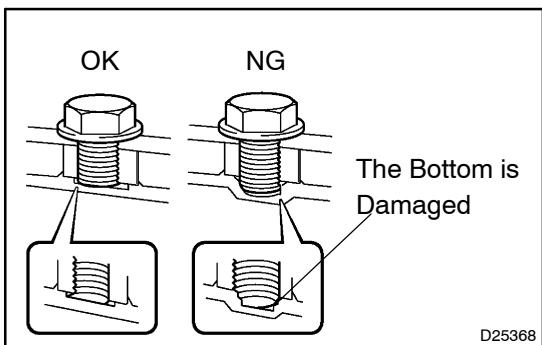
- (e) Prevent deformation of the torque converter clutch and damage to the oil pump gear.
- (1) When any marks due to interference are found on the end of the bolt for the torque converter clutch and on the bottom of the bolt hole, replace the bolt and the torque converter clutch.
- (2) All of the bolts must be the same length.
- (3) The bolts with washers must be used.

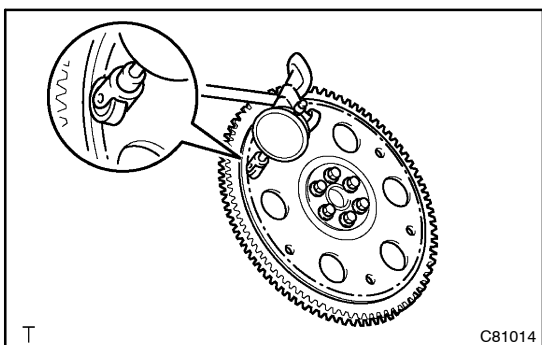
- (a) Set up a dial indicator and measure the drive plate runout.
 (b) Check the damage of the ring gear.

Maximum runout: 0.20 mm (0.0079 in.)

If the runout is not within the specification or ring gear is damaged, replace the drive plate.
