RADIO RECEIVER ASSY REPLACEMENT

6708W-03

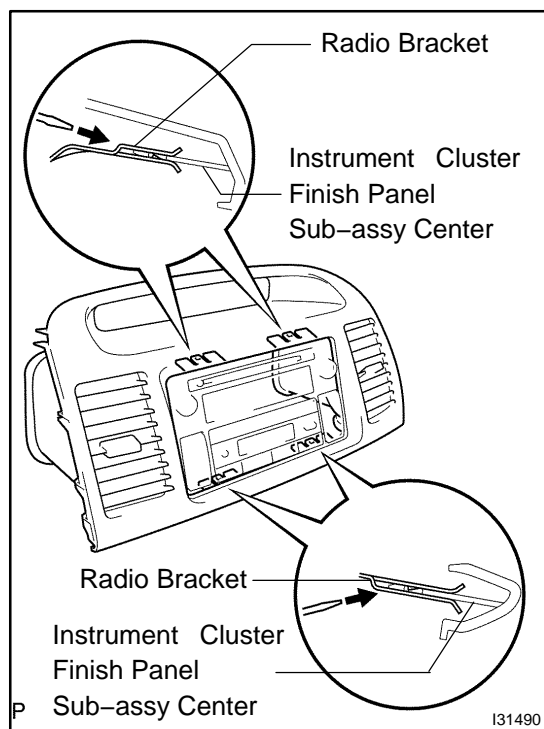
3. REMOVE RADIO RECEIVER ASSY

- (a) Insert a screwdriver at indicated point and remove the radio receiver assy from instrument cluster finish panel sub-assy center.

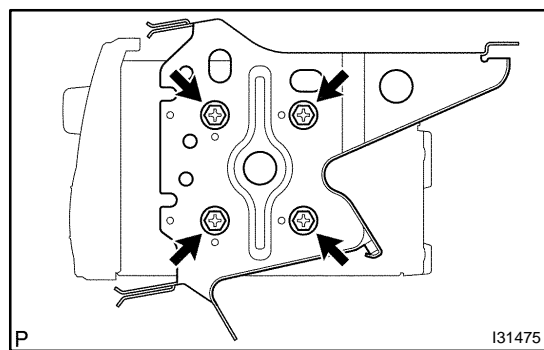
4. REMOVE RADIO BRACKET NO.1

- (a) Remove the 4 screws and radio bracket No.1.

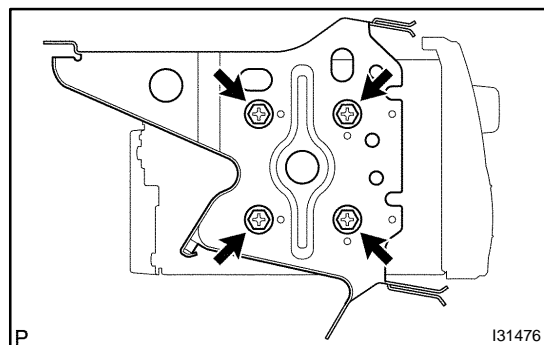
5. REMOVE RADIO BRACKET NO.2

- (a) Remove the 4 screws and radio bracket No.2.
