# TURNING ON LIGHT SWITCH DOES NOT LIGHT UP NIGHT TIME ILLUMINATION OF RADIO RECEIVER

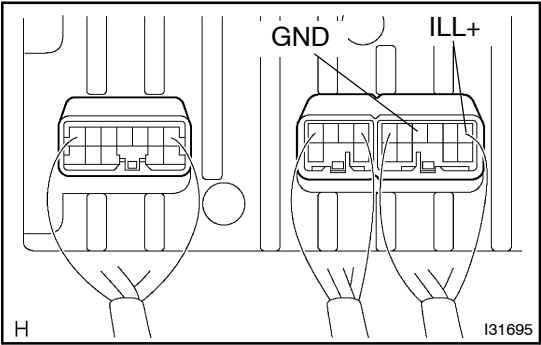
1 INSPECT RADIO RECEIVER ASSY(ILL+)

(a) Check that the voltage between terminals at each condition, as shown in the chart.

Standard:

Tester connection	Condition	Specified condition
ILL+ - GND	Light control switch TAIL or HEAD	10 - 14 V

OK CHECK AND REPLACE RADIO RECEIVER ASSY

REPAIR OR REPLACE HARNESS OR CONNECTOR
