CLUTCH SWITCH ASSY

REPLACEMENT

8201S-01

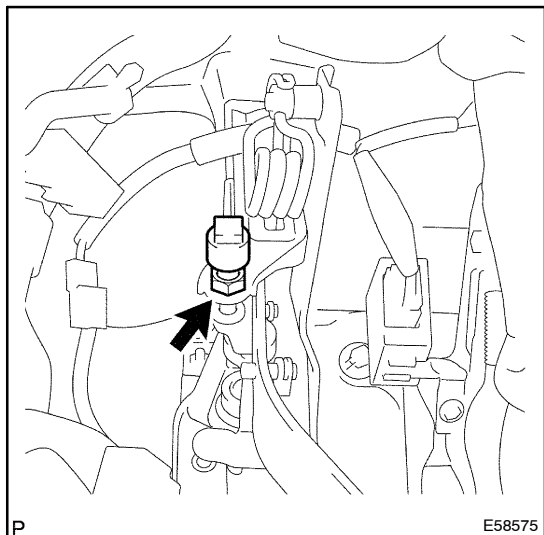
4. REMOVE CLUTCH SWITCH ASSY

- (a) Disconnect the connector.
- (b) Loosen the nut and remove the clutch switch assy.
