HEADLAMP UNIT LH

REPLACEMENT

650C4-01

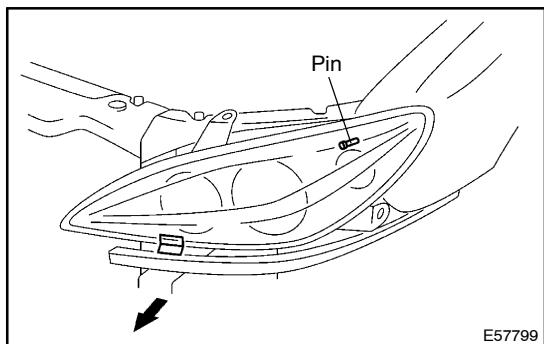
6. REMOVE HEADLAMP UNIT LH

- (a) Remove the 2 bolts.
- (b) Disconnect the connectors.

- (c) Pull out the headlight unit forward.
- (d) Remove the headlight assy.

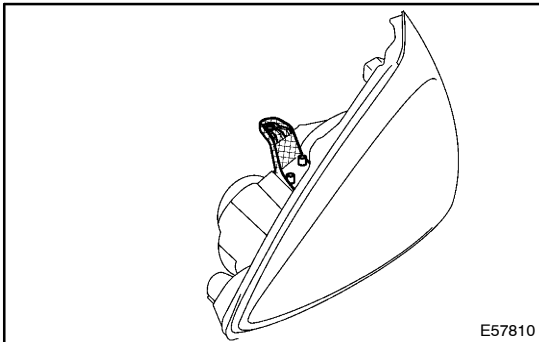
11. INSTALL HEADLAMP PROTECTOR RETAINER UPPER LH

- (a) Cut off the part shaded in the illustration and sand smooth with sandpaper.

After cutting off the part roughly, place the headlight protector retainer UPPER LH against the bosses and gradually file any interfering part until the proper condition for installation is made.

When only the installation part of the headlight unit assy LH is damaged, it can be repaired inexpensively by using a headlight protector retainer UPPER LH. In this case, however, the headlight unit assy LH itself should not be damaged.

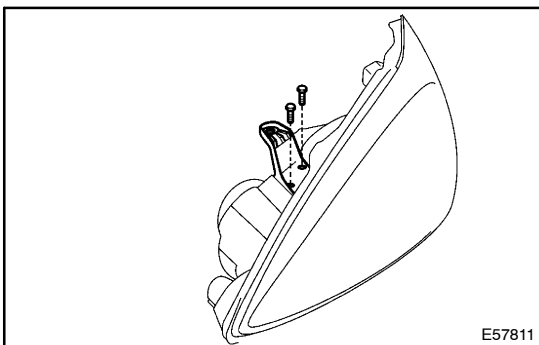
- (b) Install the headlight protector retainer UPPER LH with the 2 screws.
