ROUTE CANNOT BE CALCULATED

INSPECTION PROCEDURE

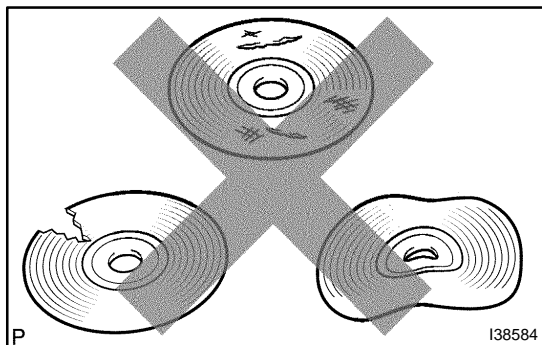
1 CHECK THE MAP DISC

- (a) Check that the map disc is not deformed or cracked.
Standard: No deformations or cracks appear on the map disc.

NG**REPLACE THE MAP DISC****OK**
