RADIO RECEIVER ASSY REPLACEMENT

6709B-02

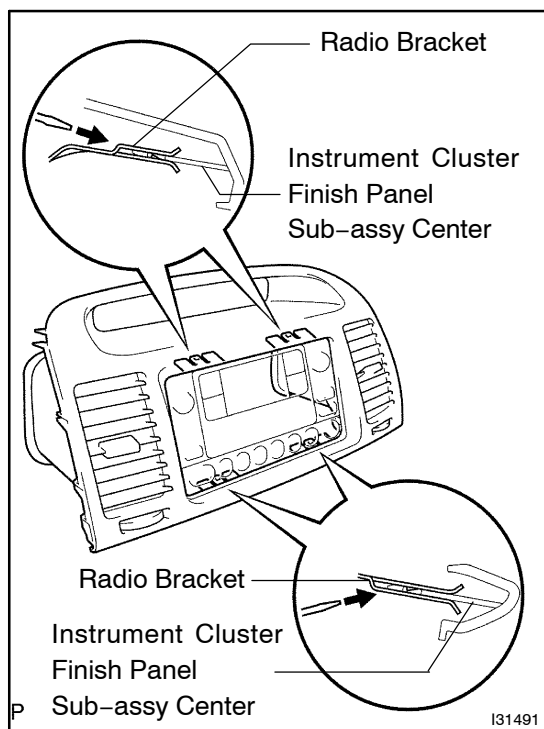
3. REMOVE RADIO RECEIVER ASSY

- (a) Insert a screwdriver at indicated point and remove the radio receiver assy from instrument cluster finish panel sub-assy center.

Tape the screwdriver tip before use.

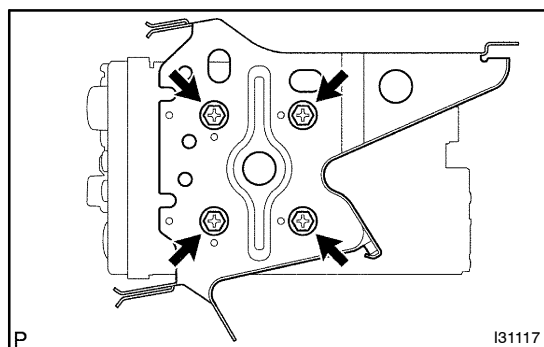
4. REMOVE RADIO BRACKET NO.1

- (a) Remove the 4 screws and radio bracket No.1.

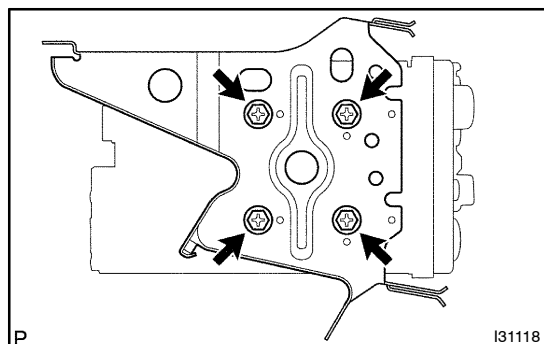
5. REMOVE RADIO BRACKET NO.2

- (a) Remove the 4 screws and radio bracket No.2.
