Mechanism of Fatigue Crack Growth in Carbon Black Filled Natural Rubber

J.-B. Le Cam, B. Huneau, E. Verron,* and L. Gornet

Institut de Recherche en Génie Civil et Mécanique, UMR 6183, Ecole Centrale de Nantes, BP 92101, 44321 Nantes Cedex 3, France

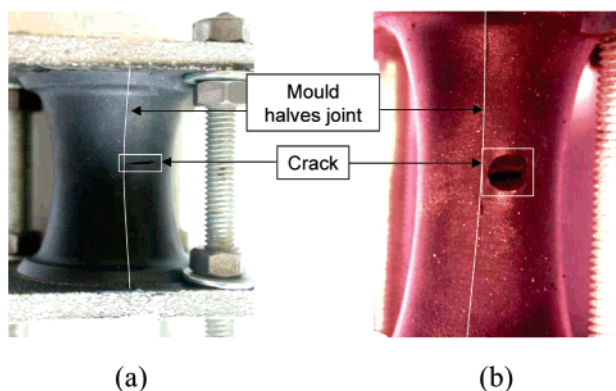
Figure 2. Sample and fatigue crack in the (a) undeformed and (b) deformed configurations.

2.4. Observation Method. The sample is fixed in a rudimentary static tensile apparatus (see Figure 2a), and it is statically stretched to the same ratio than the one enforced during the fatigue test (1.33) in order to open the crack (see Figure 2b). Then, this apparatus is placed in the SEM to observe the crack growth. As mentioned previously, the fatigue test led to initiation and propagation of a crack in the sample, and it involved a fatigue damage in the crack tip vicinity. Thus, the crack tip should be notched to reveal the fatigue damaged zones and to determine their origin. During SEM observations, it is obviously irrelevant to use a laboratory cutting tool to notch the crack. Nevertheless, it is possible to "microcut" the crack tip by imparting in situ a sufficient amount of energy to break cross-links between macromolecules. Two energy sources are used simultaneously: the first one is mechanical and consists of statically stretching the sample to a ratio equal to 1.67, i.e., higher than the level set during the cyclic loading, and the second one consists of locally concentrating the electron beam in the observation zone. In fact, the amount of energy needed to break cross-links cannot easily be determined since the number and nature of cross-links as well as the number of macromolecules in the irradiated zone are not well-known. However, the acquired experience enables us to correctly set the power of the electron beam and to recur experiments. The most favorable zones to perform microcut-

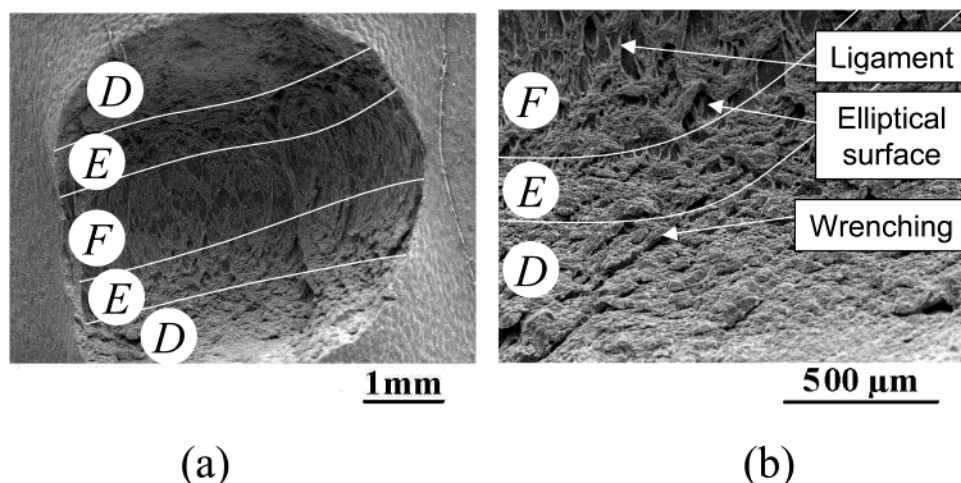
Figure 4. Details of areas D–F for two magnifications.

3.1. Crack Description. Figure 3 presents a schematic view of the crack and its surroundings. Six different areas are observed in the deformed configuration, i.e., as the sample is stretched to 1.67. Before the occurrence of the crack, there were only two zones: the central zone of the sample, denoted A in the figure, that is the most stretched part of the specimen, and the area situated on both sides of it and denoted B. When the crack occurs, four new zones appear: area C, which corresponds to the parts of area A relaxed during crack opening, and areas D, E, and F that stand for the crack itself. The photomicrographs of the three zones D, E, and F are shown in Figure 4. Area F stands for the crack tip, area D represents the material surfaces that were broken during the previous growth of the crack, and area E is the frontier between the former ones (see Figure 4a). The major difference between surfaces D and F is their stretching level. As shown in Figure 4b, area D is overlayed with wrenchings which are a typical feature of fracture surfaces observed under fatigue loading conditions.^{14,15} Here, the term "wrenchings" refers to highly stretched ligaments which break and shrink. Area F is composed of highly stretched ligaments which delimit elliptical smooth surfaces, and area E contains both wrenchings and ligaments. With regard to these observations, the number and size of ligaments in a zone seem closely related to its stretching level.

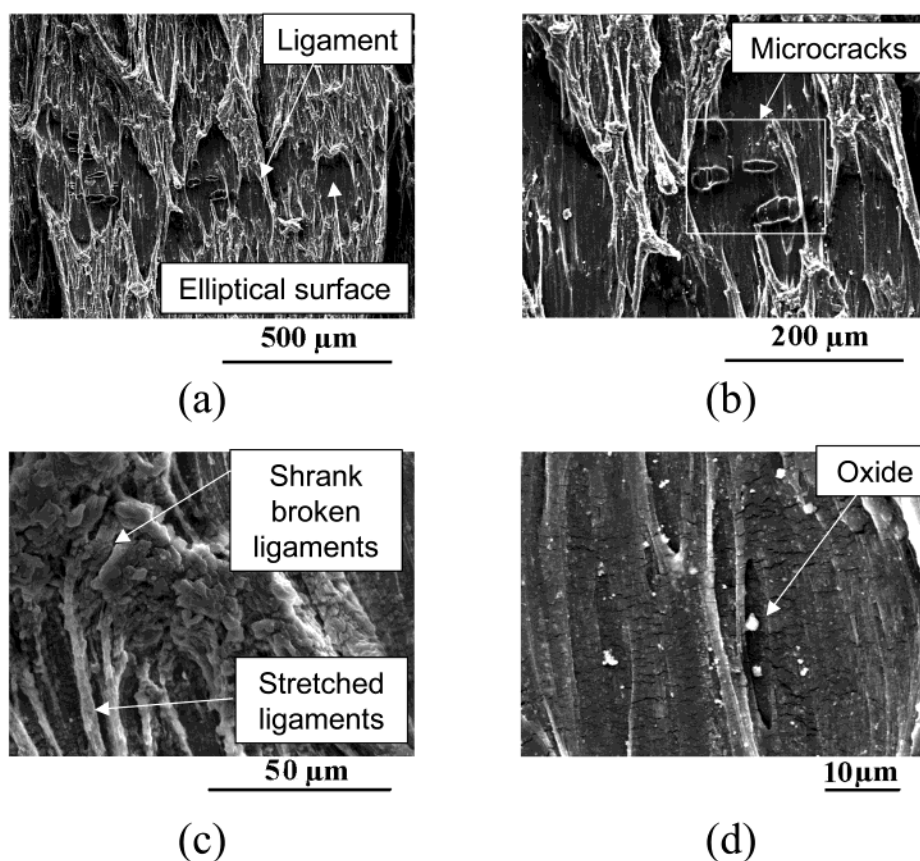
Figure 5. Details of the crack tip for four magnifications.

After this brief description of the crack, the crack tip F, in which our microcutting method will be applied, has to be more precisely examined. Figure 5 shows it for different magnifications. The crack tip is composed of a few hundred micrometers long ligaments which are highly stretched and surround smooth elliptical surfaces (see Figure 5a). Figure 5b-d presents the morphology

of these elliptical surfaces and their surroundings. First, microcracks take place in their middle part; their orientation is perpendicular to the stretch axis (see Figure 5b). The presence of these microcracks shows that the smooth areas are propitious to the propagation of the crack. This property will be used in the following to apply our microcutting method. Moreover, these smooth areas are delimited by ligaments whose extremities are located at their top and bottom. As an example, the photomicrograph in Figure 5c shows the top of any surface. It contains both stretched ligaments and a rough surface that corresponds with broken ligaments which shrank. Finally, using a larger magnification, Figure 5d shows that some zinc oxides are embedded in the relief of smooth elliptical areas. Oxides can be

considered as spherical-like particules, and their size is randomly distributed and varies between a few hundred nanometers and 5 μm.

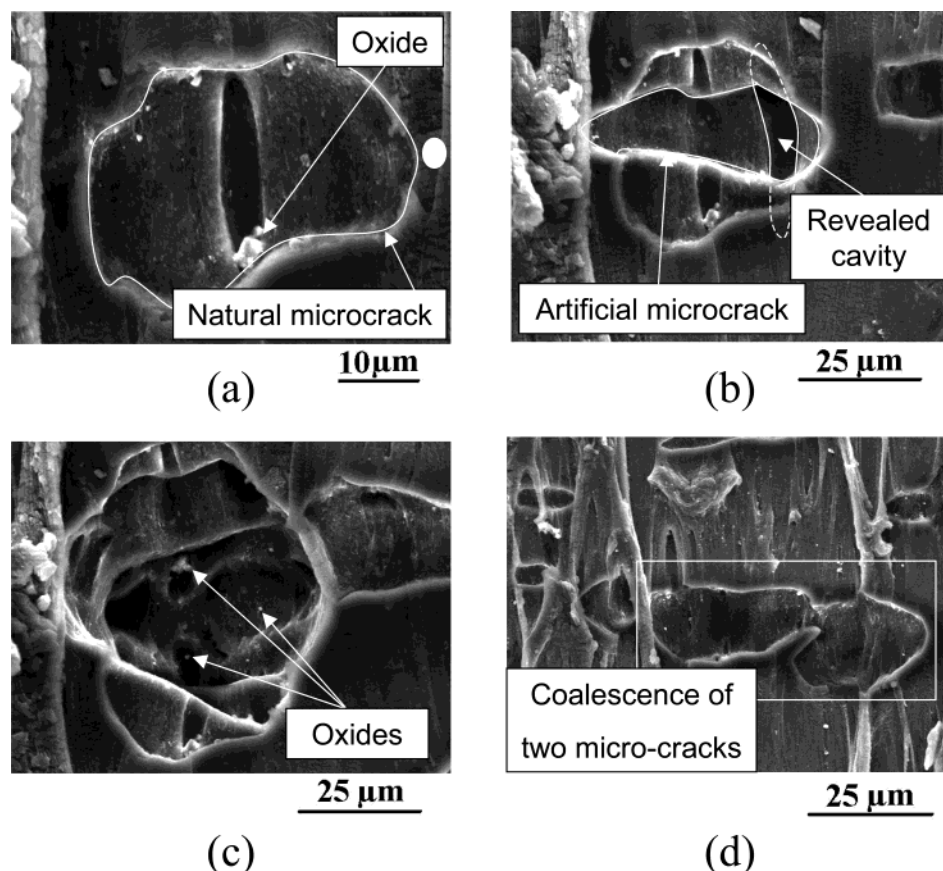
Figure 6. Chronology of the microcut experiment.

5b). Figure 6 presents the chronology of the real-time observation. The observation zone is shown in Figure 6a. It contains a natural microcrack near a ligament. In the middle of this microcrack, a stretched cavity containing an oxide takes place. Then, the electron beam is focused a few seconds beside the microcrack (see the white circle in Figure 6a). It leads to an artificial microcrack which initiates at the beam concentration point, slowly propagates to the other side of the natural microcrack, and stops at the ligament, as shown in Figure 6b. During its propagation, this artificial microcrack revealed a cavity similar to the one observed in the natural microcrack. By continuing to focus the electron beam, new microcracks are propagating in the sample depth and are revealing cavities. Most of these cavities contain oxides (see Figure 6c). Moreover, note that this microcutting can also be used to induce the coalescence of existing microcracks by concentrating the electron beam between them (see Figure 6d). Finally, it should be mentioned that, as the electron beam is focused on ligaments (the SEM power settings being unchanged), they do not break even if they are exposed for a long time. It seems to indicate that the microstructures of ligaments and elliptical areas between them are different. More precisely, this difference might be mainly due to the distribution of the crystallization ratio: the highly stretched ligaments represent the most crystallized zones of the crack tip. These results obtained under fatigue loading conditions are quiet similar to those recently established under static conditions by Trabelsi et al.,¹⁶ who demonstrate that a crystallized zone appears at crack tip of initial cut lengths 0.5 and 1 mm for stretch ratios greater than $\lambda = 1.3$.

This experiment highlights that cavities take place in the vicinity of the crack tip due to decohesion between oxides and rubber matrix. Similarly, Layouni et al.¹⁷ associate the volume change of elastomers under mechanical loading with the decohesion between zinc oxides and matrix. Cavitation in rubber is a well-known phenomenon that was thoroughly studied in the past for static loading conditions.^{18,19} Recently, it has been shown that the number of preexisting microvoids per unit volume strongly correlates with the mechanical performance of elastomers.²⁰ For fatigue loading, only internal crack growth under high hydrostatic pressure has been studied.²¹ Nevertheless, in the present case of relaxing tensile fatigue, the origin of cavitation is not established: is it only a consequence of the stress state at the crack tip, or is it also due to fatigue loading conditions? To answer these questions, a second experiment is carried out. It consists of generating a self-initiated fatigue crack and observing the cavities distribution in the sample.

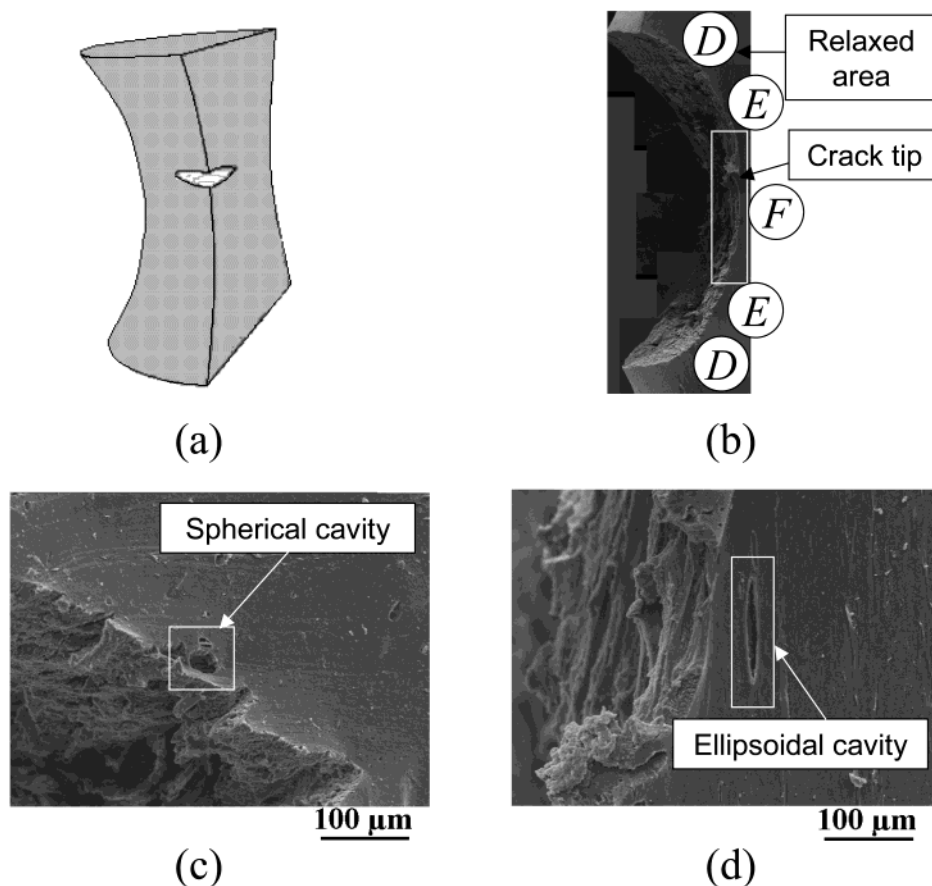
Figure 7. Second experiment: (a) cut sample, (b) global view of the crack, (c) details of relaxed areas, (d) details of the crack tip.

Figure 7 summarizes this second experiment. To observe cavities in the sample, it is cut in its undeformed configuration, as shown in Figure 7a. Afterward, it is stretched using the tensile apparatus presented above and introduced in the SEM. Figure 7b shows the opened crack tip and its surroundings. One can again distinguished relaxed zones with numerous wrunchings at the top and the bottom of the crack, and the most stretched area, i.e., the crack tip, in the middle. Large cavities are observed in both areas near the crack faces, and their shapes highly differ: they are spherical in the relaxed zones (see Figure 7c) and ellipsoidal (due to the stretching level) behind the crack tip (see Figure 7d).

Moreover, it is important to notice that the size of the large spherical cavity in Figure 7c (as compared with the size of an oxide) demonstrates that this cavity grew under cyclic loading. Examining the cut surface of the sample, a large number of cavities are revealed; most of them contain oxide, and their size rapidly decreases with their distance from the crack. From a sufficiently long distance, no more cavities are observed.
