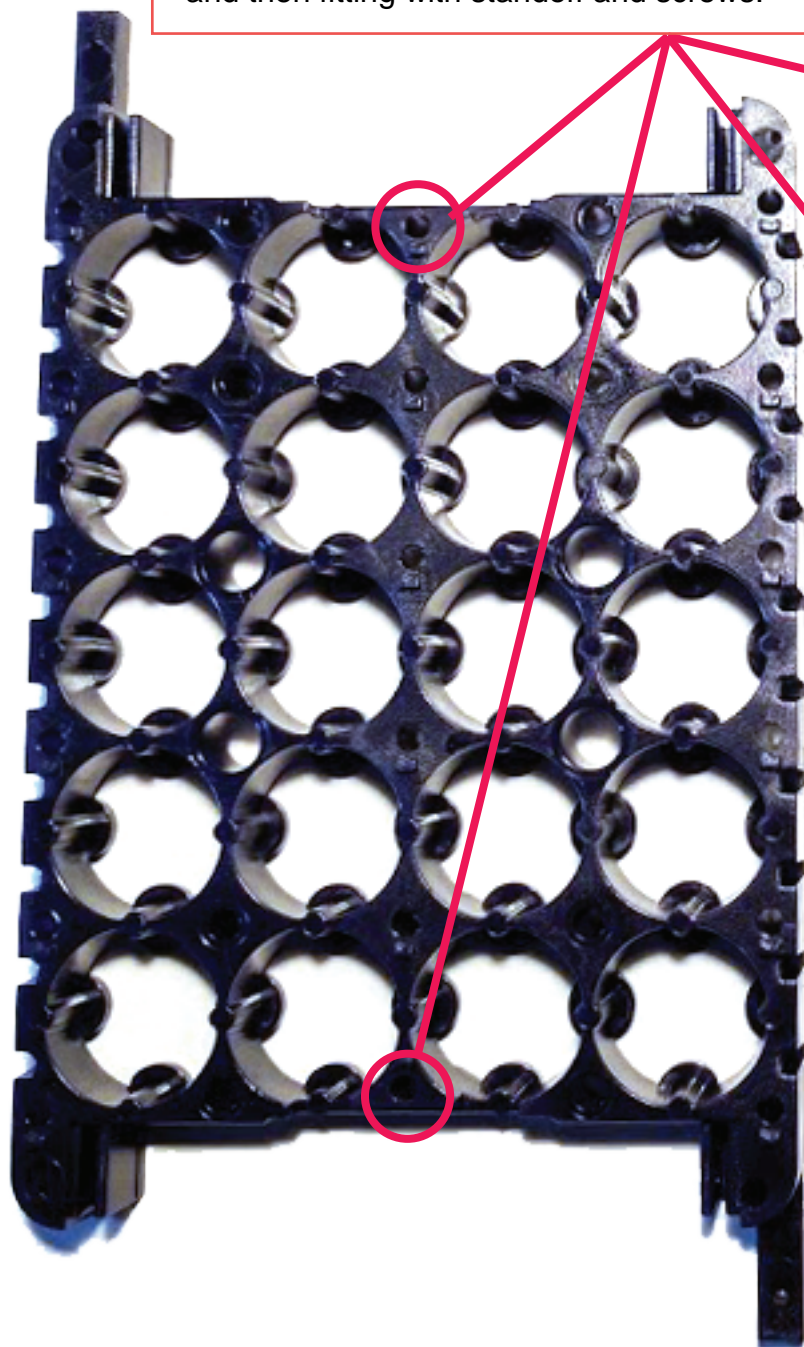
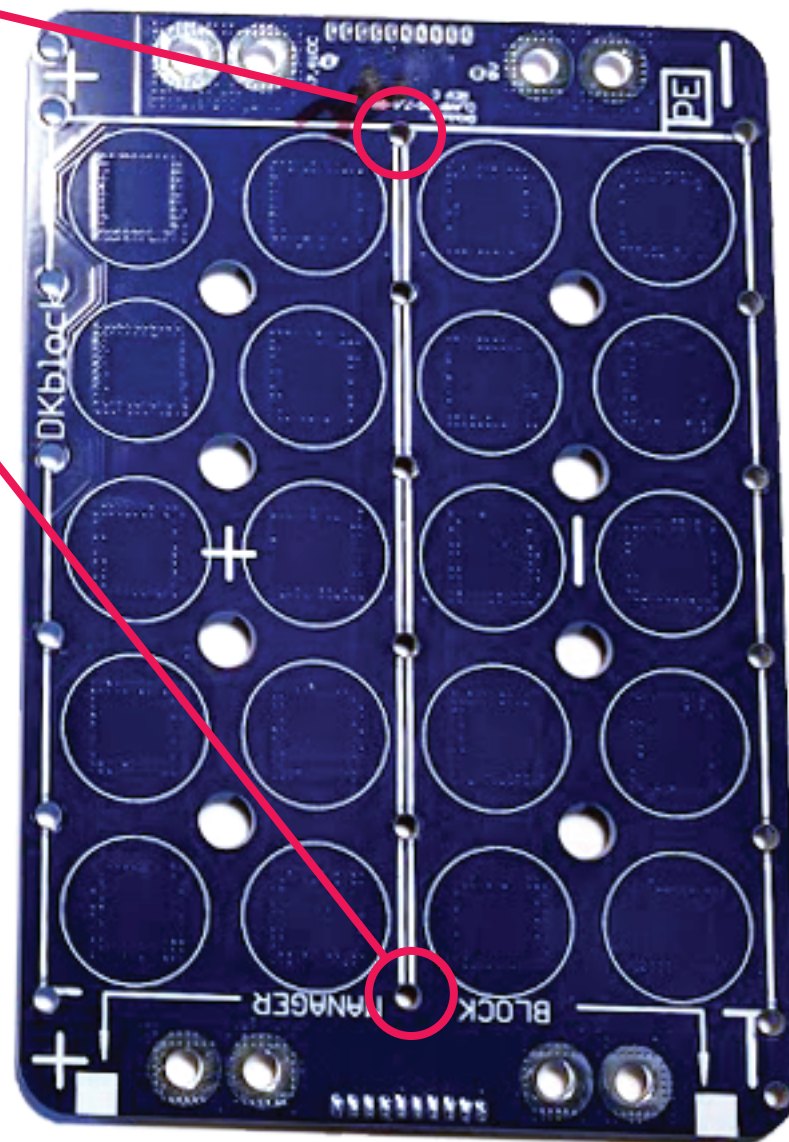
Please note that these 2 holes do not perfectly align on this version although they will be fixed in the next revision. Please fix by clearing with a 1/8" drill bit after assembly, and then fitting with standoff and screws.
