# 300SA Stage Accuracy Report

Customer Name:	GF - Singapore
System Description:	300SA Prober with ATT Chuck
System #:	QM2

## 25C Glass Accuracy

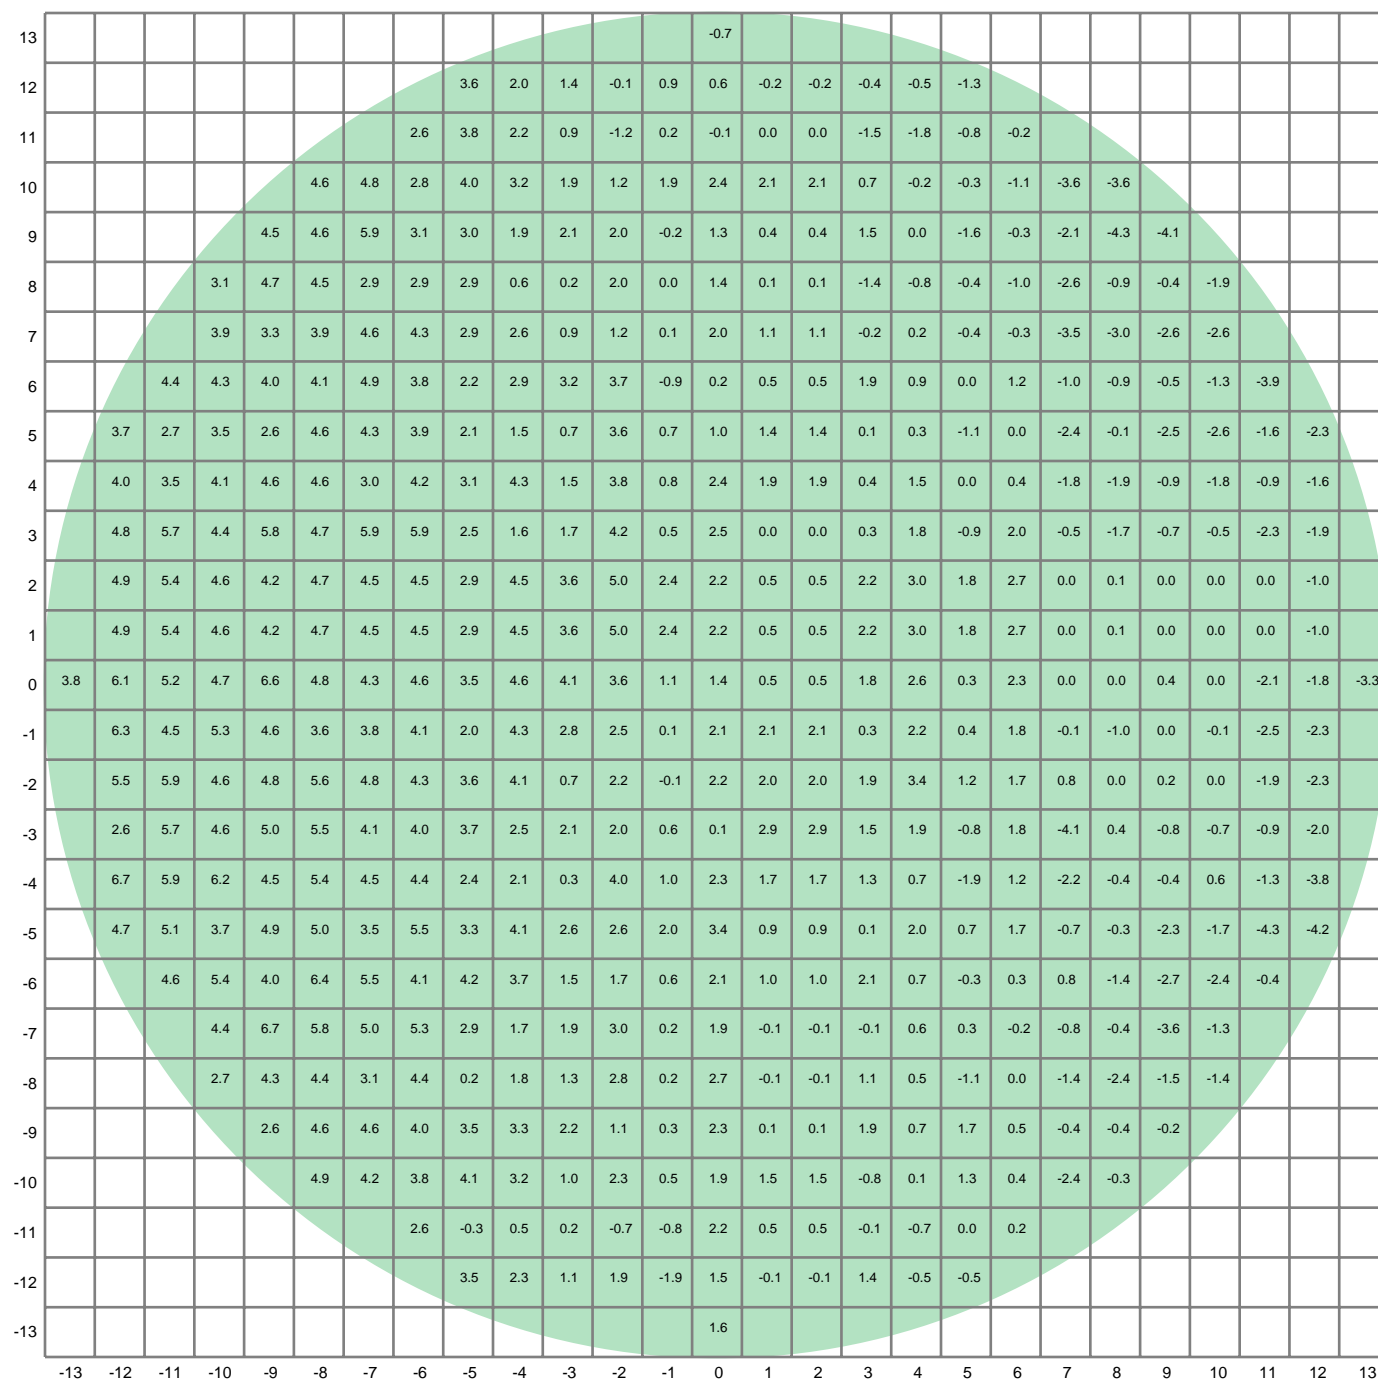
X Axis Error Map (um)

Wafer Used:	Precision Glass	
Measurement Method:	Image Recognition *Typical measurement uncertainty is +-1um **See Map on following page for die tested	
Minimum Error:	Xmin: -8.5um	Ymin: -8.2um
Maximum Error:	Xmax: 7.6um	Ymax: 11.2um
Specification:	+-5um	
Pass/Fail:	PASS

Wafer Used:	Precision Glass	
Measurement Method:	Image Recognition *Typical measurement uncertainty is +-1um **See Map on following page for die tested	
Minimum Error:	Xmin: -2.1um	Ymin: -4.2um
Maximum Error:	Xmax: 5.3um	Ymax: 3.7um
Specification:	+-5um	
Pass/Fail:	PASS

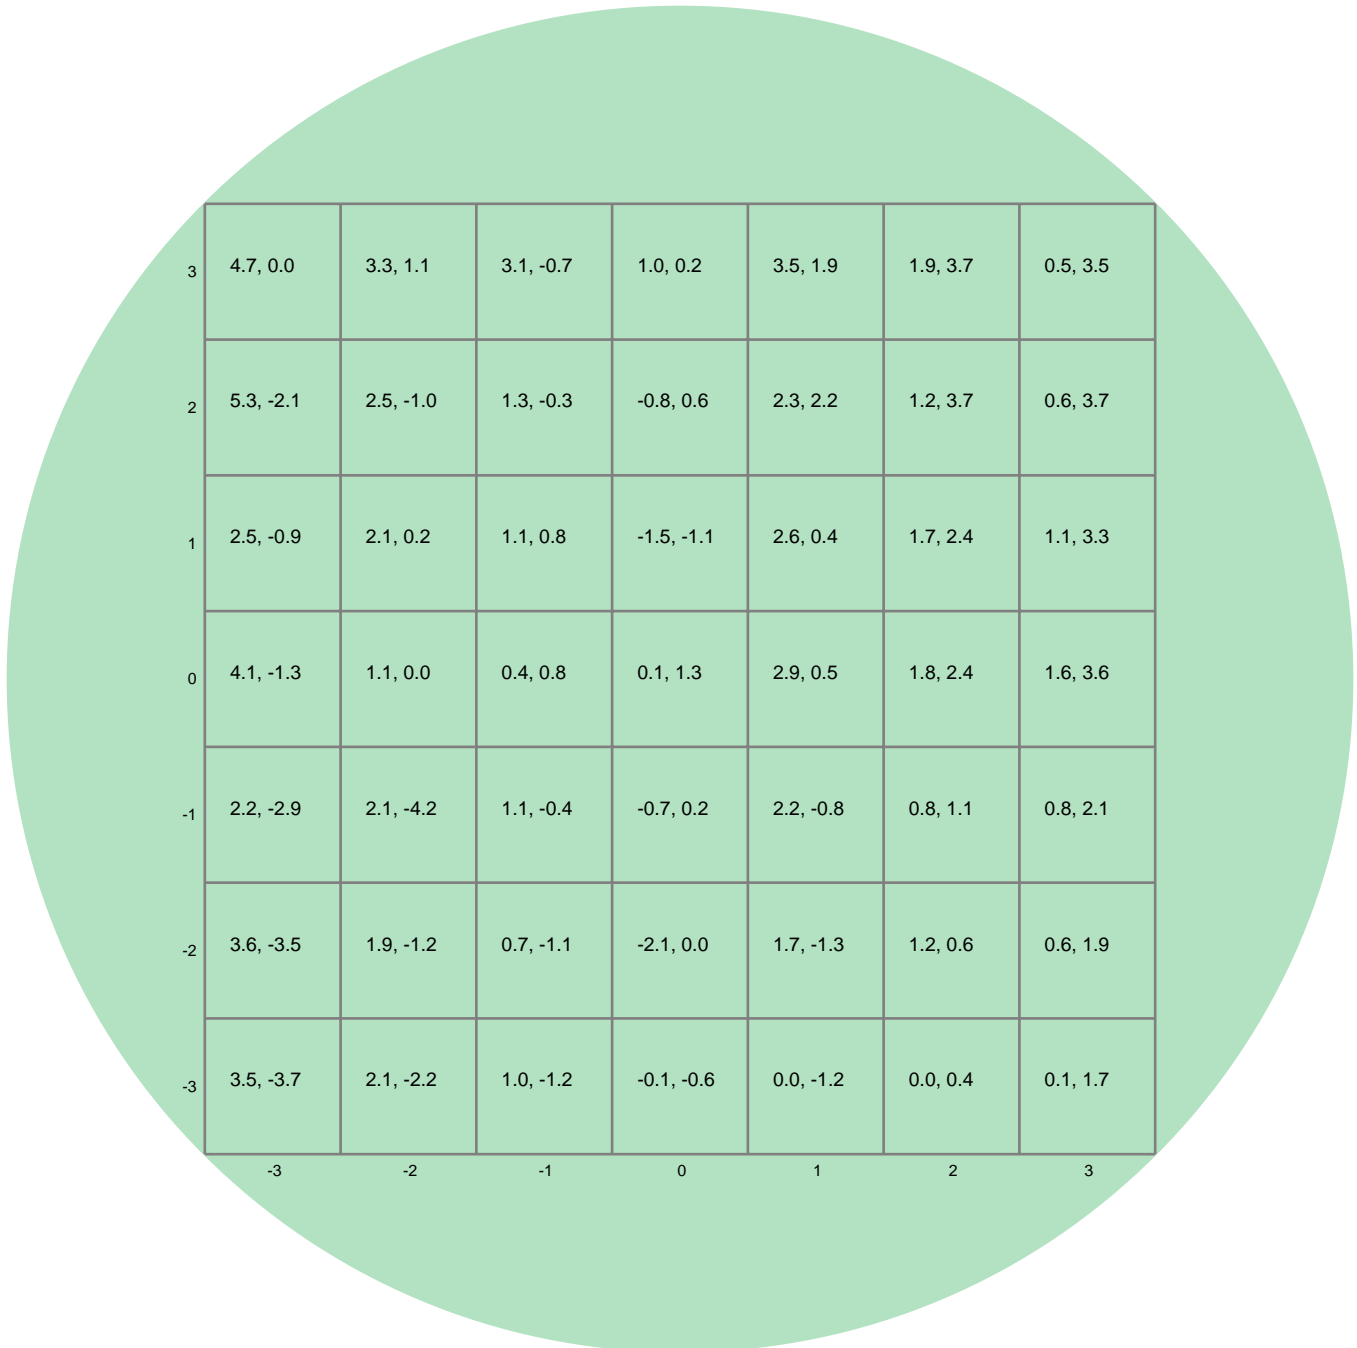
X, Y Error Map (um)

## 25C Glass Accuracy
