2019 Tampa Bay Water Quality Assessments

A Tampa Bay Estuary Program Initiative to Maintain and Restore the Bay's Seagrass Resources

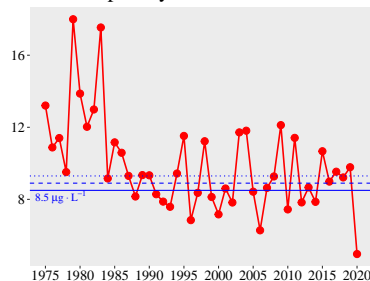
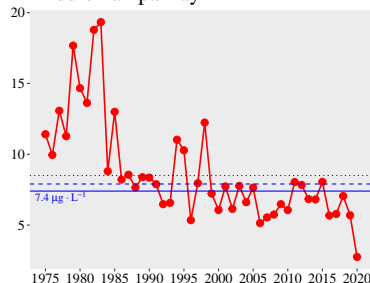
Figure 3: Historic chlorophyll-a annual averages for the four bay segments.

Water quality (chlorophyll-a and light penetration) remained supportive of seagrass in Hillsborough Bay (HB), Middle Tampa Bay (MTB), and Lower Tampa Bay (LTB)(Table 1, Figure 3). The nuisance algae, *Pyrodinium bahamense*, was again reported in Old Tampa Bay (OTB) during May - September 2019, contributing to a large magnitude chlorophyll-a exceedance that has persisted for a long duration (5yrs). However, it should be noted that effective light penetration was still observed to be supportive of seagrass in all bay segments, including OTB (Table 1).

— Annual Mean — Management Target - - +1 se (small exceedance) - - +2 se (large exceedance)
