2019 Tampa Bay Water Quality Assessments

A Tampa Bay Estuary Program Initiative to Maintain and Restore the Bay's Seagrass Resources

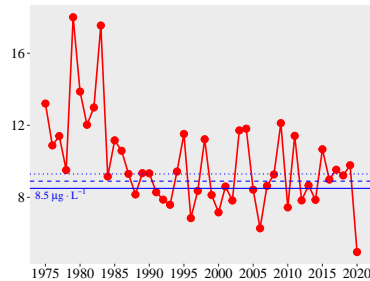
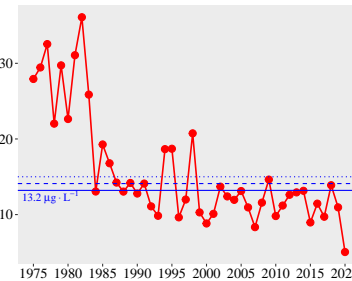
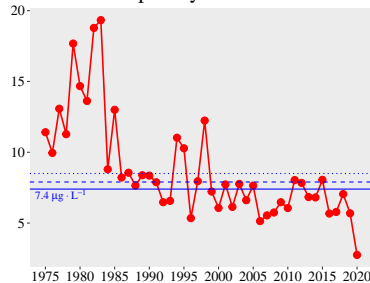
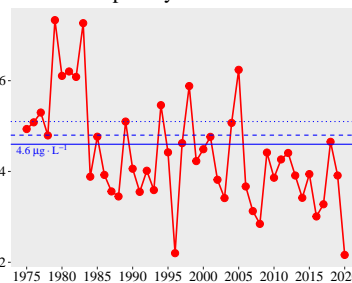
Figure 3: Historic chlorophyll-a annual averages for the four bay segments.

— Annual Mean — Management Target — +1 se (small exceedance) — +2 se (large exceedance)

Old Tampa Bay

Hillsborough Bay

Middle Tampa Bay

Lower Tampa Bay

Water quality (chlorophyll-a and light penetration) remained supportive of seagrass in Hillsborough Bay (HB), Middle Tampa Bay (MTB), and Lower Tampa Bay (LTB)(Table 1, Figure 3). The nuisance alga, *Pyrodinium bahamense*, was again reported in Old Tampa Bay (OTB) during May - September 2019, contributing to a large magnitude chlorophyll-a exceedance that has persisted for a long duration (5yrs). However, it should be noted that effective light penetration was still observed to be supportive of seagrass in all bay segments, including OTB (Table 1).
