2019 Tampa Bay Water Quality Assessments

A Tampa Bay Estuary Program Initiative to Maintain and Restore the Bay's Seagrass Resources

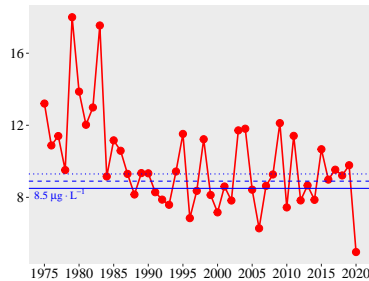
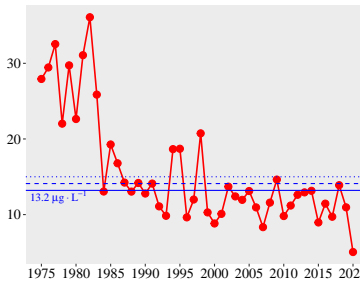
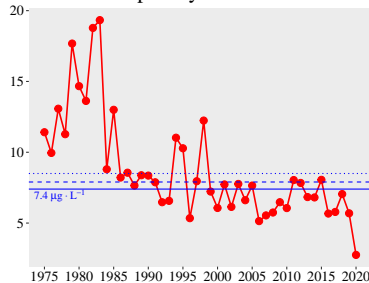
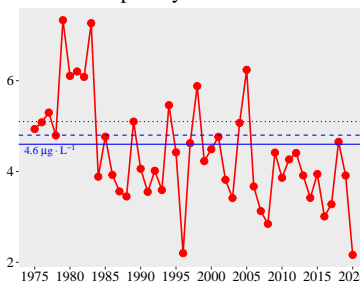
— Annual Mean — Management Target - - +1 se (small exceedance) - - +2 se (large exceedance)

Figure 3: Historic chlorophyll-a annual averages for the four bay segments.

Water quality (chlorophyll-a and light penetration) remained supportive of seagrass in Hillsborough Bay (HB), Middle Tampa Bay (MTB), and Lower Tampa Bay (LTB)(Table 1, Figure 3). The nuisance alga, *Pyrodinium bahamense*, was again reported in Old Tampa Bay (OTB) during May - September 2019, contributing to a large magnitude chlorophyll-a exceedance that has persisted for a long duration (5yrs). However, it should be noted that effective light penetration was still observed to be supportive of seagrass in all bay segments, including OTB (Table 1).
