2019 Tampa Bay Water Quality Assessments

A Tampa Bay Estuary Program Initiative to Maintain and Restore the Bay's Seagrass Resources

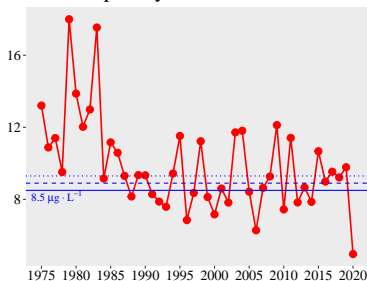
Figure 3: Historic chlorophyll-a annual averages for the four bay segments.

— Annual Mean — Management Target — +1 se (small exceedance) — +2 se (large exceedance)

Water quality (chlorophyll-a and light penetration) remained supportive of seagrass in Hillsborough Bay (HB), Middle Tampa Bay (MTB), and Lower Tampa Bay (LTB)(Table 1, Figure 3). The nuisance alga, *Pyrodinium bahamense*, was again reported in Old Tampa Bay (OTB) during May - September 2019, contributing to a large magnitude chlorophyll-a exceedance that has persisted for a long duration (5yrs). However, it should be noted that effective light penetration was still observed to be supportive of seagrass in all bay segments, including OTB (Table 1).
