2019 Tampa Bay Water Quality Assessments

A Tampa Bay Estuary Program Initiative to Maintain and Restore the Bay's Seagrass Resources

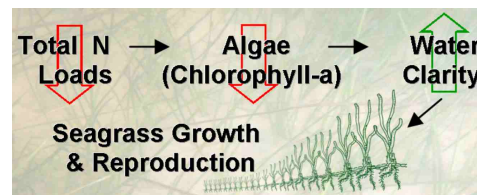
Figure 2: Seagrass restoration with N management.

Light availability to seagrass is the guiding paradigm for TBEP's Nitrogen Management Strategy. Because excessive nitrogen loads to the bay generally lead to increased algae blooms (higher chlorophyll-a levels) (Figure 2) and reduce light penetration to seagrass, an evaluation method was developed to assess whether load reduction strategies are achieving desired water quality results (i.e. reduced chlorophyll-a concentrations and increased water clarity).
