# 2019 Tampa Bay Water Quality Assessments

A Tampa Bay Estuary Program Initiative to Maintain and Restore the Bay's Seagrass Resources

# Progress Towards Meeting Regulatory Goals

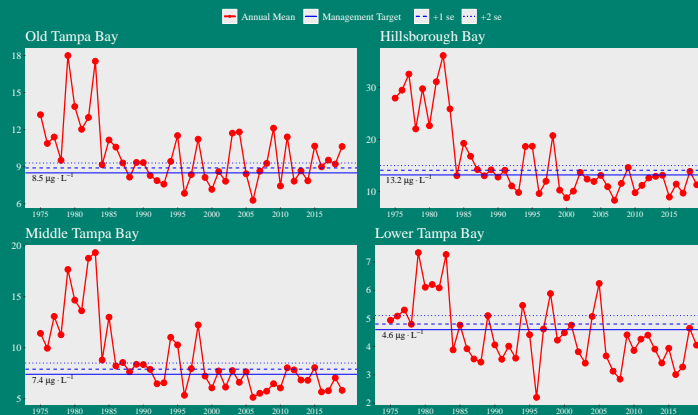
Figure 3: Historic chlorophyll-a annual averages for the four bay segments.

Water quality (chlorophyll-a and light penetration) remained supportive of seagrass in Hillsborough Bay (HB), Middle Tampa Bay (MTB), and Lower Tampa Bay (LTB) (Table 1, Figure 3). The nuisance alga, *Pyrodinium bahamense*, was again reported in Old Tampa Bay (OTB) during the Summer and Fall 2019, contributing to a small magnitude chlorophyll-a exceedance. In all bay segments, separate algal bloom events contributed to individual stations exceeding the bay segment chlorophyll-a targets (Figure 4). However, effective light penetration was supportive of seagrass in all bay segments (Table 1).
