# 2019 Tampa Bay Water Quality Assessments

A Tampa Bay Estuary Program Initiative to Maintain and Restore the Bay's Seagrass Resources

# Progress Towards Meeting Regulatory Goals

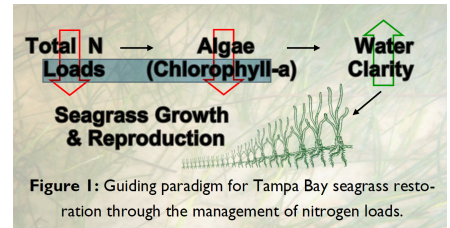
Light availability to seagrass is the guiding paradigm for TBEP's Nitrogen Management Strategy. Because excessive nitrogen loads to the bay generally lead to increased algae blooms (higher chlorophyll-a levels) (Figure 1) and reduce light penetration to seagrass, an evaluation method was developed to assess whether load reduction strategies are achieving desired water quality results (i.e. reduced chlorophyll-a concentrations and increased water clarity).

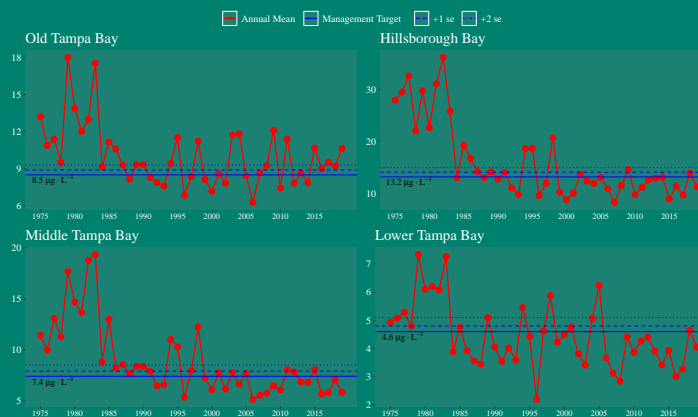
Figure 3: Historic chlorophyll-a annual averages for the four bay segments.

Water quality (chlorophyll-a and light penetration) remained supportive of seagrass in Hillsborough Bay (HB), Middle Tampa Bay (MTB), and Lower Tampa Bay (LTB) (Table 1, Figure 3). The nuisance alga, *Pyrodinium bahamense*, was again reported in Old Tampa Bay (OTB) during the Summer and Fall 2019, contributing to a small magnitude chlorophyll-a exceedance. In all bay segments, separate algal bloom events contributed to individual stations exceeding the bay segment chlorophyll-a targets (Figure 4). However, effective light penetration was supportive of seagrass in all bay segments (Table 1).

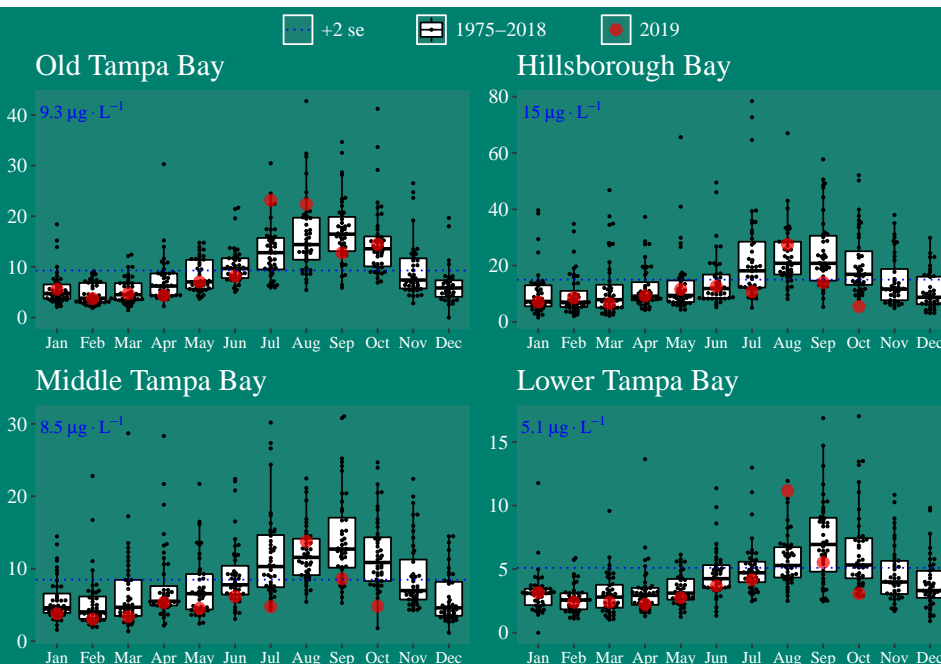
Figure 6: Chlorophyll-a monthly averages from 1975-2018 for the four bay segments. The monthly averages for 2019 are shown in red. Historic chlorophyll-a annual averages for the four bay segments.

Chlorophyll-a concentrations were evaluated within the bay on a monthly basis during 'r maxyr' and compared to prior years' levels (Figure 6). Elevated concentrations in Old Tampa Bay and Lower Tampa Bay were primarily due to *Pyrodinium bahamense* and *Karenia brevis* blooms, respectively. Hillsborough Bay also showed elevated concentrations during two months in 2018 - the fall event coincided with blooms of the nonharmful alga, *Tripos hircus*.
