Minuteman 1 Flight

12APR25

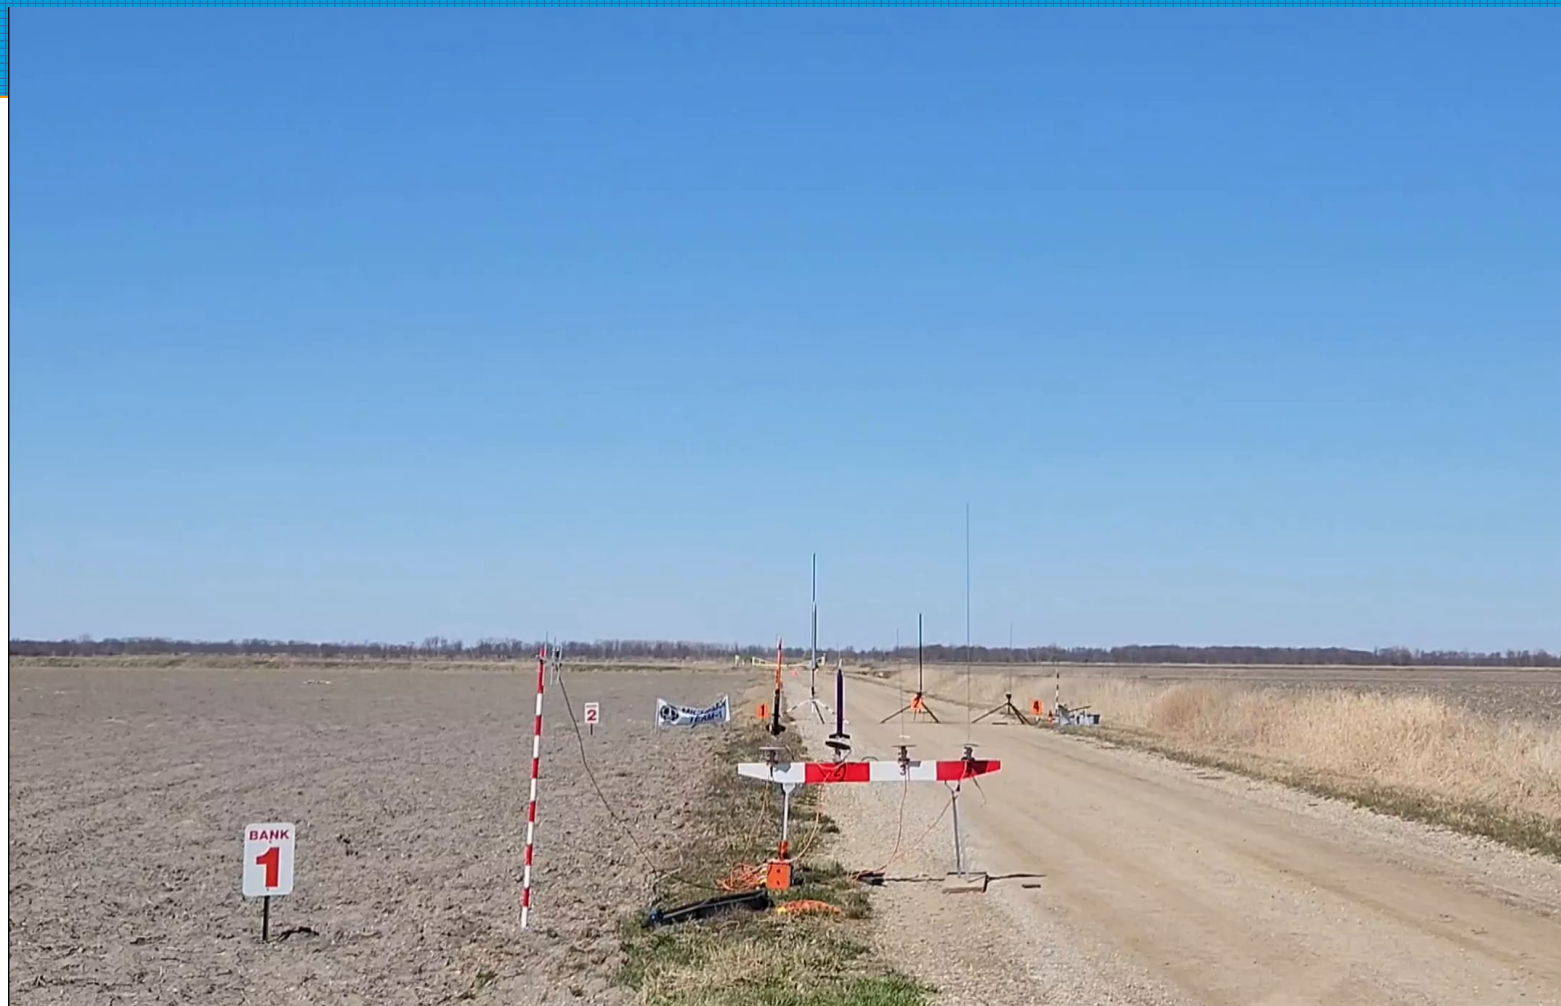
01 Takeoff

- Initial nominal takeoff
- Good angle
- Not stuck on rails

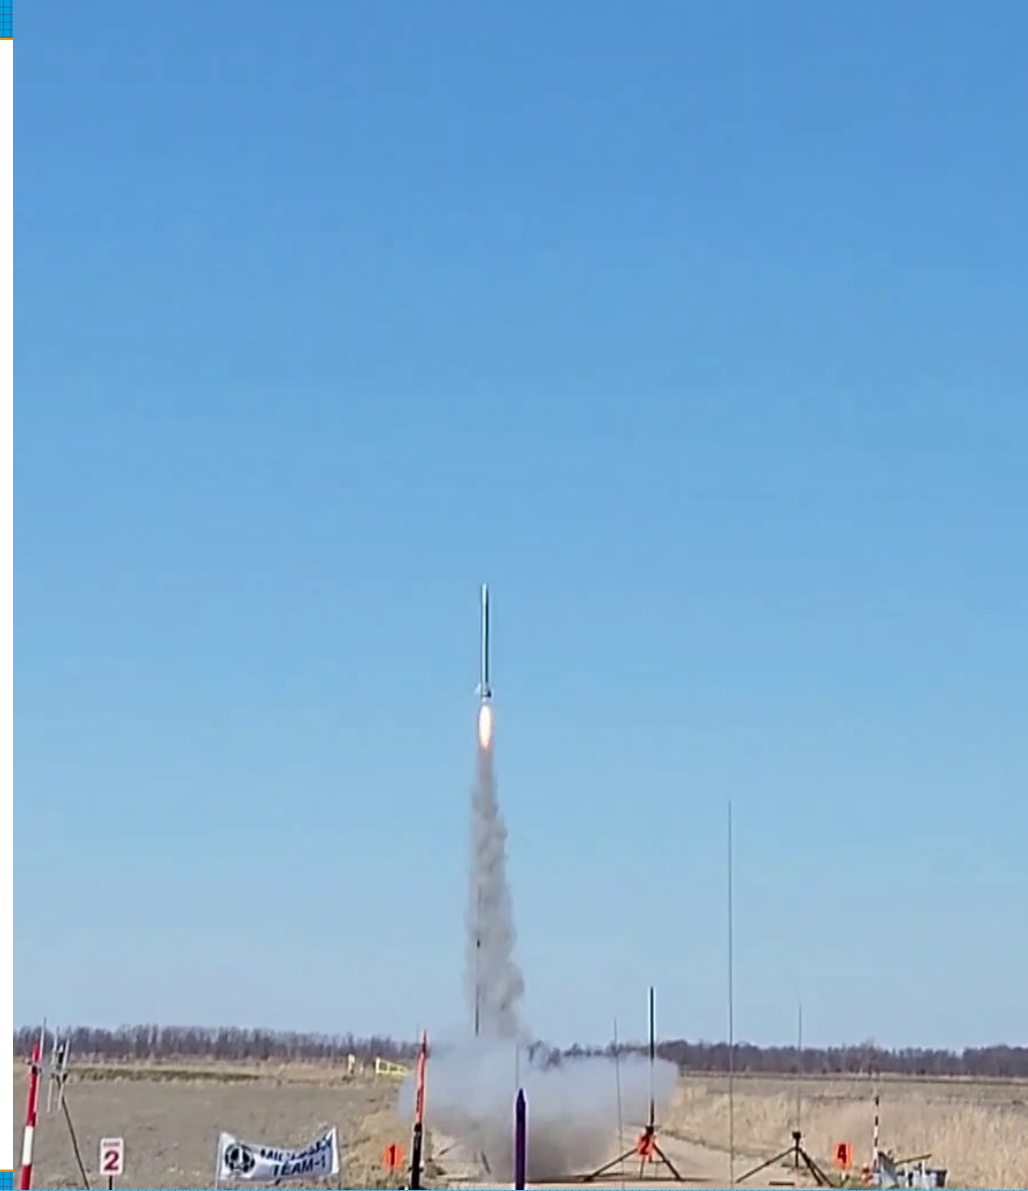
02 Stage Separation

- Stage Separation
- Due to Black Powder combustion.
- ~2.5 s into flight. Motor was set to deploy at 8 s into flight, so 5.5s early.
- No combination of delay drilling tool setup can cause this, barring catastrophe

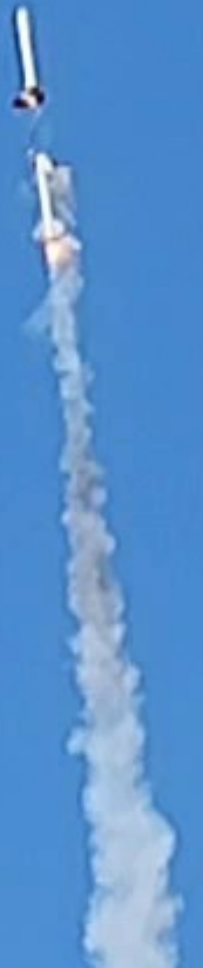
Parachute Deploys

- Parachute not caught or folded incorrectly
- Parachute behaves nominally

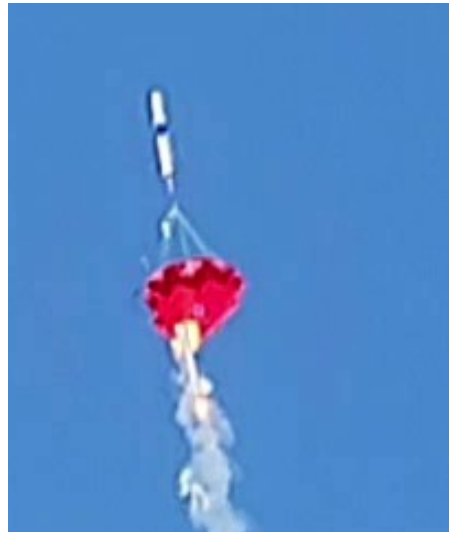
Avionics &
nose

Parachute &
rope

"fin can" &
motor

Parachute / lower stage crash

- Parachute is hit by lower stage, minor damage
 - 1 broken string
- Interstage strap burnt away roughly here, stages completely separate

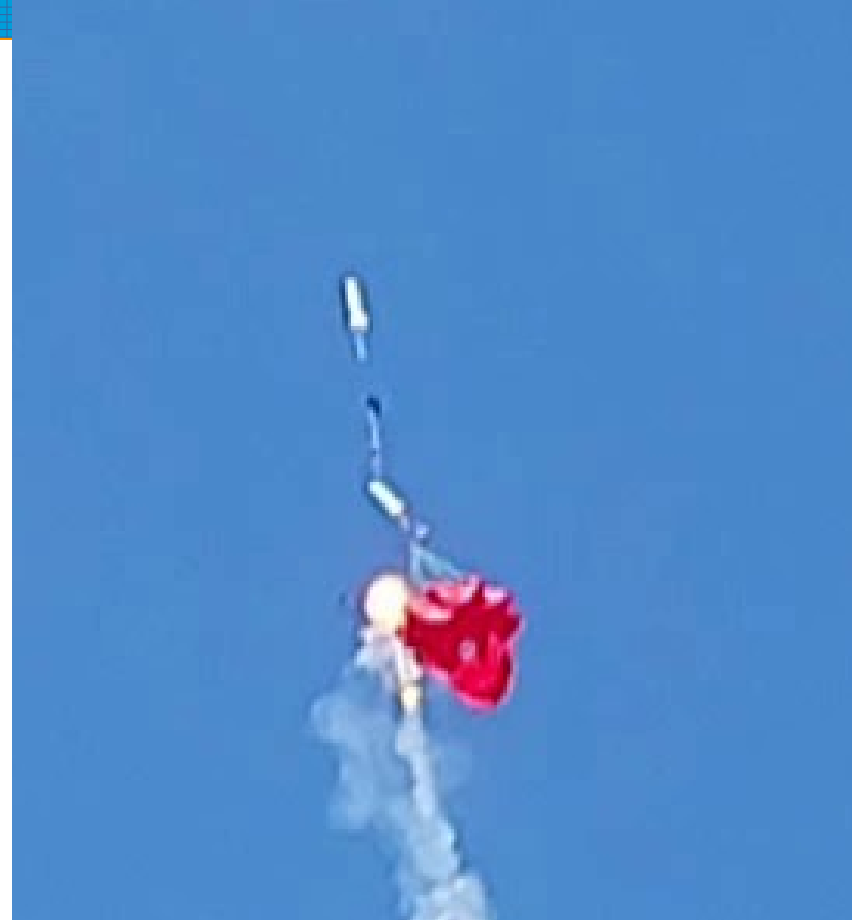
Lower stage Apogee

- Rocket motor continues combustion, under low pressure, thick clouds.
- Significant internal charring

Fireproof
blanket

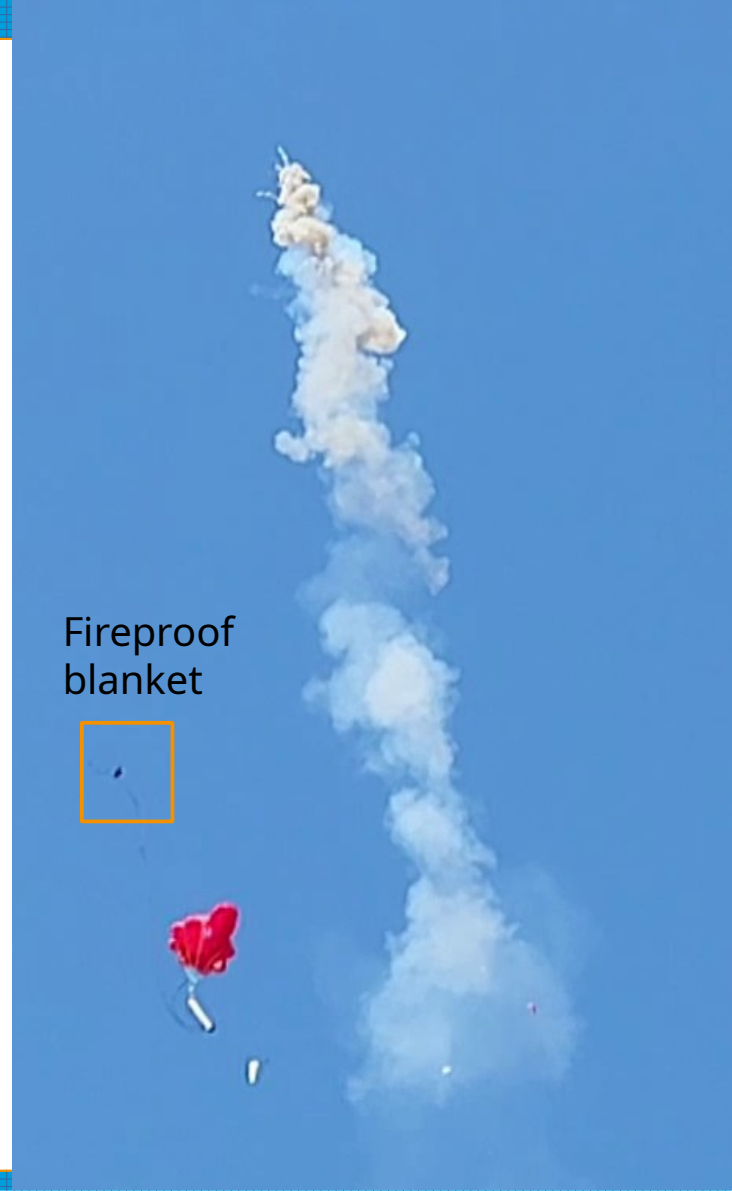
Descent

- Lower stage burns
- Visible recovery wadding (fireproof paper)

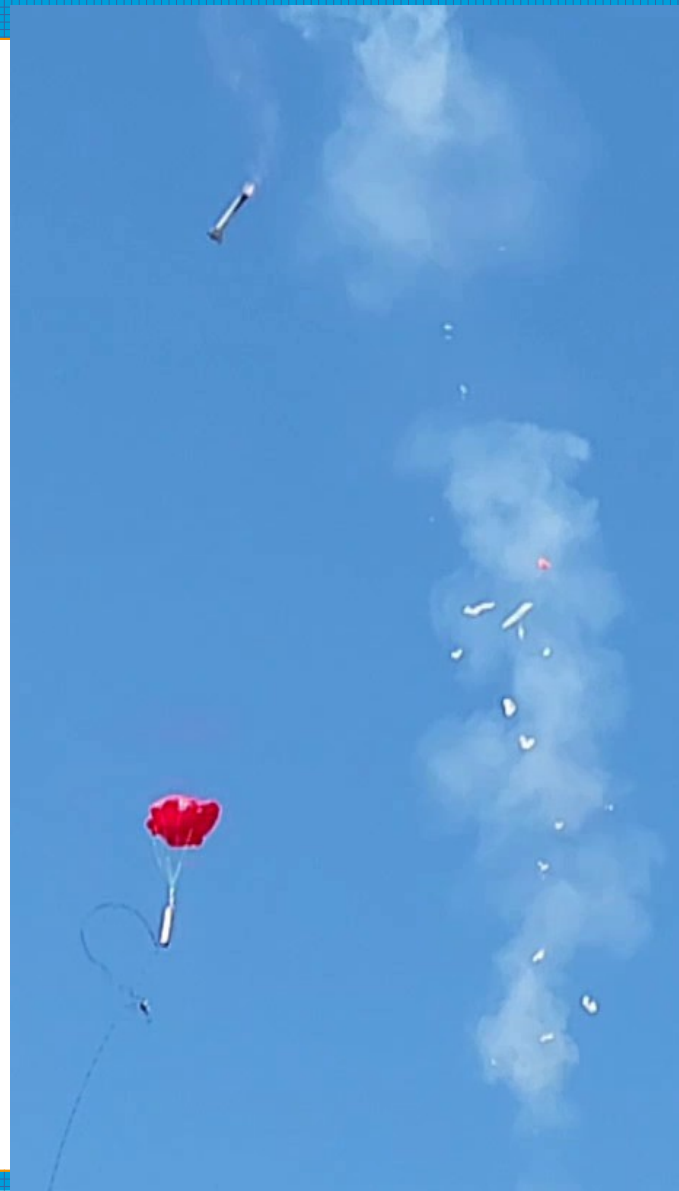
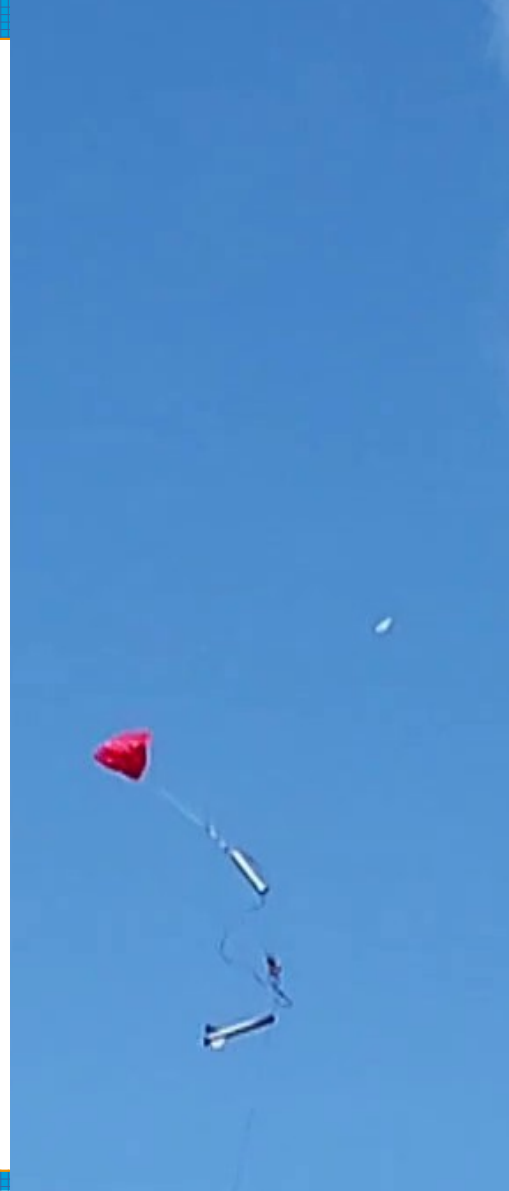
Damages

- Toasted fin can
- Melted through interstage strap
- Parachute damage
- Verdict: buy a new kit
 - \$150

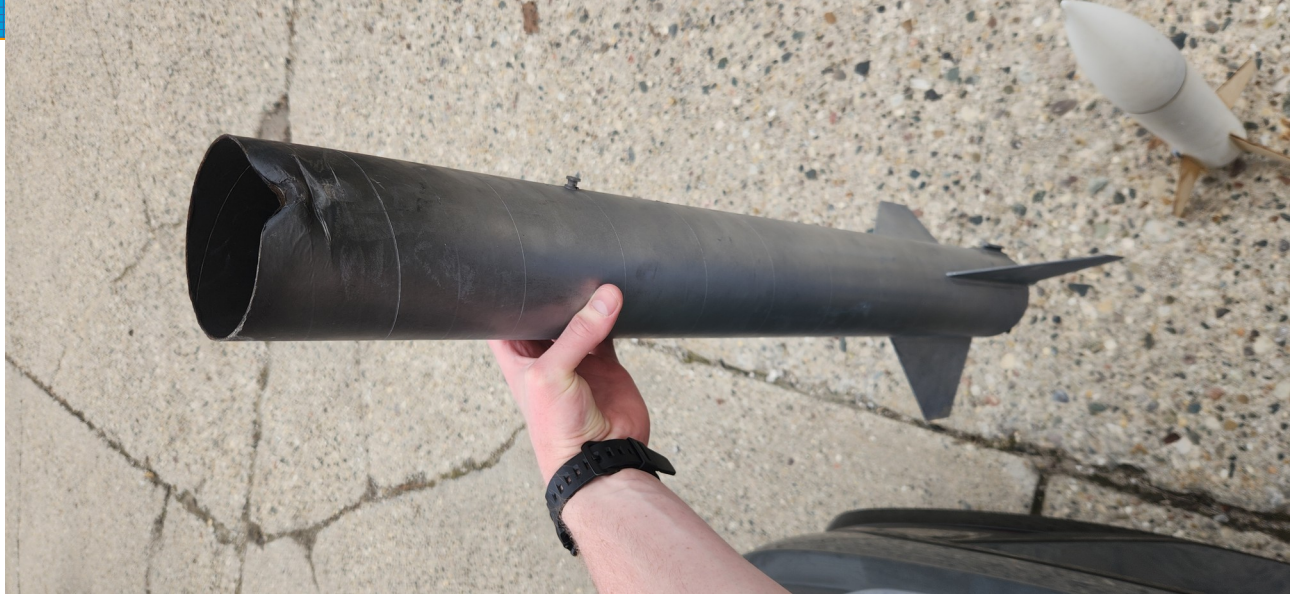
Upsides

- “Zipper” prevention worked great! Normally these events tear a crack down the side of the airframe
- 3d printed ladder I designed to spread out force from energetic deployments
- One individual in the launch video remarked “Thats gonna be a zipper” and was surprised when I showed him this portion of the rocket, almost intact, compared to what usually happens in these events.
