Address: 1800-1870 Hampton Run, Broadview Heights, OH 44147, USA

Drawing Name: 1800-1870 Hampton Run

Parjana, Inc.

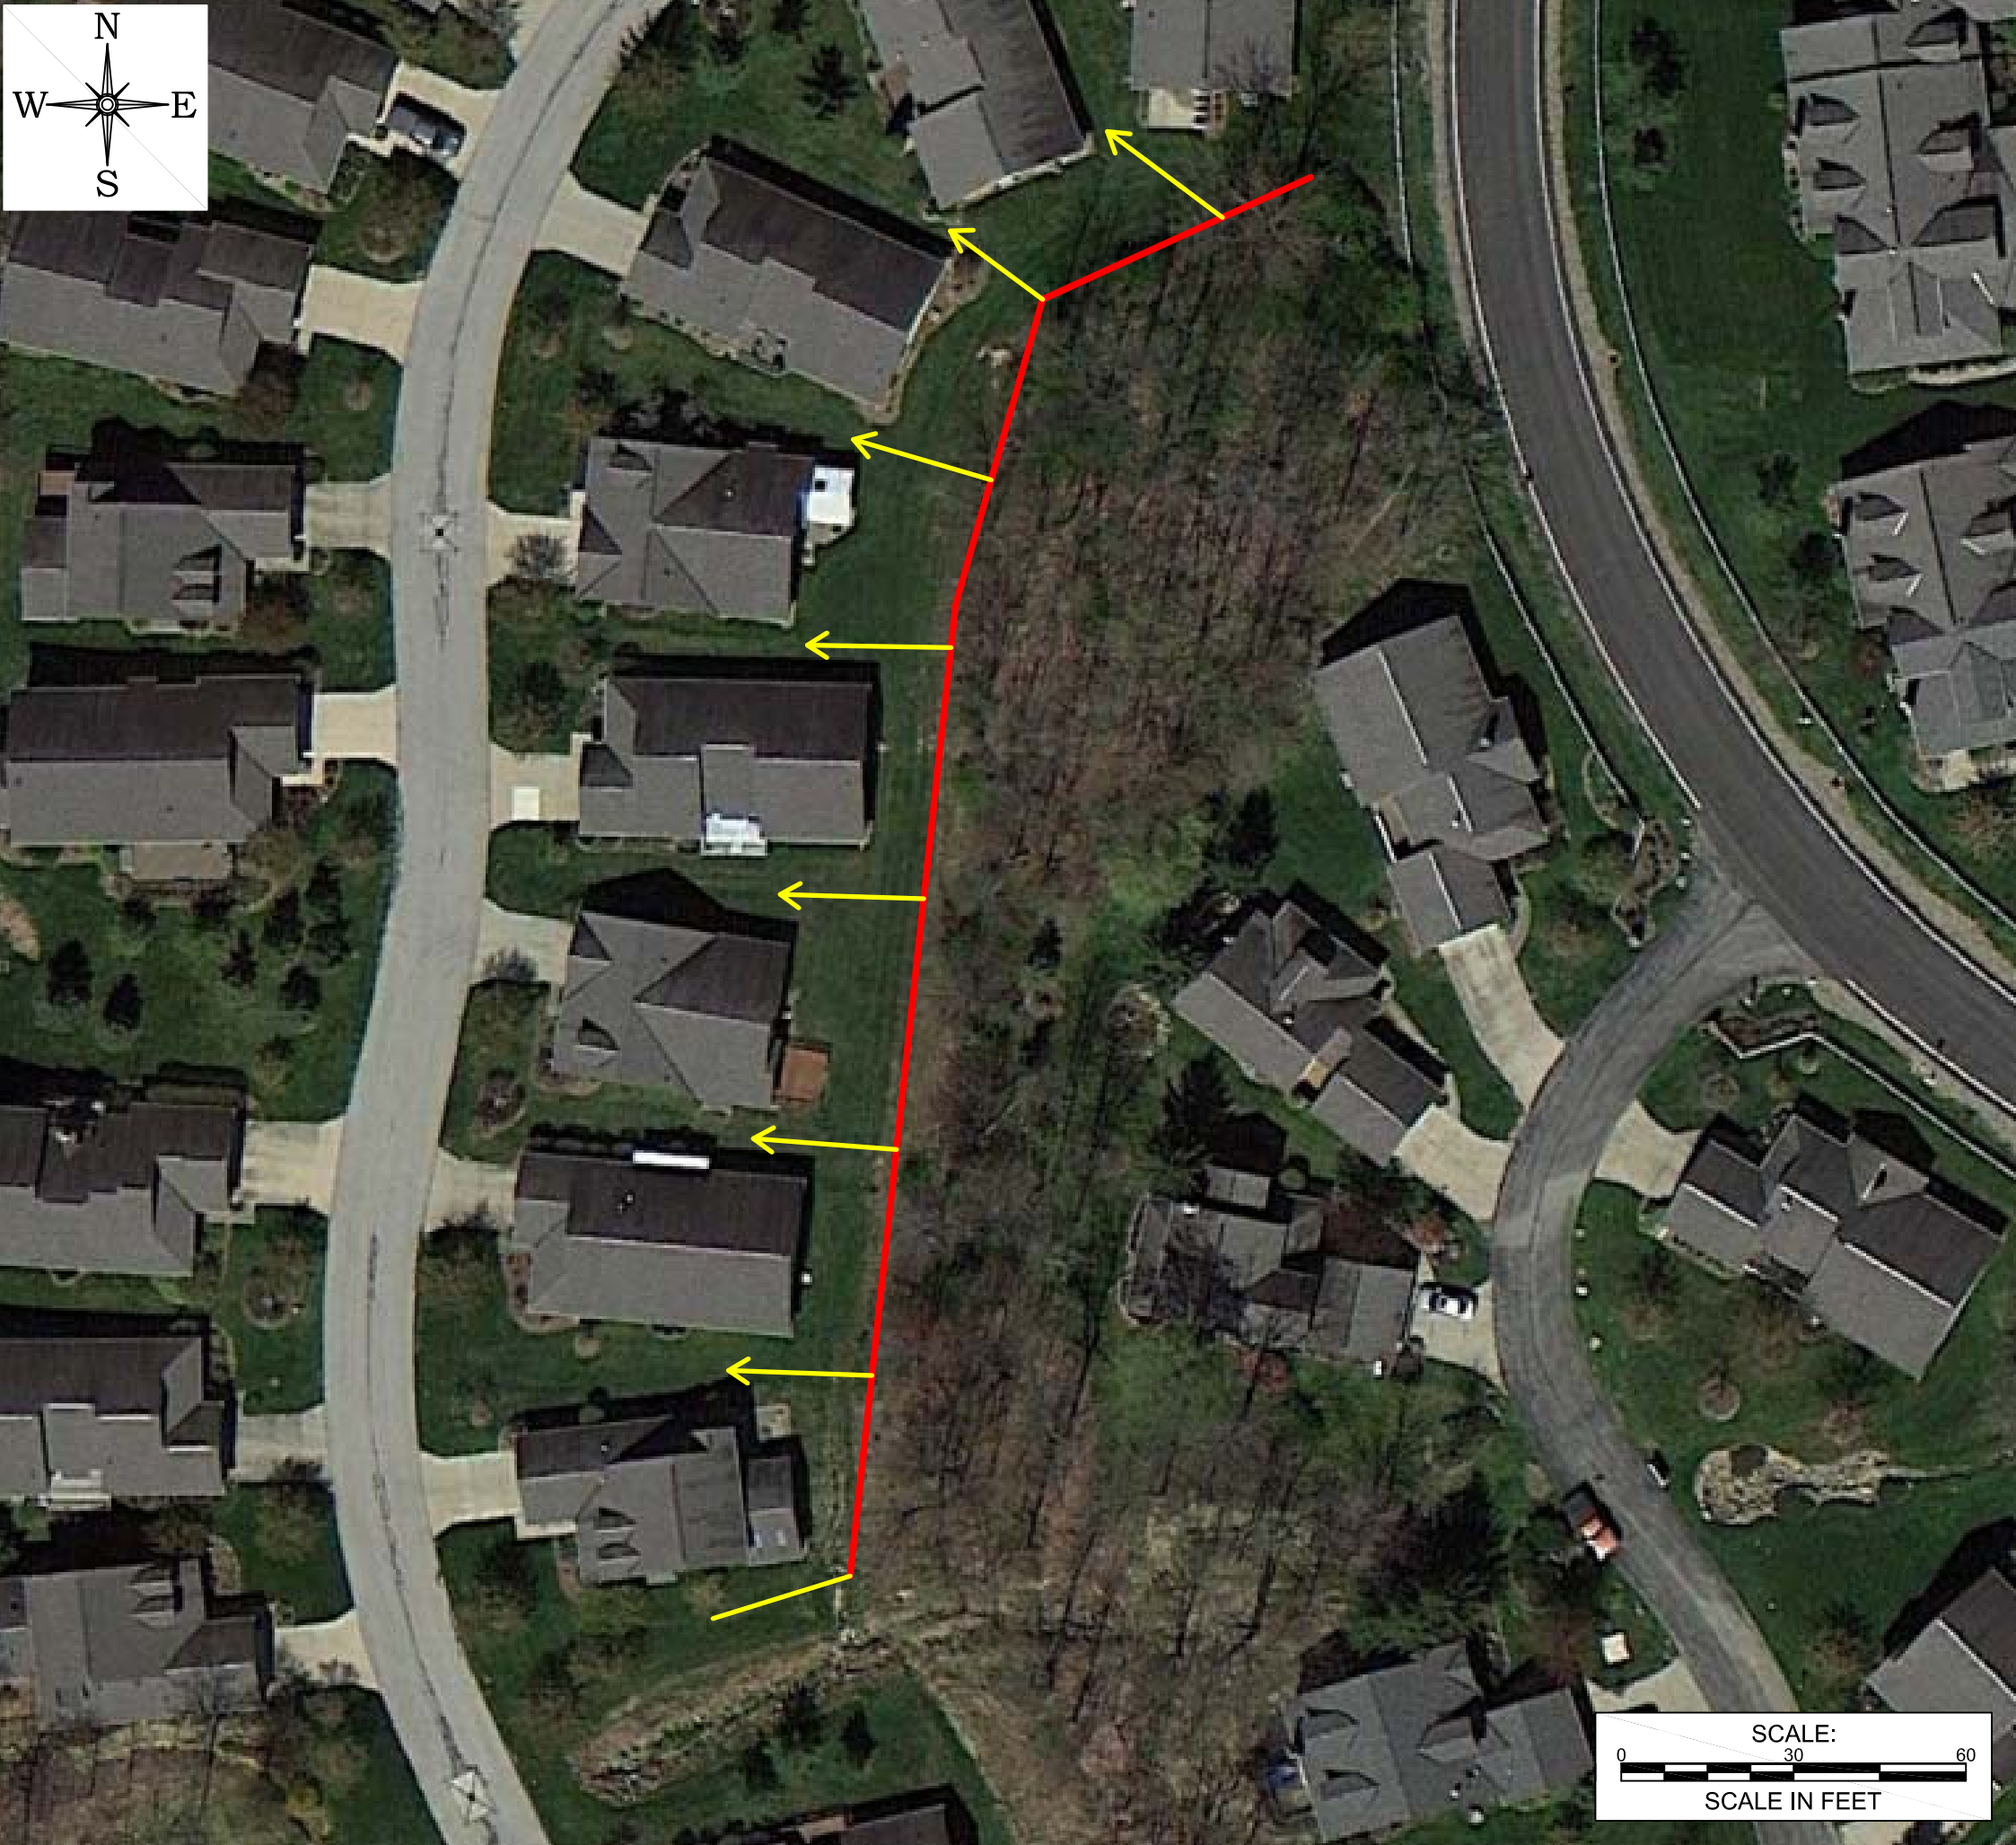
EGRP: 505 - 617
Linear Feet of EGRP: 4734' - 5786'

Water accumulation in this area is affected by the elevation drop and underground water flow moving West. To resolve the issue, EGRPs must be placed in the set locations marked by the red and yellow lines. The red line is a defined pattern of EGRPs that will work to capture and transfer water to the yellow lines. The yellow lines will then push the water below the basement foundation, allowing it to flow freely underground without any obstructions. This will diminish standing water problems in this area.
