# Brandon Phillips Field

5425 Winton Ridge Lane, Cincinnati OH 45232

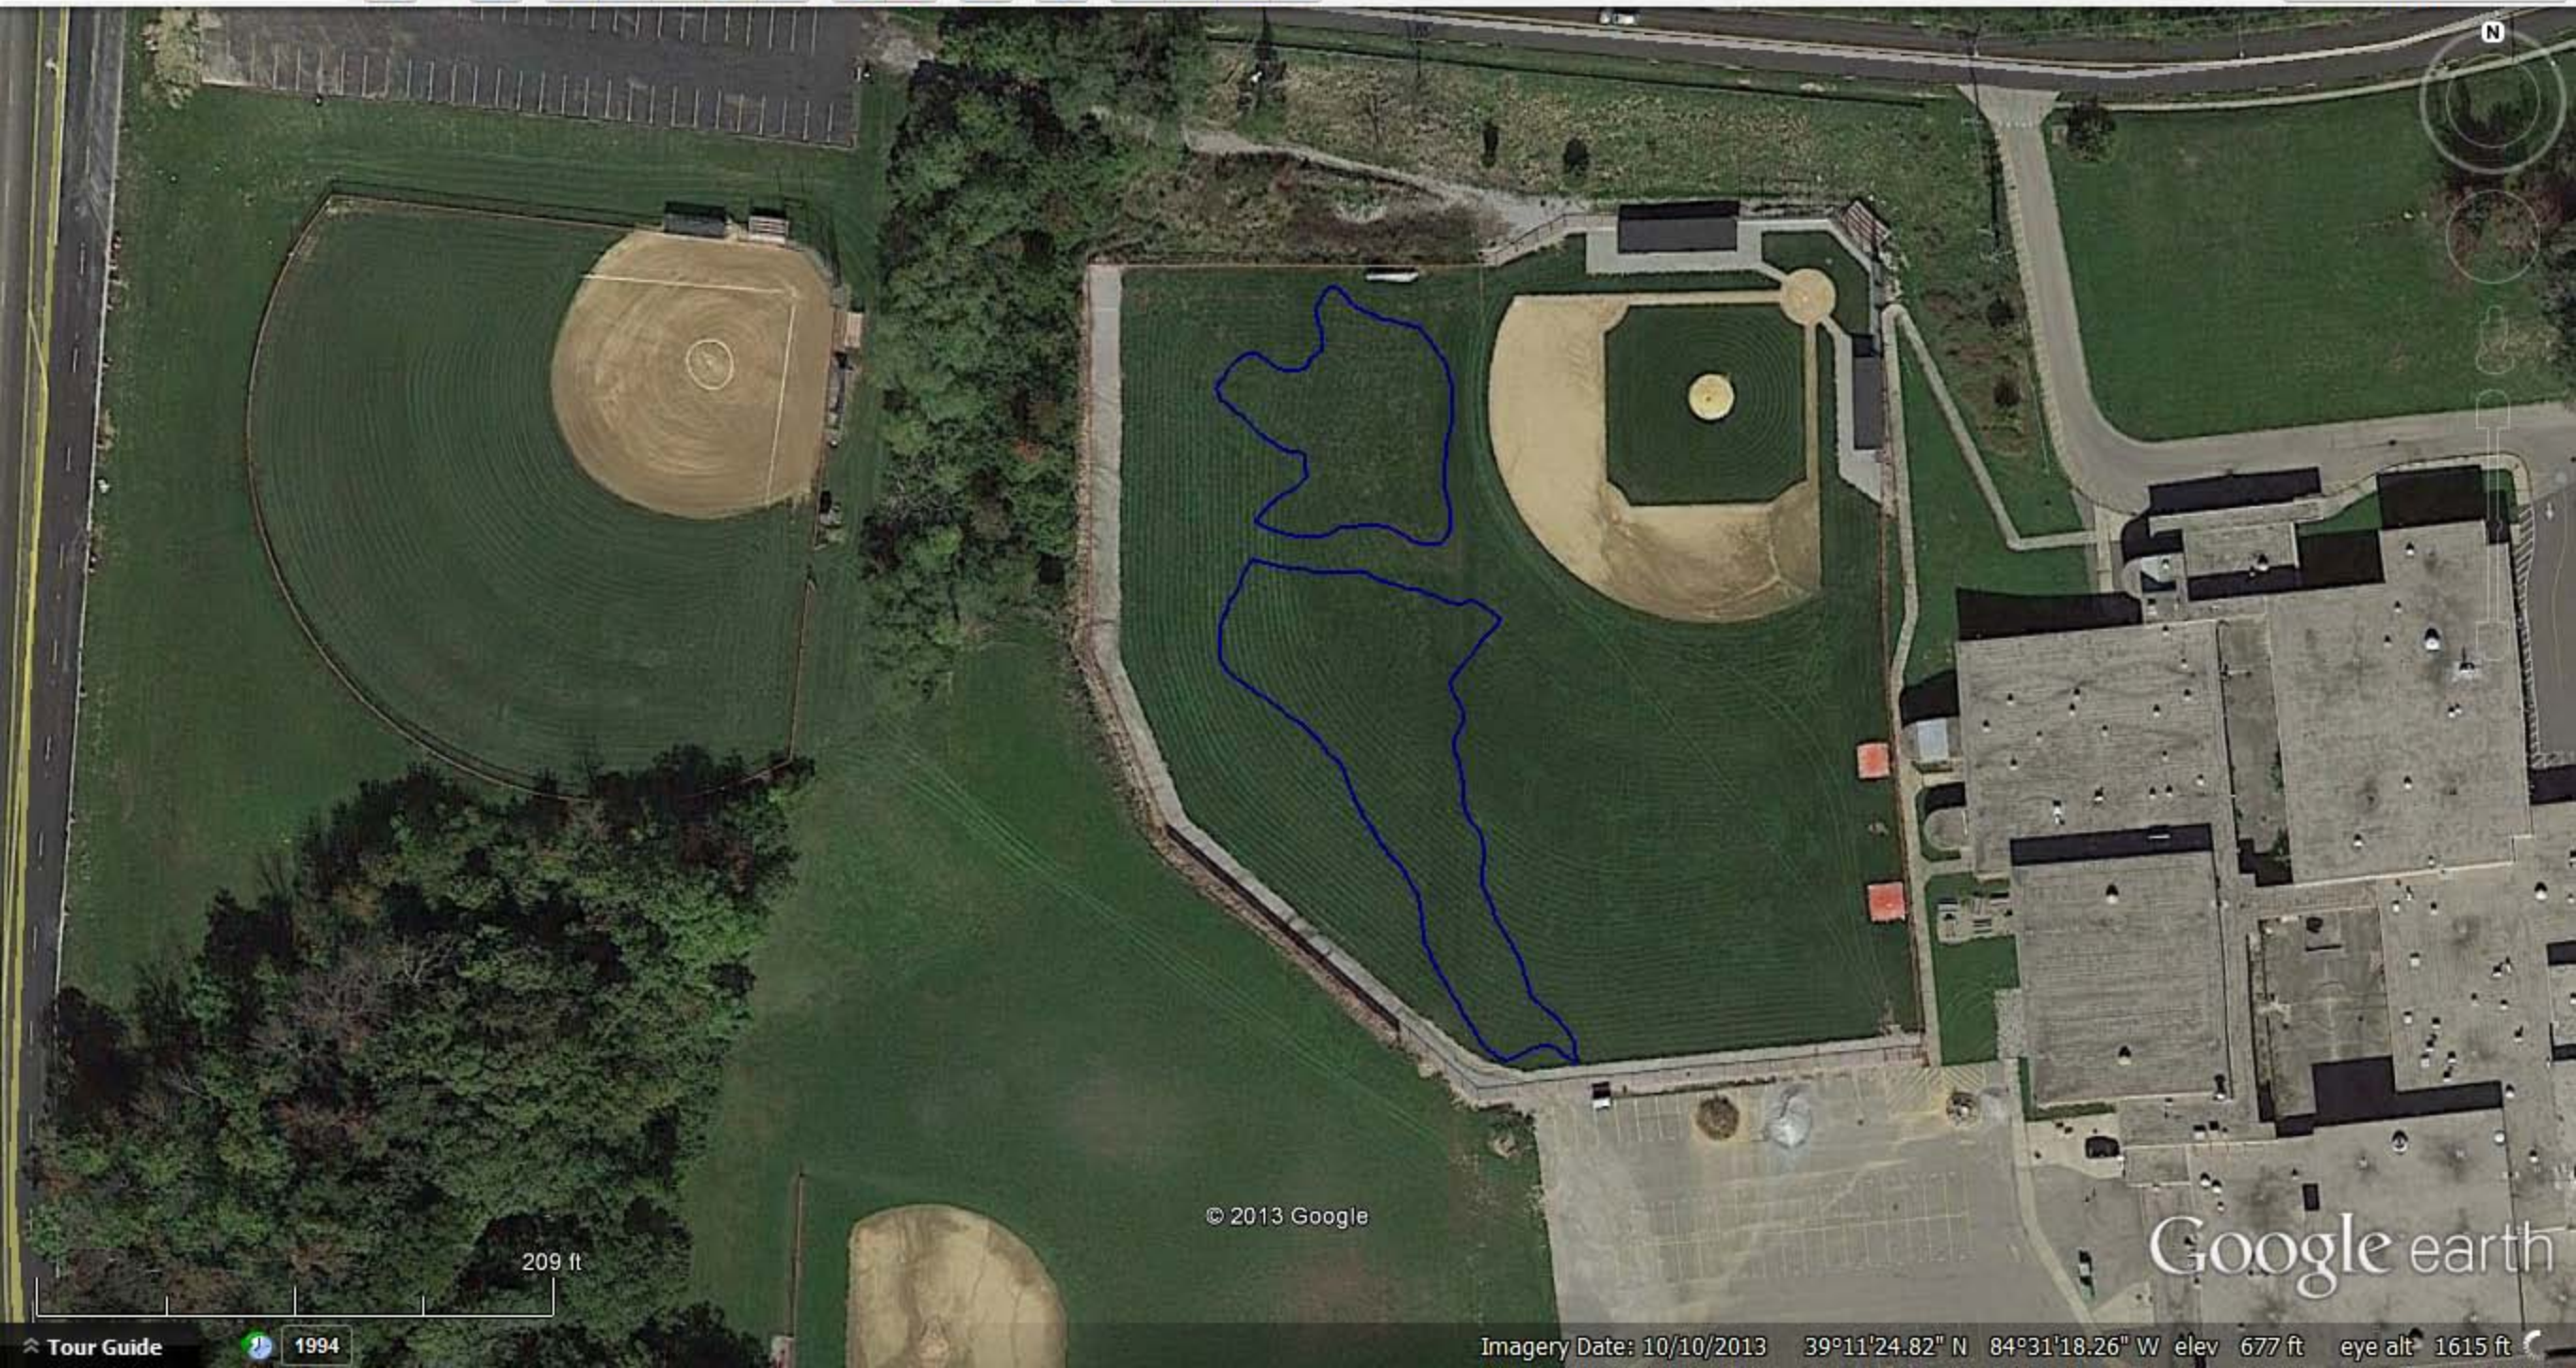
A drainage pipe was installed sometime in 2012. See #5 below for details

1. The field maintenance manager indicates that the infield and left field dry very well. These areas are even playable in the late afternoon after a heavy morning rain. The area circled on the photo can take 1 and maybe 2 days to dry after a heavy rain.
2. The right field area circled in yellow does not drain well and they often have to rope off a section of this area.
3. The Reds would like to have the right field playable when the rest of the field is playable.
4. The washout occurring where the centerfield and leftfield fence intersect is NOT a problem that the Reds are concerned about. We should not design for this issue.
5. The drain pipe is not drainage for the field itself but rather to keep the water coming downhill from the north from entering the field. So the water enters a manhole to the north of the field and takes it south end of the field to the south.
