Brandon Phillips Field

5425 Winton Ridge Lane, Cincinnati OH 45232

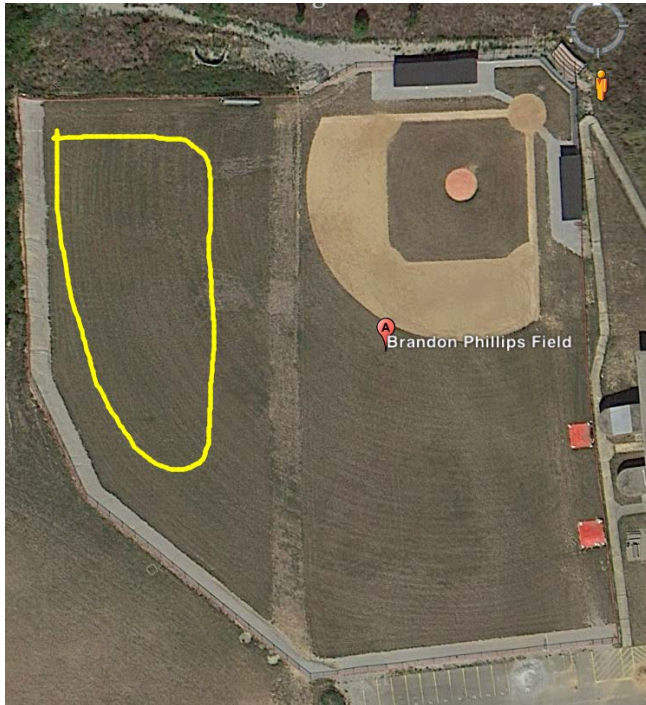
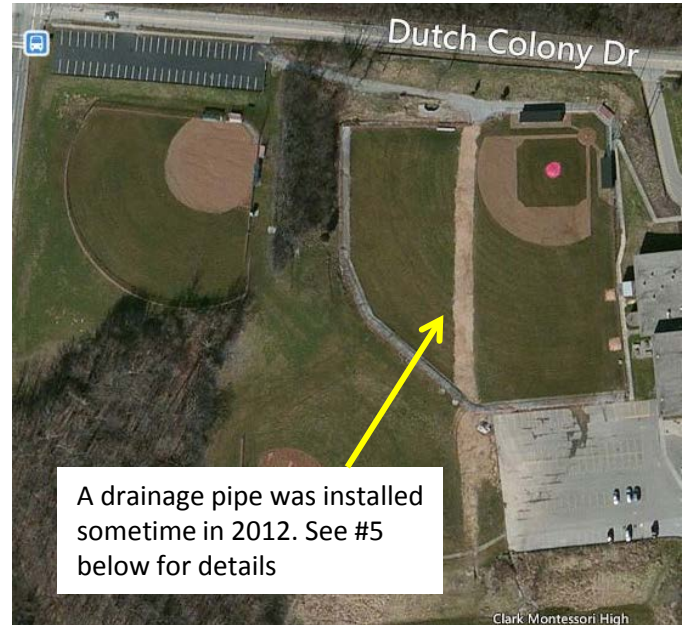
A drainage pipe was installed
sometime in 2012. See #5
below for details

1. The field maintenance manager indicates that the infield and left field dry very well. These areas are even playable in the late afternoon after a heavy morning rain. The area circled on the photo can take 1 and maybe 2 days to dry after a heavy rain.
2. The right field area circled in yellow does not drain well and they often have to rope off a section of this area.
3. The Reds would like to have the right field playable when the rest of the field is playable.
4. The washout occurring where the centerfield and leftfield fence intersect is NOT a problem that the Reds are concerned about. We should not design for this issue.
5. The drain pipe is not drainage for the field itself but rather to keep the water coming downhill from the north from entering the field. So the water enters a manhole to the north of the field and takes it south end of the field to the south.
