# AAA PROPERTY SERVICES

## Additional Items

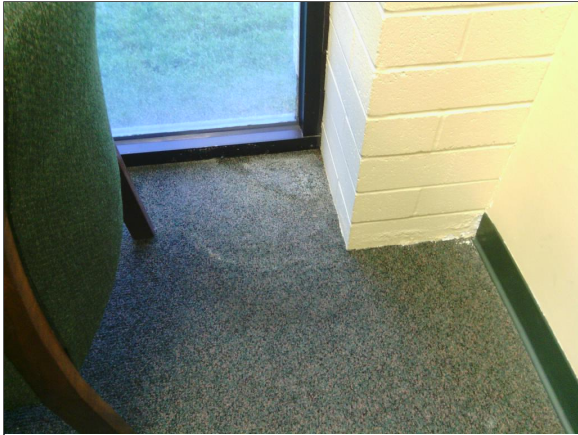
Back office (Debi Engelbrecht) has moisture intrusion at lower window corner. Previously repaired in 2009, this is an issue again.
