# Application Note

## DP83867 Troubleshooting Guide

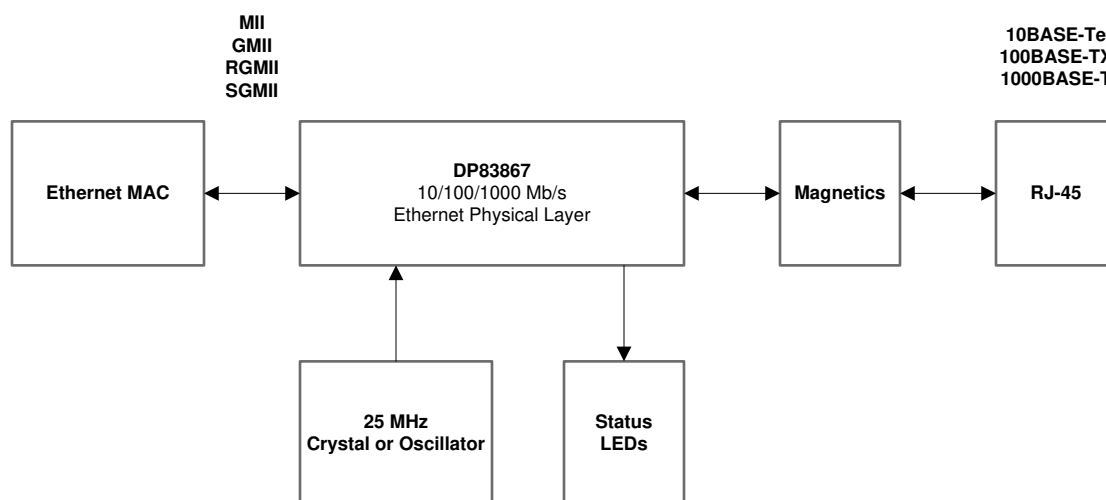
**Figure 1-1. DP83867 Block Diagram**

Figure 1-1 is a high-level system block diagram of a typical DP83867 application.

The DP83867 can connect to an Ethernet MAC and to a media. The connection to the media is via a transformer and a connector.

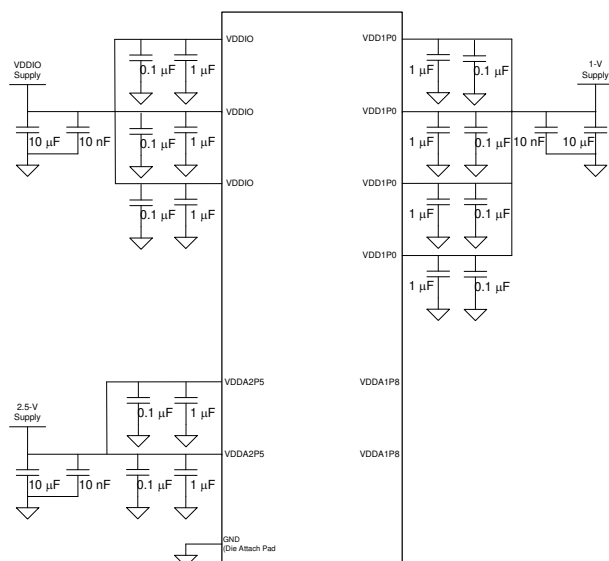
**Figure 2-1. Two Supply Configuration**

The DP83867 supports two configurations for power supplies as shown in [Figure 2-1](#) and [Figure 2-2](#). DP83867 can operate with as few as two supplies. When operating in the three-supply configuration, the VDDA1P8 supply

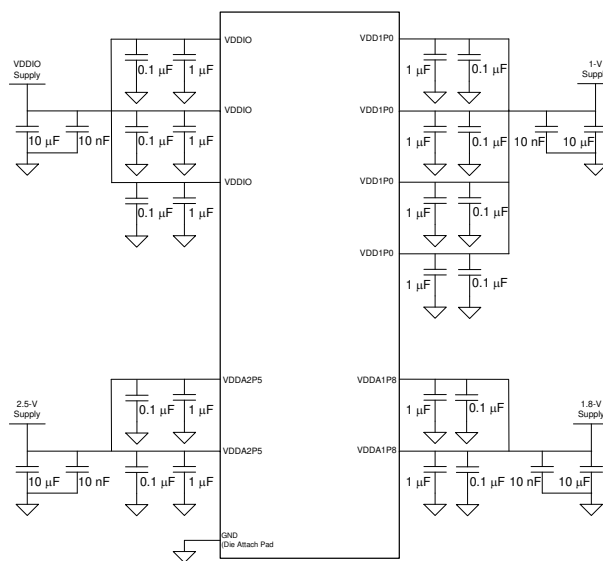
**Figure 2-2. Three Supply Configuration**

must be stable within 25ms of the VDDA2P5 supply ramping up. There is no sequencing requirement for other supplies when operating in three supply mode. When powering down the DP83867, the VDDA1P8 supply needs to be brought down before the VDDA2P5 supply. Power up the board and verify the sequence of these supplies with an oscilloscope.

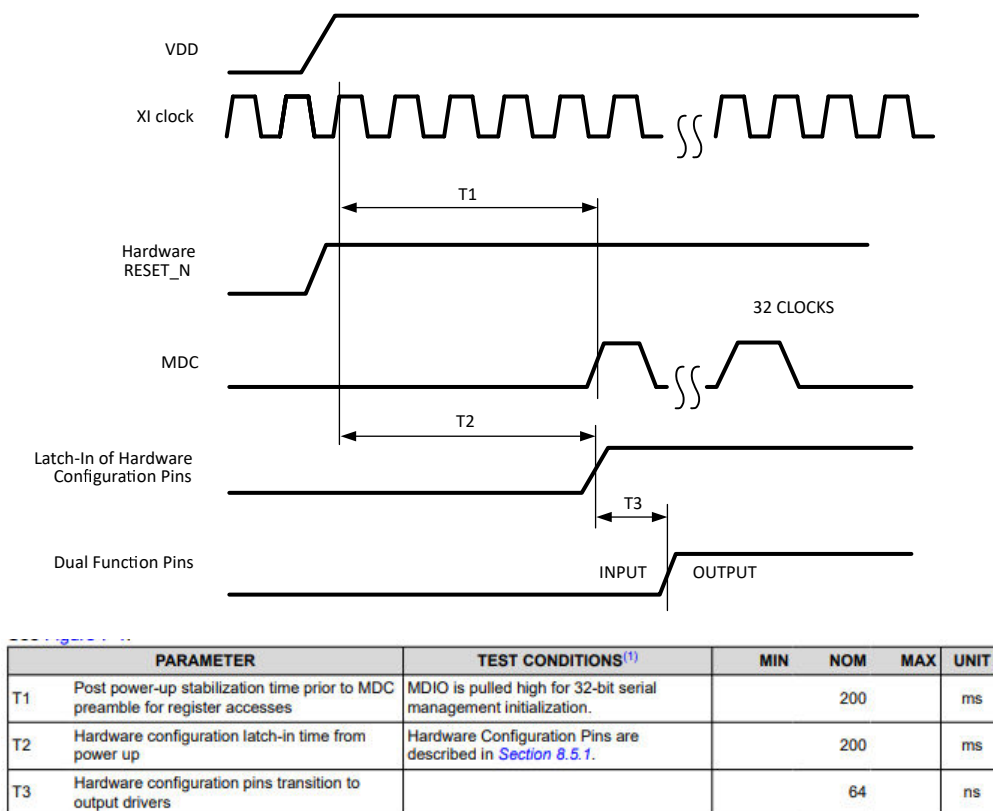
**Figure 2-3. Strap Latch-in Process**

Strap Latch-in process occurs during power up process. Latch-in event normally occurs within 200ms after VDD pull up.

For further confirmation, the strap values can be read from the registers. The values are available in register 0x006E (STRAP\_STS1) and register 0x006F (STRAP\_STS2). [Section 3.8.2](#)

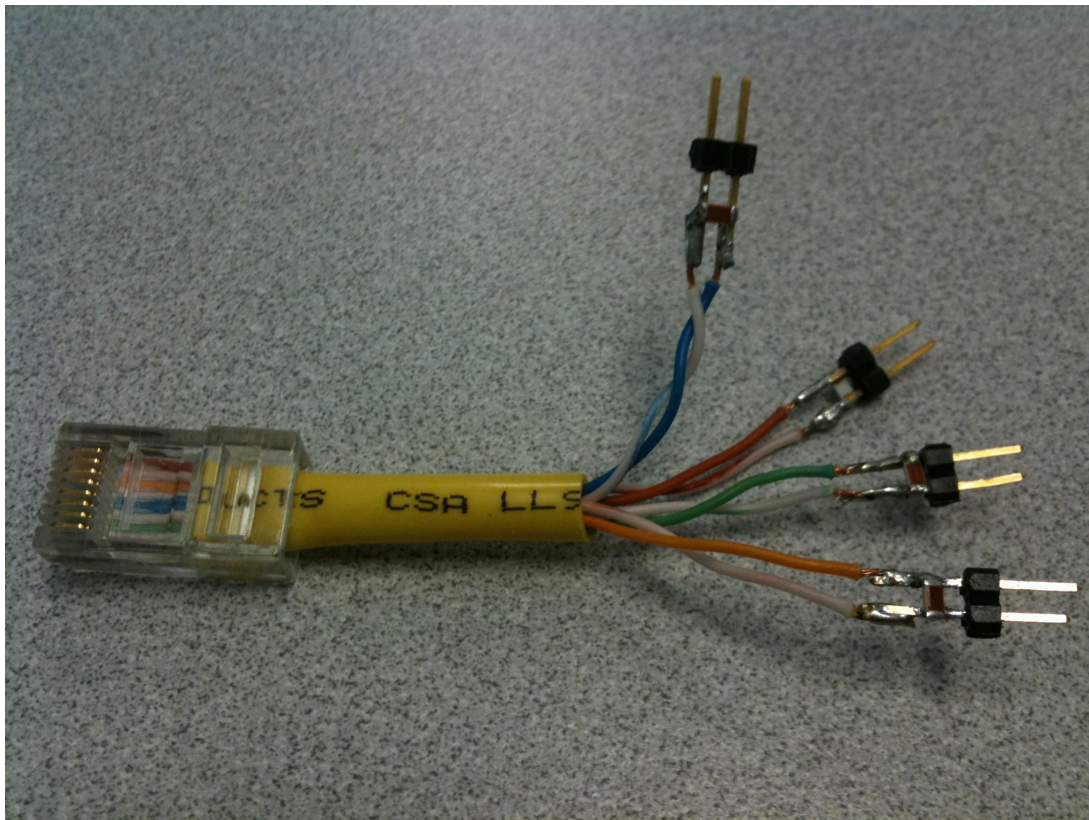
Figure 2-6. 100 Ohm Terminated Cable for MDI Signal Measurement

A short Ethernet cable with 100 Ohm terminations can be used for measuring the MDI signals. A terminated cable is shown in Figure 2-6. A connection diagram for making measurements with the terminated cable is shown in Figure 2-7.

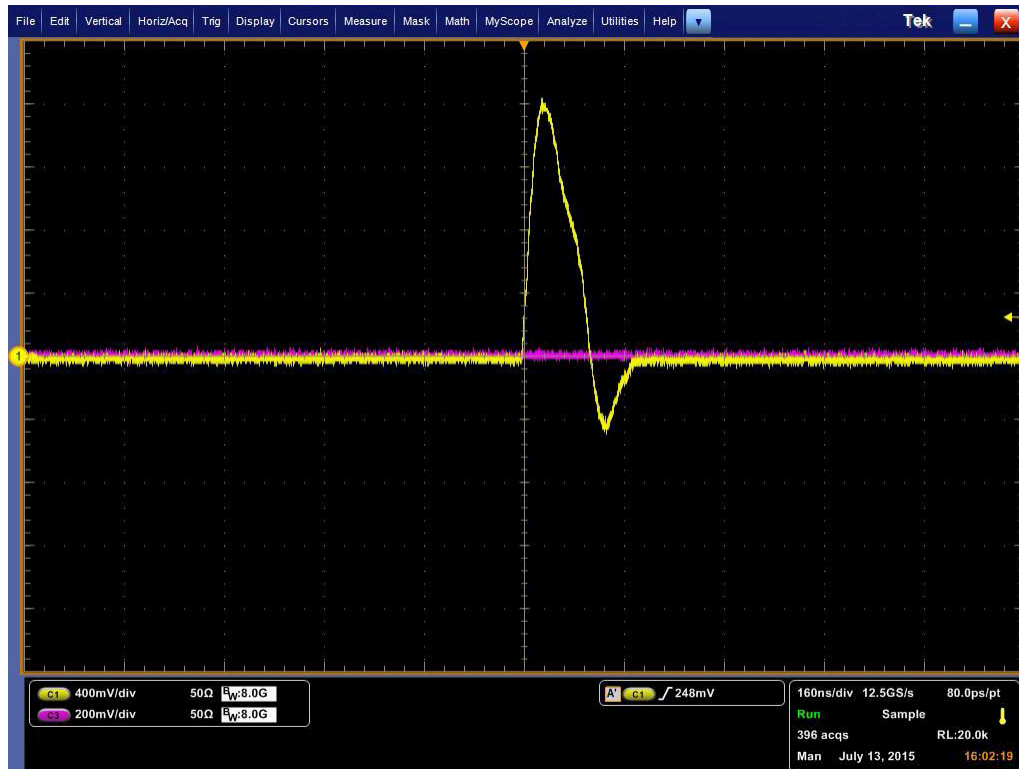
**Figure 2-8. DP83867 Link Pulse**

Auto-Negotiation link pulses are nominally 100ns wide. Pulses are spaced by 62μs or 125μs and are transmitted in bursts. The bursts are nominally 2ms in duration and occur every 16ms. An example link pulse is shown below in [Figure 2-8](#).

Observing this pulse confirms the PHY is on and attempting to link.

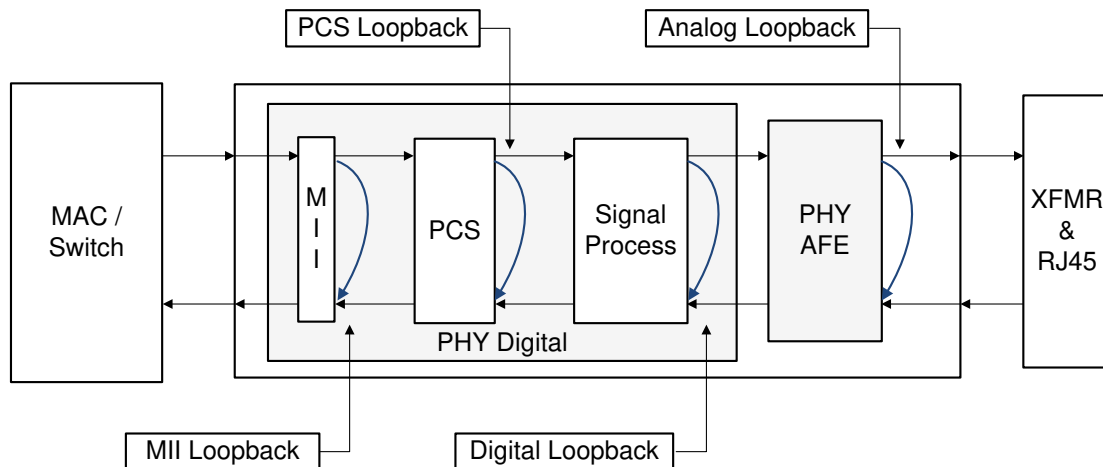
**Figure 2-9. Block Diagram, Loopback Modes**

Loopback mode could determine the communication issue occur on MAC < -- > PHY or PHY < -- > PHY. MII loopback, PCS loopback, Digital Loopback, and Analog Loopback could isolate the PHY < -- > PHY communication. Reverse Loopback could isolate the MAC < -- > PHY communication. The following diagrams illustrate the various loopback mode that DP83867 have:

Analog loopback is typically used to verify the PHY's full internal data path, while reverse loopback is used with a link partner to verify the data path along the MDI.

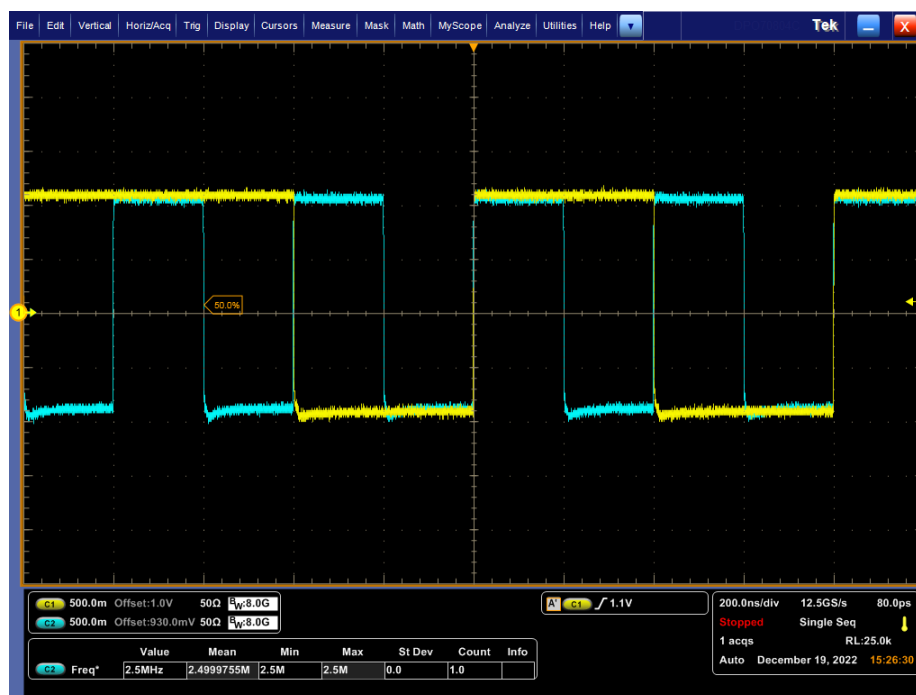
**Figure 2-11. 10 Mbps Data Aligned with RX\_CLK**

Verify the frequency of the clock (C2) as 2.5MHz, and the data (C1) being sampled at the rising edge of the clock.

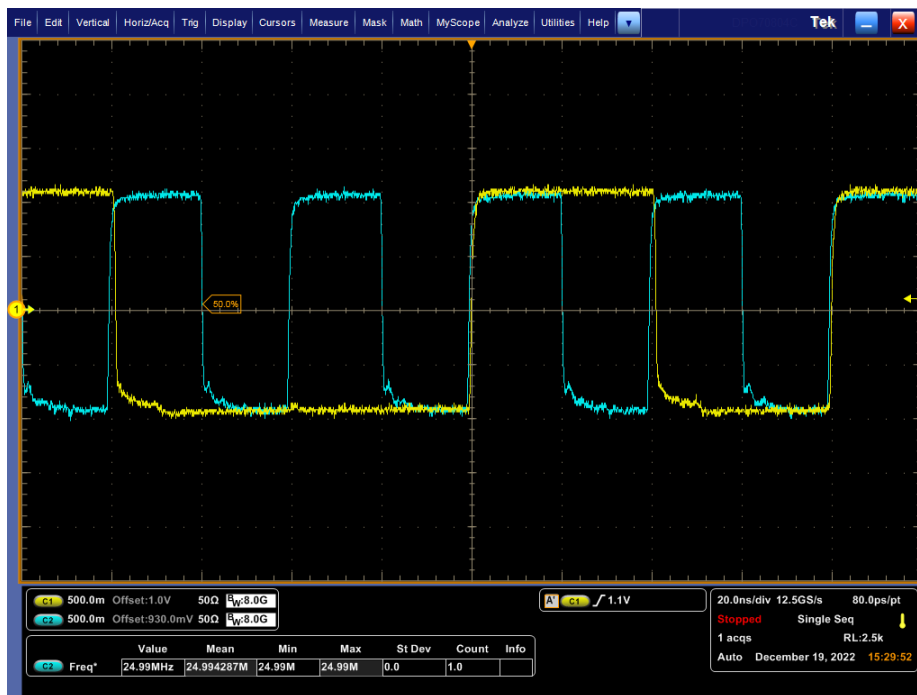
Figure 2-12. 100 Mbps Data Aligned with RX\_CLK

Verify the frequency of the clock (C2) as 25MHz, and the data (C1) being sampled at the rising edge of the clock.

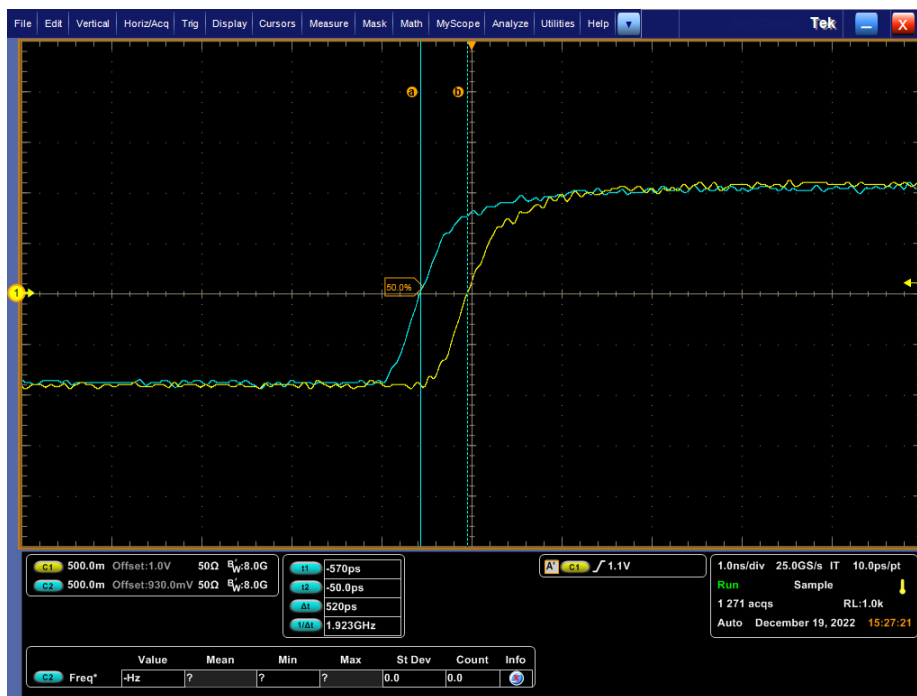
Figure 2-13. 10Mbps Data and Clock Delay in Align Mode

Verify the delay between clock and data is <500ps in align mode.

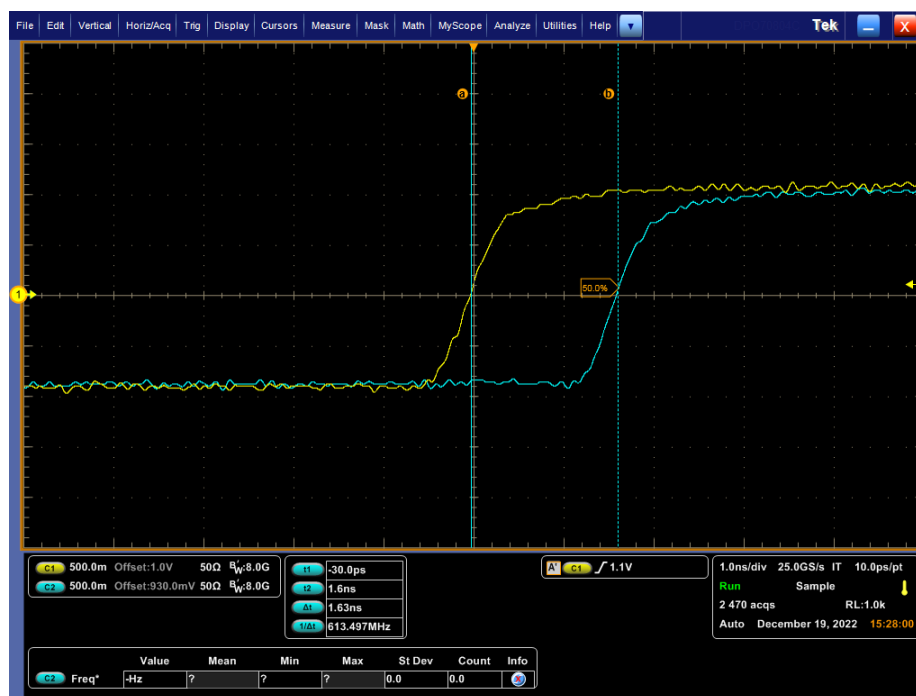
Figure 2-14. 10 Mbps Data and RX\_CLK in Shift Mode (4ns Programmed Delay)

Verify the delay between clock and data is >1ns in shift mode. The programmed delay is relative to the clock's initial position in aligned mode. Measuring the difference in the clock's position before and after setting shift mode yields a value closer to the programmed delay.

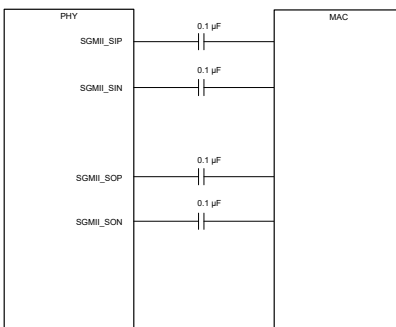
1. Check register 0x0037 bit[1:0] for link up status of SGMII interface.
2. Check schematic on SGMII lines make sure there is 0.1uF DC blocking caps.

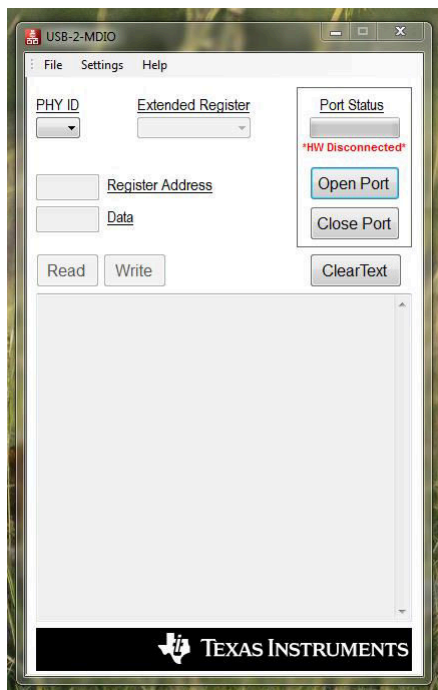
**Figure 3-1. USB-2-MDIO GUI**

If register access is not readily available in the application, USB-2-MDIO GUI is available from TI and can be used with an MSP430 Launchpad, and purchased through [TI.com](http://ti.com). The GUI supports reading and writing registers as well as running script files. USB-2-MDIO GUI can be used with the DP83867 and the other devices in TI's Ethernet portfolio. The USB-2-MDIO User's Guide and GUI are available for download at: [USB-2-MDIO serial management tool](#).
