BURNED-AREA REPORT
(Reference FSH 2509.13)

- A. Fire Name:** Pole Creek Fire
- B. Fire Number:** OR-DEF-000537
- C. State:** OR
- D. County:** Deschutes
- E. Region:** R6
- F. Forest:** Deschutes National Forest
- G. District:** Sisters Ranger District
- H. Fire Incident Job Code:** P6G7ZZ
- I. Date Fire Started:** September 9, 2012
- J. Date Fire Contained:** October 17, 2012
- K. Suppression Cost:** \$17,790,000 (as of 10/16/12)

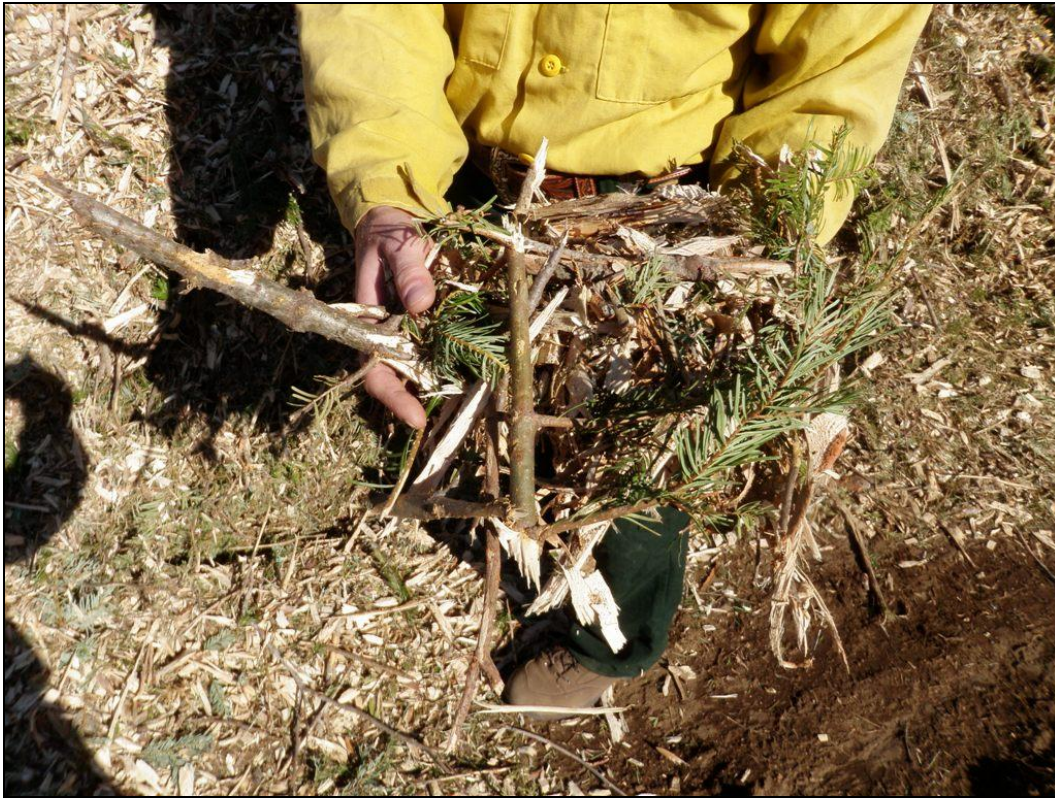
Figure 1: A sample of the native mulch material stockpiled at the Pole Creek Fire.

Through fire suppression prep work, a lot of roadside vegetation was thinned to reinforce the perimeter fire lines. Much of this material was chipped and stockpiled in various locations for potential rehabilitation use. See Photo 1. The mulch material is a mix of fine chips, needles, larger shreds and small branches. Photo 2 shows some of the side slopes that would be treated with mulch. **Recommended Treatment (L1 Aerial Application of Biomass)**

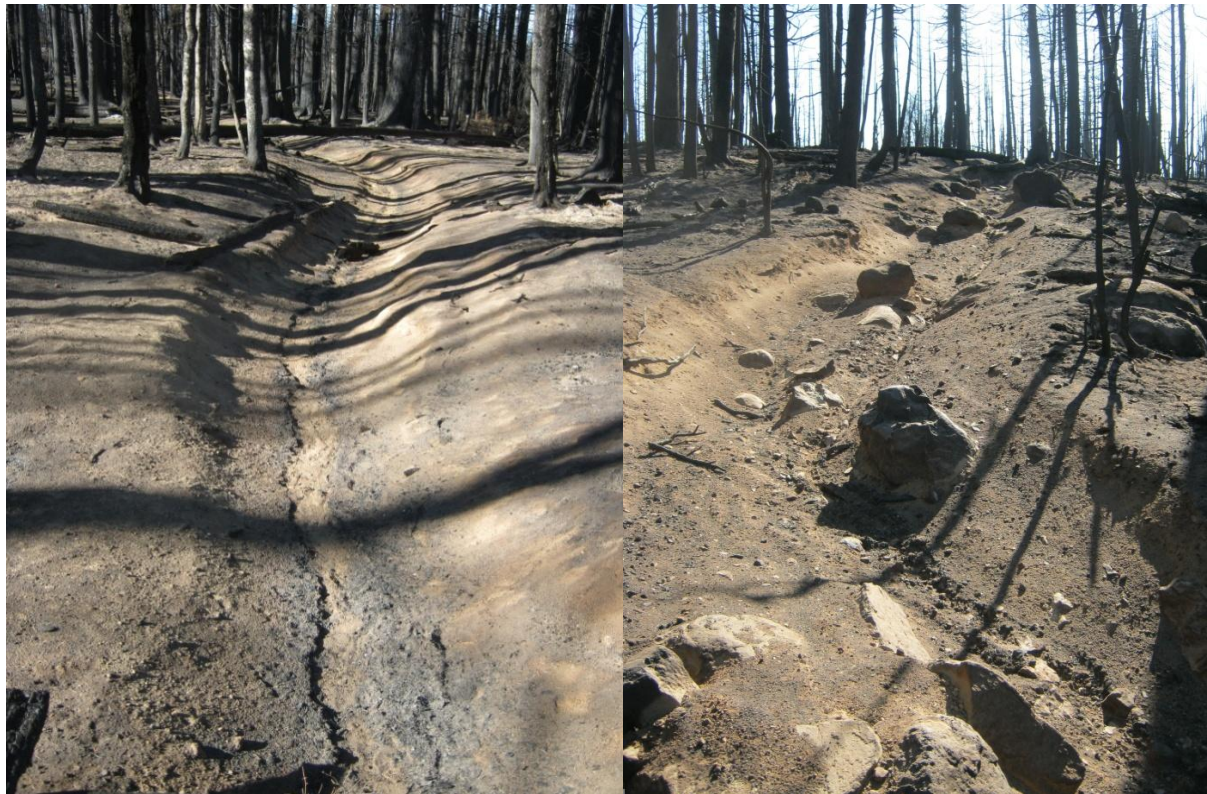
Figure 3: Portions of the Metolious-Windigo Horse Trail showing loss of drainage structures and potential for erosion.

- Trail System Emergency Drainage Control and Tread Stabilization – The Metolious-Windigo Horse Trail received a significant amount of fire related damage to trail tread and erosion control devices (wooden water bars). The segment of trail surveyed (from upper Three Creeks Snow Park to Park Meadow trail) received severe fire damage along most of its length. The critical issue for this trail is damage to the trails tread and drainage structures. This, as indicated by a minimal amount of rain that fell in Sept during the fire, is highly susceptible to water channeling and erosion. The hydrophobic condition of the severely burned soils coupled with the slope and terrain along this trail will result in severe sheet flow onto and down the trail. To protect the values at risk, rock and log water bars and check dams will need to be installed and in some areas the trail berms will need to be pulled in to prevent water from concentrating in the trail.

Without treatment, the probability of impacts to significant investments on or in close proximity to the burned National Forest lands is Very Likely, and the magnitude of consequences is Moderate leading to a Very High risk determination. **Recommended Treatment (R8 Trail System Emergency Drainage and Tread Stabilization).**
