# LODGEPOLE FIRE

## FS-2500-8 BURNED-AREA REPORT

SALMON-CHALLIS NATIONAL FOREST  
INITIAL REPORT  
OCTOBER 1, 2013

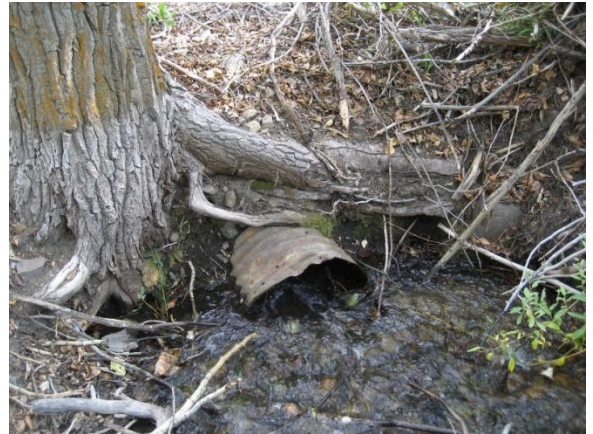
Challis Creek Road (FR#080): Forest Road #080 provides access up Challis Creek to Mosquito Flat Reservoir. This is a well maintained, well-traveled road. Post-fire flood risks to this road include two locations where bank erosion on Challis Creek is threatening the road. Post-fire floods and associated debris jams could potentially result in further loss of road. However, high burn severity in the watershed upstream of these locations is limited, and streamflows are regulated by the outflow from Mosquito Flat Reservoir, so the risk of damage in Challis Creek itself is low. Post-fire flood risks to this road also include four locations where the road crosses tributaries at culverts. The percentage of high burn severity in these watersheds ranges from 1 to 8%, with Lodgepole Creek presenting the highest risk. Debris from these drainages has the potential to block culverts and route flow down the road, causing erosion and potential loss of road. These culverts are appropriately sized, with the exception of the White Valley Creek culvert. The White Valley Creek culvert is an old 2-foot diameter, 32-foot long culvert with reduced capacity. Flood flows also have access via an 180-foot long roadside ditch to 2-foot diameter relief culvert.

*White Valley Creek Culvert on FR#080*

Purpose of Treatment: Replacement of the undersized culvert on White Valley Creek on FR#080 is recommended for immediate implementation in the fall of 2013 in order to decrease the risk of road failure, erosion, and sediment delivery during post-fire runoff.

Design Specifications: The 2-foot diameter by 32-foot long White Valley Creek culvert on FR#080 would be replaced with a 4-foot by 6-foot squash culvert in approximately the same location. A 4-foot by 6-foot squash culvert at 2.5% gradient would be able to accommodate approximately 230cfs, but this capacity would be decreased because the culvert would be partially buried for fish passage design. The design flow at this location is approximately 180cfs. It is likely that during a flood, some of the flow will spill out of the main channel and flow via the ditch through the 2-foot relief culvert.

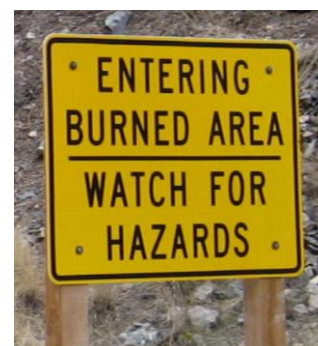
Design Specifications: Road signs would consist of 2-post, large, reflective signs. Signs would follow Forest Service Region 4 specifications. Signs would read "Entering Burned Area, Watch for Hazards". The cost of signs, materials, and installation of each sign is estimated to be \$300. The total cost of this treatment (4 signs) is estimated to be \$1200.

Hazard warning signs were placed in 4 locations along road portals into the burned area in September 2013, using extra signs that had been previously purchased for other projects. Therefore, no BAER funding is requested as part of this report.
