**SEQUOIA  
BURNED-AREA REPORT**  
(Reference FSH 2509.13)

- ☐ 1. Initial Request (Best estimate of funds needed to complete eligible rehabilitation measures)  
☐ 2. Interim Report  
    ☐ Updating the initial funding request based on more accurate site data or design analysis  
    ☐ Status of accomplishments to date  
☒ 3. Final Report (Following completion of work)

A. Fire Name: Sequoia

F. Forest: Dixie National Forest

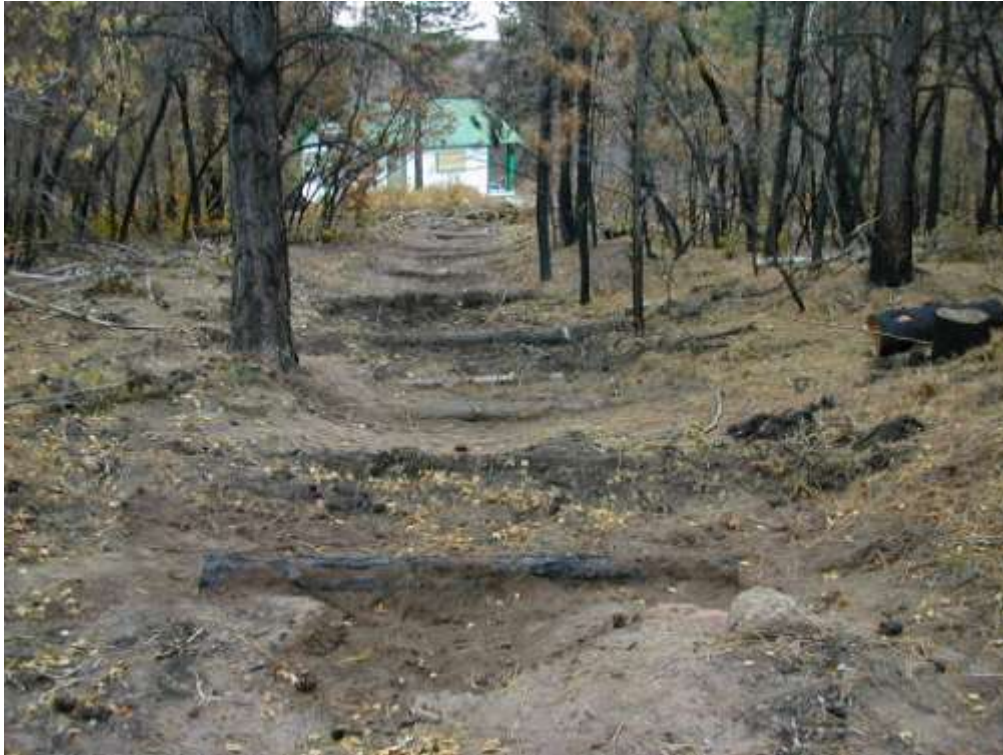
**Photo 1 – The log erosion barriers installed have successfully captured nearly 5 inches of sediment from 2 storms. The barriers also have been successful at diverting the water flow from both the Browse Guard Station and pre historic cultural resource sites in the area.**

Felling of trees to slow expected gully erosion is necessary for the historic Browse Guard Station and other prehistoric sites near Mill Creek. This treatment covered approximately 0.5 acres to the southwest of the Browse Guard Station. The purpose is to reduce the amount of downcutting and water that is being directed toward two cultural resources sites. Installation occurred on July 29-30, 2002 with a follow up treatment on November 7, 2002.
