BURNED-AREA REPORT

PART II - BURNED-AREA DESCRIPTIONA. Fire Name: TieB. Fire Number: ID-CTF-003181C. State: IdahoD. County: Teton and BonnavilleE. Region: Intermountain (R4)F. Forest: Caribou-Targhee NFG. District: Palisades & Teton BasinH. Fire Incident Job Code: P4KM8F (0415)I. Date Fire Started: 8/22/2016J. Date Fire Contained: 9/6/2016K. Suppression Cost: \$5,385,000 (as of 9/4/2016)

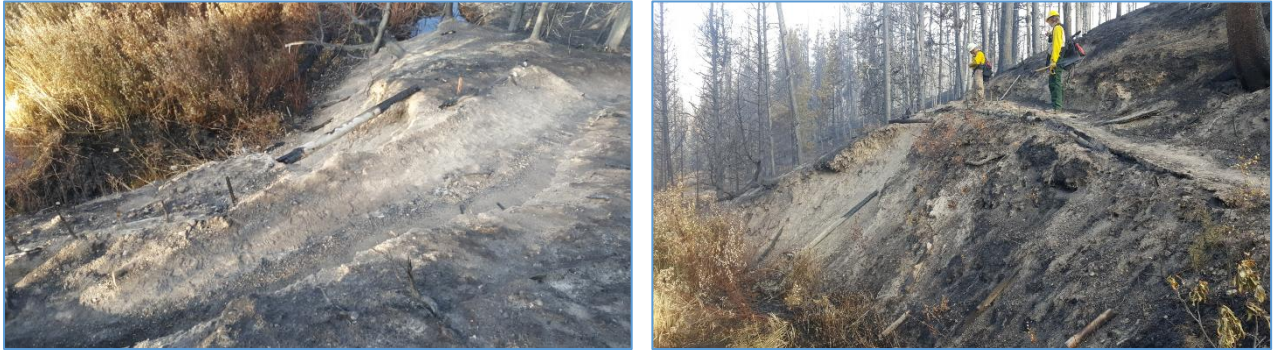
Trails 200 & 207 were used by fire suppression personnel and most existing hazard trees were removed. The Tie Canyon Trail (200) received damage to two log retaining walls and will need to be stabilized (reconstructed) to protect trail from being eroded away and to reduce the safety hazards associated with losing the trail tread; ~~The trail itself is also at risk of eroding away at these locations.~~ The fire burned the two log retaining walls, which essentially eliminated the trail tread across a steep slopes. This creates a dangerous conditions for trail travelers and threatens the loss of trail infrastructure. In addition, three bog areas need to be armored to protect the trail infrastructure from localized increases in runoff & erosion expected due to the burned area: one on the 200 trail and two 207 trail.

Photos log retaining structure that was damaged by fire. Trail tread will be lost with future erosion.

- Trail Stabilization: BAER funds are appropriate for treatment of anticipated fire erosion events on trails, but not to improve trails to standards over pre-fire conditions. The objective of the proposed stabilization treatments are to ~~1) make the 200 trail safe for public use by replacing two log retaining structures that burnt during the fire and 2) to~~ stormproof the trails (200 & 207) from accelerated erosion. Wildfire accelerated surface flows down trails are probable and if not treated will cause significant surface erosion and failure in localized areas. Treatments:

1. Armor three bog areas (2 on Trail #207 & 1 on Trail # 200).
 2. Stabilize two burned out retaining log structures located on Trail #200.
- EDRR for Invasive Species and Noxious Weeds: First year weed monitoring should include 25 feet on each side of the trails within the fire area and roads used to access the fire area. This would amount to roughly 100 acres of road and trail corridors.

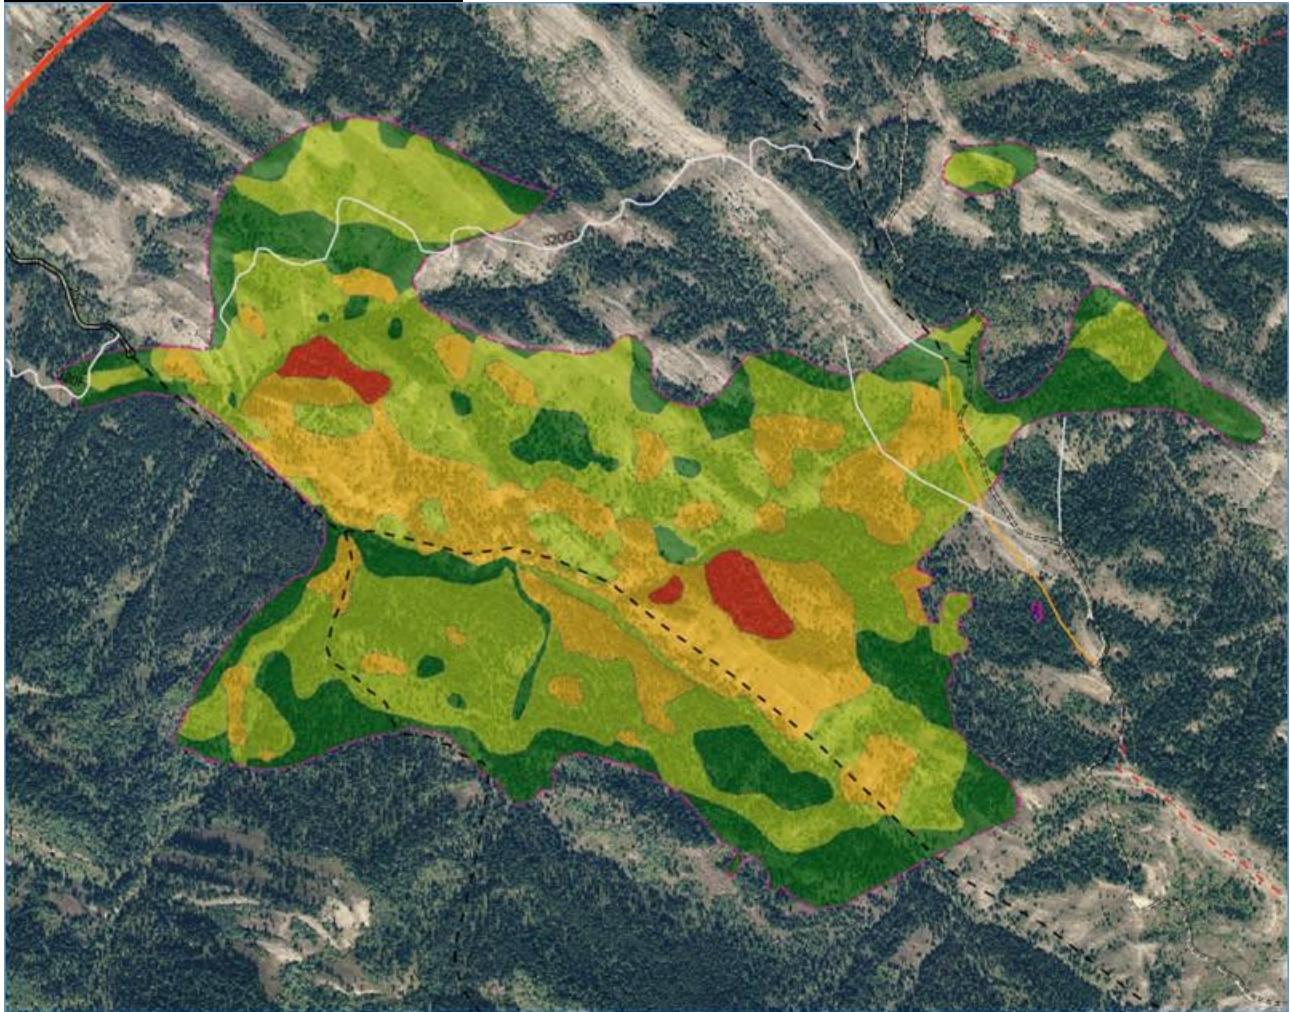
Attachment: Burn Serverity Map

- A. Burn Severity: 266 acres (26% unburned); 482 acres (48% low); 245 acres (24% moderate); 21 acres (2% high)
- B. Water-Repellent Soil (NFS acres only): 266 acres (moderate + high burn severity)
- C. Soil Erosion Hazard Rating (Burned NFS acres only):
5% (low) 45% (moderate) 50% (high)
- D. Erosion Potential (tons/acre): In the first year post-fire, burned areas have about a 50% probability of less than 2 ton/acre. There is a lesser chance, about a 10% probability, than erosion rates could well exceed soil loss tolerance values of 4-5 tons/acre.
- E. Sediment Potential: cubic yards/square mile: Not calculated
