SADDLE COMPLEX

FS-2500-8
BURNED-AREA REPORT

Date of Report: 10/3/2011

PART II - BURNED-AREA DESCRIPTIONA. Fire Name: Saddle Complex (Idaho Portion) B. Fire Number: ID-SCF-011175C. State: IDAHO D. County: LemhiE. Region: R-4 F. Forest: Salmon-ChallisG. District: North Fork Ranger District H. Fire Incident Job Code: P4GA5TI. Date Fire Started: 08/18/2011 J. Date Fire Contained: 0% will not be contained until significant weather event occurs.K. Suppression Cost: \$1,911,160 as of Sept 30, 2011**L. Fire Suppression Damages Repaired with Suppression Funds**

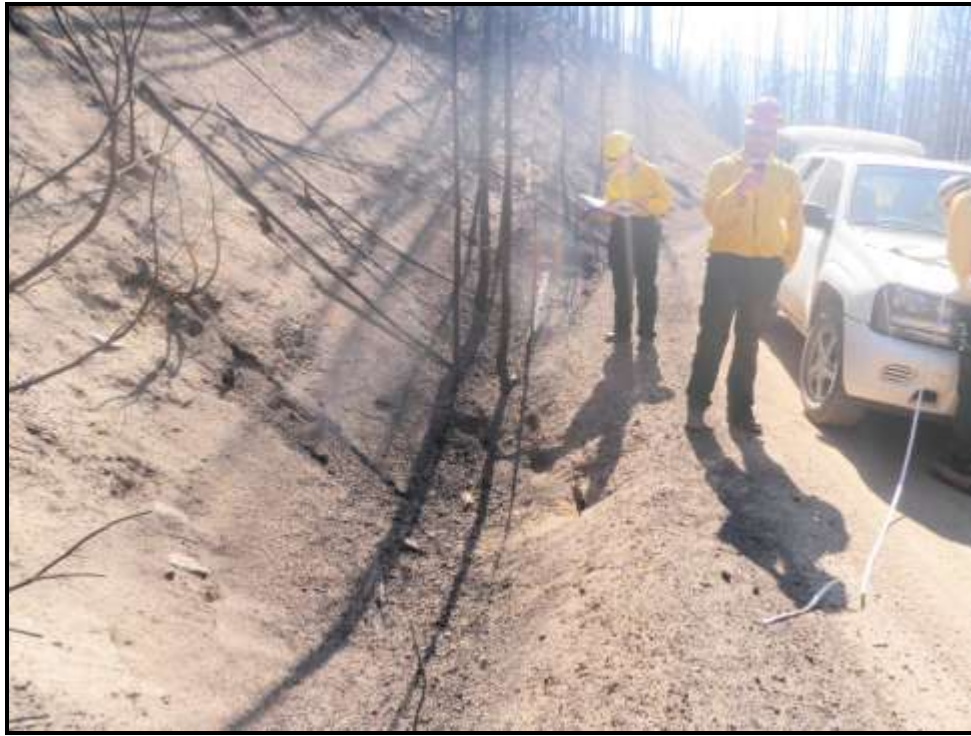
- Forest Development Road 60044 – Several inside ditches are currently full, as well as numerous inside ditch relief pipes are presently blocked or not large enough to transport higher runoff rates. Failure of these features could result in the loss of the road prism.

Figure 2. Typical non-function ditch relief pipe.

The treatments are designed to increase the flow and debris passage capacity at road crossings.

A total of 9 perennial channel culverts, 2 ephemeral channel culverts and 23 other drainage features (install rolling dips, clean or replace cross drain culverts) would be implemented to increase flow and debris passage anticipated as a result of the changed condition in fire area.

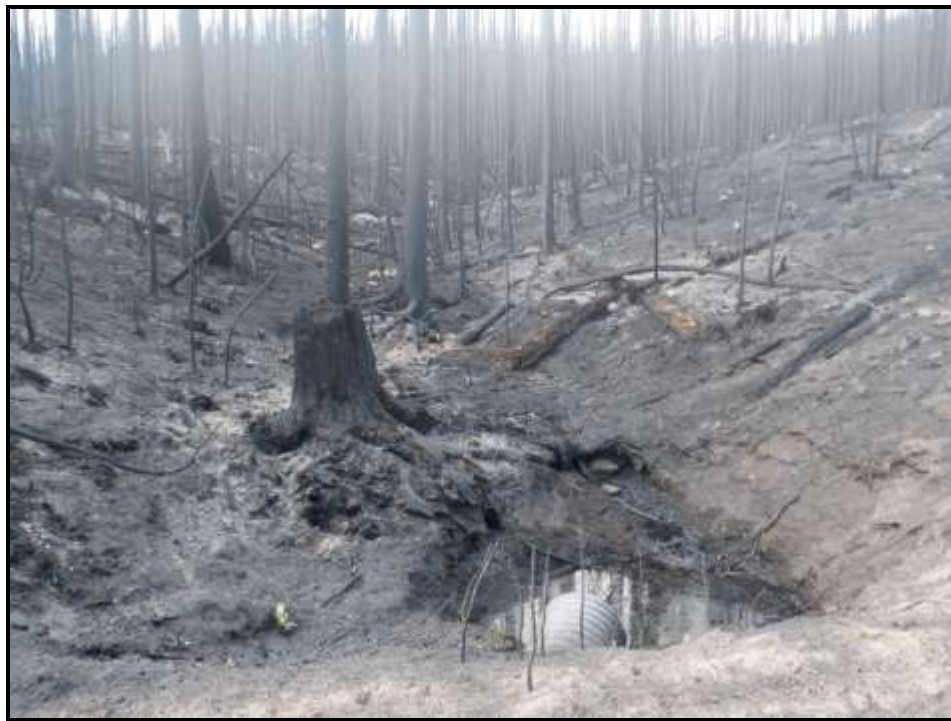
- Forest Development Road 60065 – Several drainage features including drain dips, inside ditches, ditch relief pipes and culverts are currently blocked, not functioning, or not of appropriate size to carry larger drainage runoff. Failure of these features could result in the loss of road prism and exacerbate sediment delivery to the Upper Horse Creek, the Woods Fork and Horse Creek stream systems. This route provides the only access to year round residences at the Gattin Ranch. Even short periods of closure would leave residents unable to access food and medical services.

Figure 3 Example of undersized culvert needing improvement to increase the flow and debris passage capacity.

Culvert #	Existing size	Anticipated Flow	Recommended size to accommodate adjusted peak flows and increased debris passage.
12	None	12-14 cfs	24 inch
15	24 inch	86-99 cfs	60 inch
24	24 inch	84-93 cfs	60 nch
26	15 nch	9-12 cfs	30 inch
28	None	12-14 cfs	30 inch
29	24 inch	175-207 cfs	60 inch
32	24 inch	45-54 cfs	48 inch
33	24 inch	45-54 cfs	36 inch
34	15 inch	18-22 cfs	24 inch
35	24 inch	56-71 cfs	54 inch
36	24 inch	24-31 cfs	42 inch

All culverts will be buried $\frac{1}{2}$ of their depth to allow for a natural stream substrate and provide for aquatic organism passage to meet Forest Service direction. Flow capacities were modeled for open channel flow with natural substrate occupying $\frac{1}{2}$ of pipe volume.

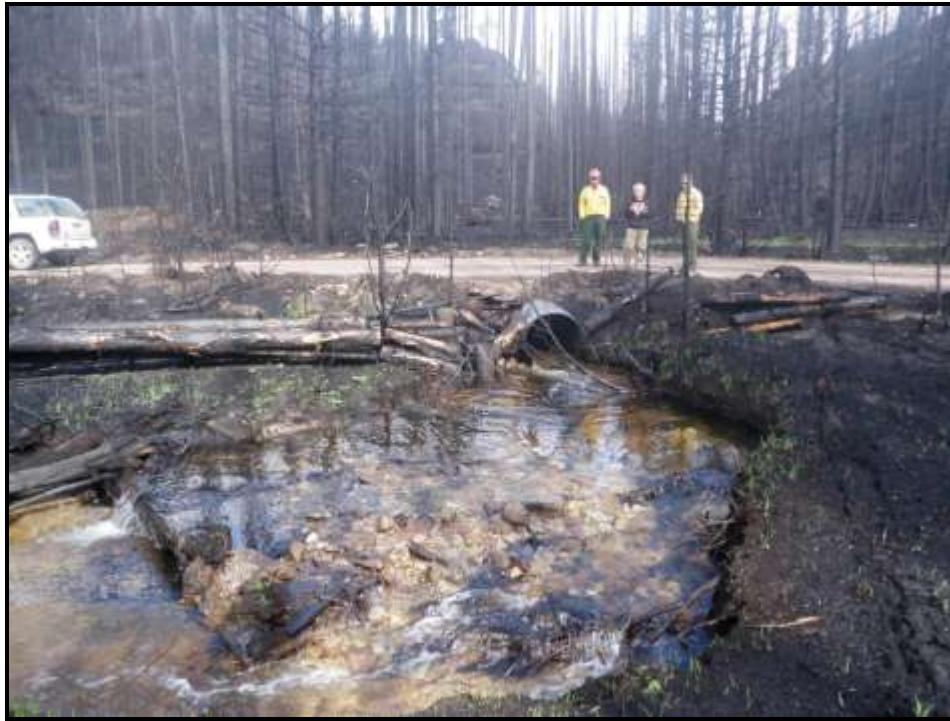
Figure 4. Example of culvert needing modification to avoid road closure, damage to infrastructure, and provide for aquatic organism passage.

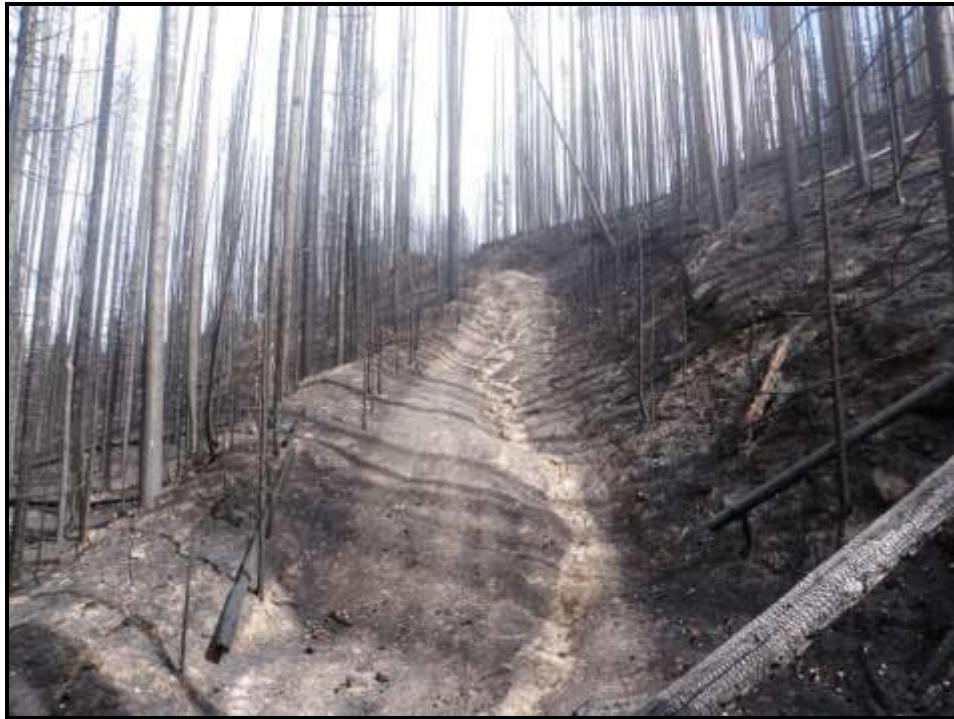
- 4. Water Quality and Listed Species Habitat – In addition to the potential failure of drainage features along FD roads, 044 and 065 non-system roads and user created routes within the Horse Creek drainage area are steep and unmaintained. The potential for these roads to transport sediment and increase runoff to Horse Creek is high. Aquatic resources of concern include Horse Creek and its tributaries. Horse Creek has populations two Federally listed fish species; Bull Trout and Steelhead. Fire effects on these aquatic resources include the potential of increased stream sedimentation from surface and road erosion and the increased potential for debris flows within the fire perimeter.

Figure 5. Non-system unauthorized route contributing sediment to Horse Creek.

C. Road and Trails									
Culvert Modification IDIQ Contract	Unit	6,496.00	11	\$71,456	\$0		\$0	\$0	\$71,456
Road Drainage Work (dips, inside ditch)	Unit	4,000.00	1	\$4,000	\$0		\$0	\$0	\$4,000
Unauthorized Route Closure and Stabilization	Unit	4,355.00	1	\$4,355	\$0		\$0	\$0	\$4,355
COR Pete Schuldts	Days	298.00	14	\$4,172	\$0		\$0	\$0	\$4,172
Hydrologist	Days	181.00	3	\$543	\$0		\$0	\$0	\$543
Implementation Leader	Days	345.00	3	\$1,035	\$0		\$0	\$0	\$1,035
<i>Insert new items above this line!</i>				\$0	\$0		\$0	\$0	\$0
<i>Subtotal Road & Trails</i>				\$85,561	\$0		\$0	\$0	\$85,561

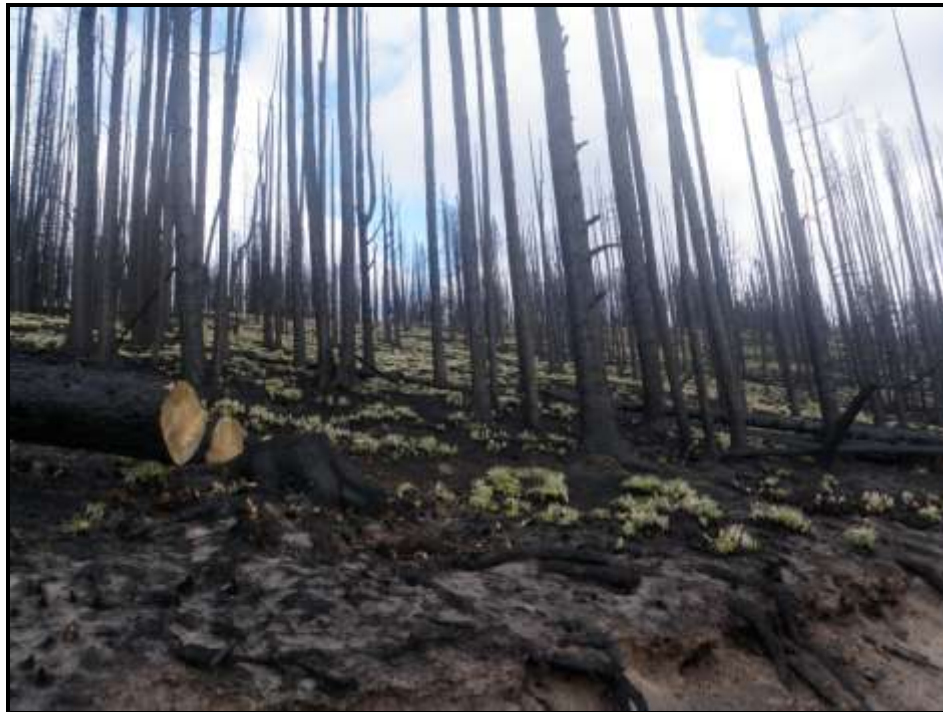
- 5. Soil Productivity – Fire effects include the potential for increased soil erosion and stream sedimentation until vegetative recovery has restored ground cover to pre-fire conditions. Although the fire burn was intense in the Horse Creek/Woods Fork drainage, the severity levels were intermixed throughout, scorching ground cover and woody debris in isolated areas, while leaving root crowns and larger debris on a majority of the hillslopes.

Figure 6. Regrowth on Bear grass root crowns.
