Snow Fire 2020

Date of Report: October 6, 2020**BURNED-AREA REPORT****PART I - TYPE OF REQUEST****A. Type of Report**

PART II - BURNED-AREA DESCRIPTION**A. Fire Name: Snow****B. Fire Number: CA-RRU-119353****C. State: California****D. County: Riverside****E. Region: 05 Pacific Southwest****F. Forest: San Bernardino****G. District: San Jacinto****H. Fire Incident Job Code: 1502 PNNLV1****I. Date Fire Started: 9/17/2020****J. Date Fire Contained: 10/15/2020 (Estimated)****K. Suppression Cost: \$1,750,000 (as of 9/30/2020)****L. Fire Suppression Damages Repaired with Suppression Funds (estimates):**

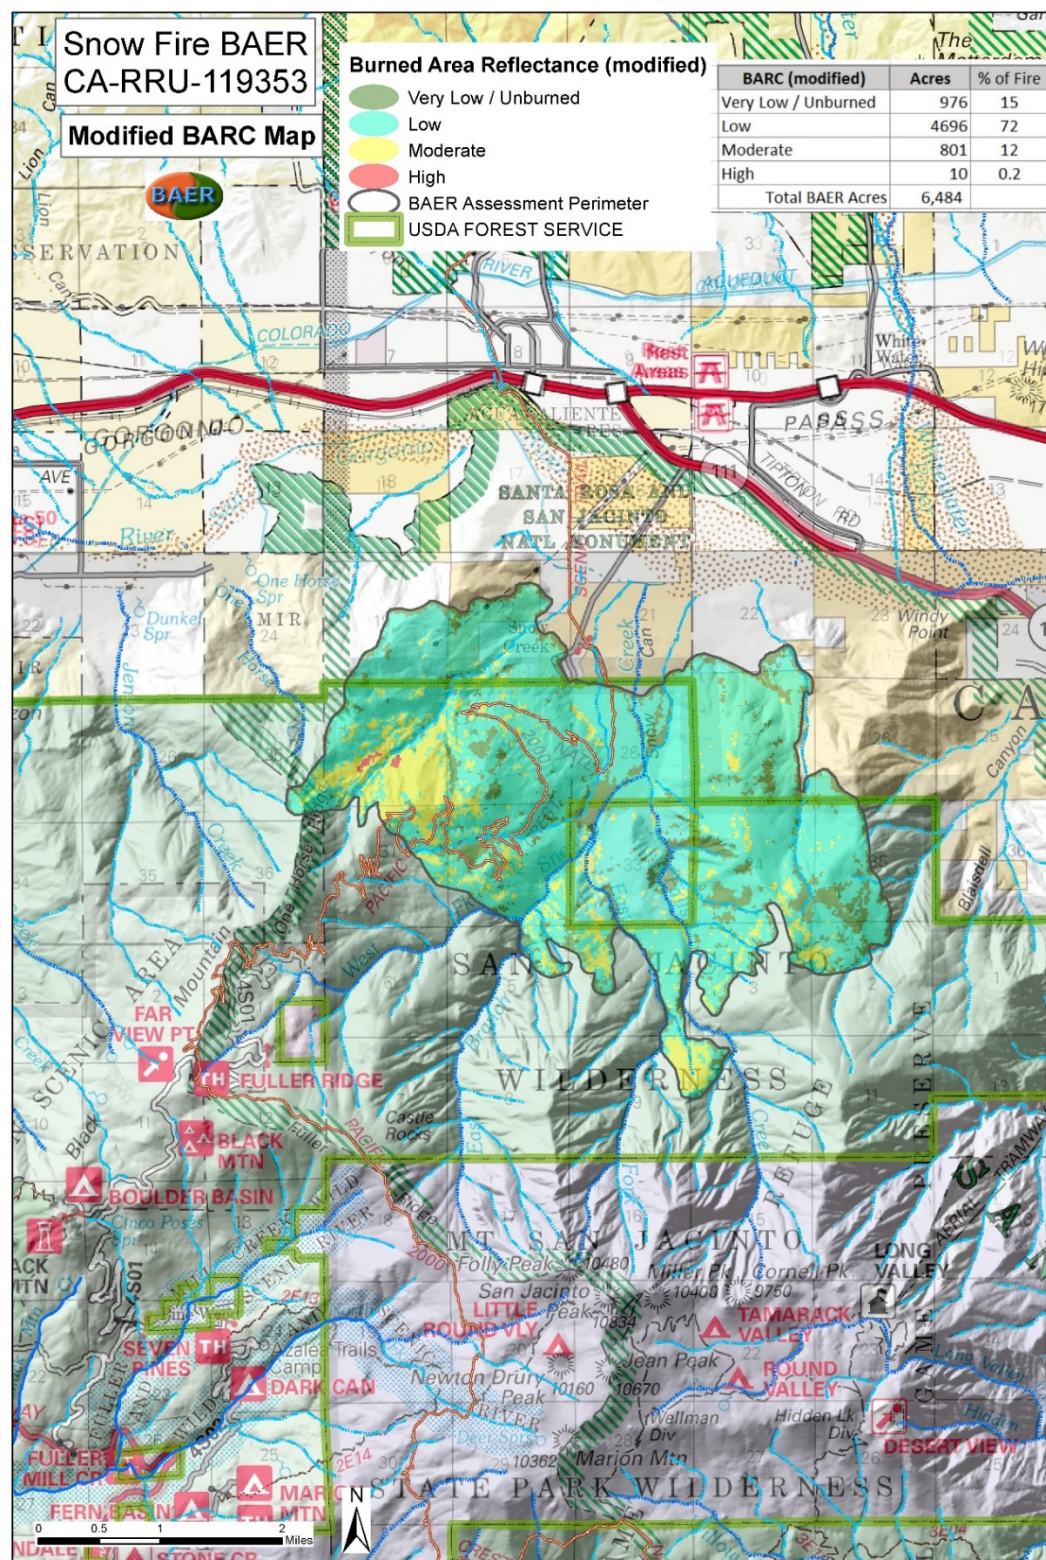
Figure 1: Snow Modified BARC Map

A. Burn Severity (acres): All references to soil burn severity observations, effects, and ground conditions associated with the Snow Fire are based on the modified BARC and not on a final ground truthed soil burn severity model.

The soil burn severity (SBS, per modified BARC) shows 13% burned at high and moderate soil burn severity. The rest of the fire was either low soil burn severity or unburned. All references to soil burn severity observations, effects, and ground conditions associated with the Snow Fire are based on the modified BARC and not on a final ground truthed soil burn severity model.
