[Interim 1](#)[Date of Report: Jan 26, 2021](#)**STATE CREEK FIRE BURNED-AREA REPORT**

PART II - BURNED-AREA DESCRIPTION**A. Fire Name:** State Creek**B. Fire Number:** MT-BDF-006645**C. State:** Montana**D. County:** Jefferson**E. Region:** 01 – Northern Rockies**F. Forest:** Beaverhead-Deerlodge NF**G. District:** Butte RD**H. Fire Incident Job Code:** P1NH76**I. Date Fire Started:** 08/29/2020**J. Date Fire Contained:** 12/30/2020 (estimated)**K. Suppression Cost:** \$1,608,470.15**L. Fire Suppression Damages Repaired with Suppression Funds (estimates):**

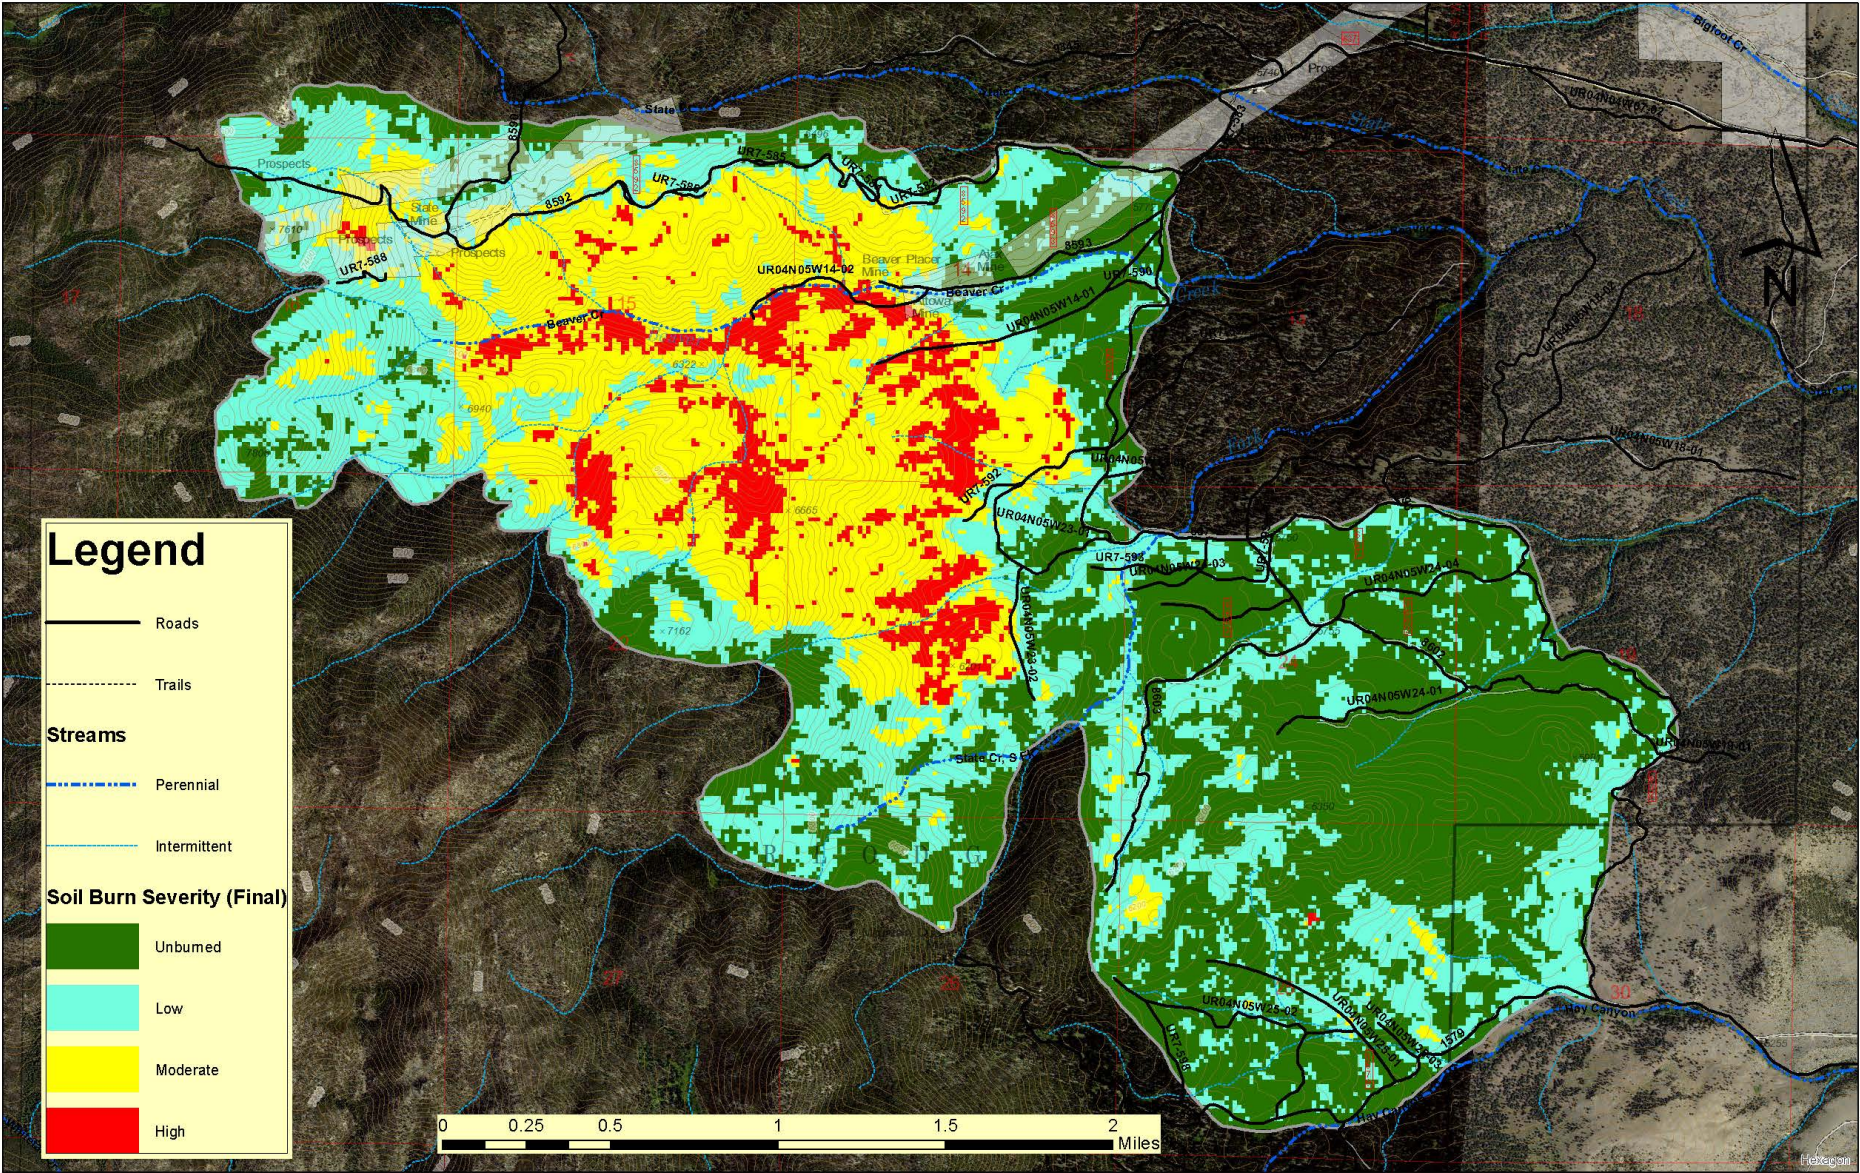
State Creek Final Soil Burn Severity

A. Burn Severity (acres):

Soil Burn Severity	NFS	Other Federal (BLM)	Private	Total	% within the Fire Perimeter
Unburned	1,551	86	53	1,690	39%
Low	1,179	71	98	1,348	31%
Moderate	1,004	0	42	1,046	24%
High	262	0	1	263	6%
Total	3,996	157	194	4,347	100%
