BURNED-AREA REPORT
(Reference FSH 2509.13)**PART I - TYPE OF REQUEST**

A. Fire Name: Paola Ridge

F. Forest: Flathead

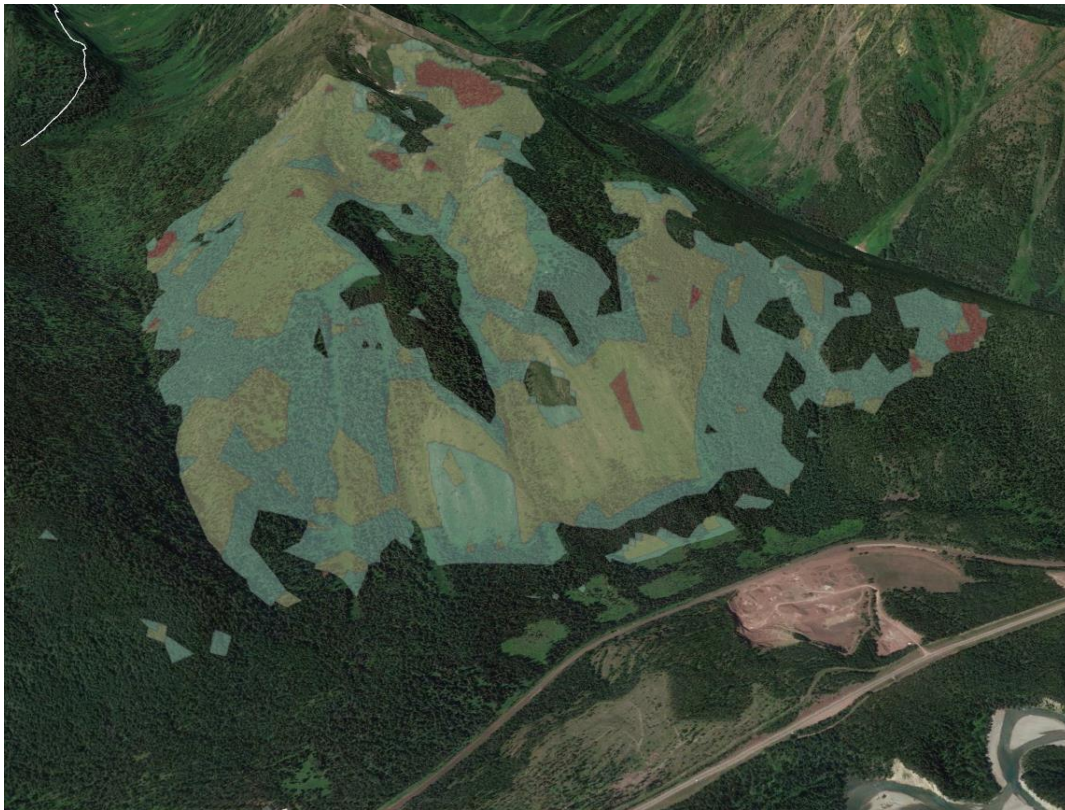
The Paola Ridge Fire burned roughly 861 acres on a face drainage between the Paola Creek and Dickey Creek watersheds. The first order streams that drain the burned area terminate at the base of the hillslope. This was a mixed severity burn with good mosaic (Figure 1). The BARC imagery has not been field verified. However, numerous field verification efforts from past fires on the forest have shown that initial BARC imagery slightly over-estimates severity.

Figure 1. Paola Ridge BARC imagery looking west.
