BURNED-AREA REPORT
(Reference FSH 2509.13)**PART I - TYPE OF REQUEST**

- A. Fire Name: Potato Complex B. Fire Number: AZ-ASF-060252
C. State: AZ D. County: Navajo
E. Region: 03 F. Forest: Apache-Sitgreaves
G. District: Black Mesa H. Fire Incident Job Code: P3CN2Y
I. Date Fire Started: 6/6/2006 J. Date Fire Contained: June 23, 2006
K. Suppression Cost: 3.7 million
L. Fire Suppression Damages Repaired with Suppression Funds
 1. Fireline waterbarred (miles): 1 Most of the line on <5% slope, slashed if material available
 2. Fireline seeded (miles): 46
 3. Other (identify):
M. Watershed Number: 1502001001 (Upper Chevelon Canyon) 1502001003 (Lower Chevelon Canyon)
N. Total Acres Burned: 6248
 NFS Acres(☒) Other Federal () State () Private ()
O. Vegetation Types: Ponderosa Pine, Pinyon Juniper Woodlands
P. Dominant Soils: 51, 52, 187, 186, 41, 183,
Q. Geologic Types: Sedimentary (limestones, sandstones)

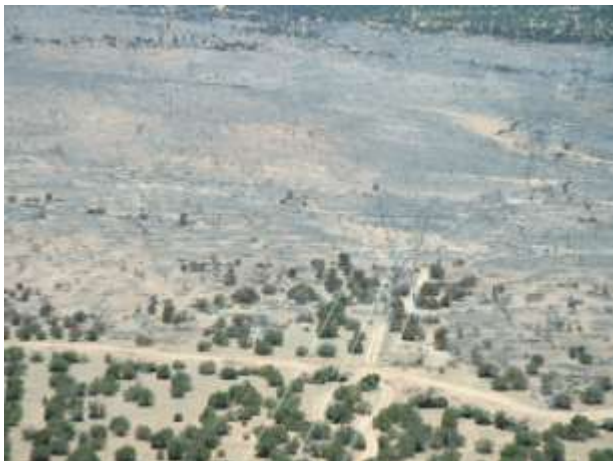
Moderate/High burn severity with PJ

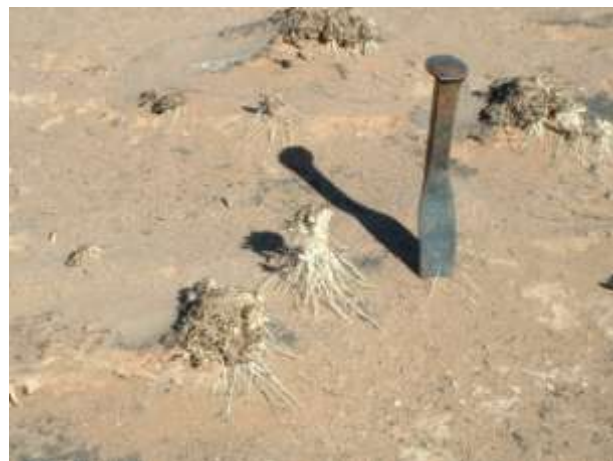
Wind erosion exposing blue grama roots

This fire was wind driven and burned in a long narrow corridor oriented in the predominant wind direction for this area. Most of the burn occurred on flat mesa tops that are now exposed to long, uninterrupted wind fetches. Considerable wind erosion has already taken place in the northern portion of the burn resulting in redistribution of soils on the mesa tops. Dunes of soil material have formed downwind of any obstructions. Remaining root crowns of live grasses in the less severely burned areas are being undermined and exposed by the wind erosion indicating that already 1 to 3 inches of soil have been eroded in parts of the north end of the burn. Wind erosion will likely be as great a hazard to this area of the burn as water erosion.

Due to the extreme wind erosion conditions that are occurring in soil group 1 and 2, seeding of a cereal wheat cover crop is recommended to add surface roughness and to improve perennial plant microhabitat. This area of approximately 2200 acres will receive a mix of 7.5 seeds/square foot of winter wheat (*Triticum aestivum*), western wheatgrass (*Pascopyrum smithii*), sideoats grama (*Bouteloua curtipendula*), and 2.5 seeds/square foot of sand dropseed (*Sporobolus cryptandrus*) during the summer monsoon rains to ensure optimum germination conditions. Three species are adapted to sandy soil surface textures and low soil moisture conditions, one is adapted to heavier soils that occur more frequently in the southern

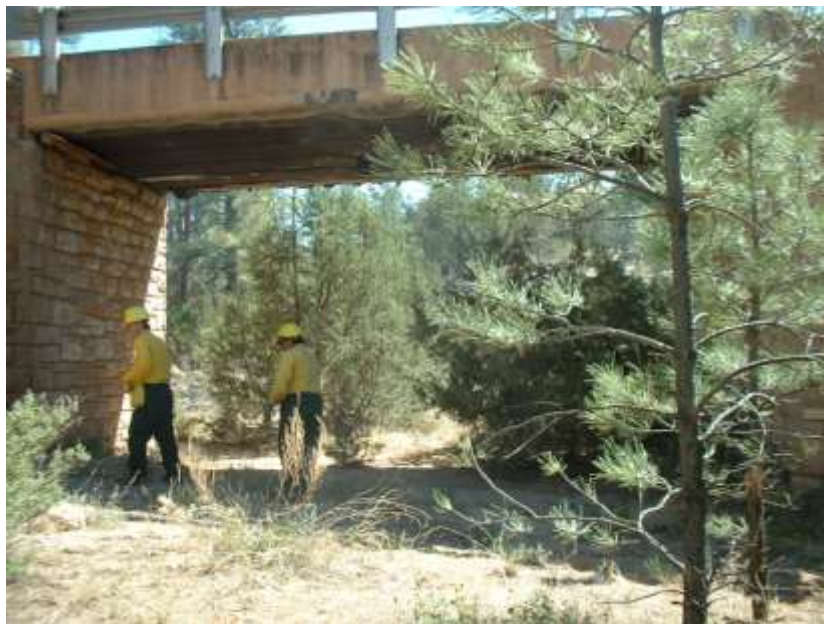
FR 504, a principal travel route in this portion of the District, crosses the burned area. Three bridge stream crossings occur along this reach of the road – on Wildcat Canyon, Daze Canyon and an unnamed ephemeral tributary of Daze Canyon. All three bridge crossings have ample capacity to accommodate the increased water flows which might result from this fire. However, trees and brush growing in the channel above the Daze Crossing bridge present a hazard by potentially restricting flow through the structure and accumulating woody debris at its upstream end. Much of the Daze Canyon watershed (43%) has been burned, and there is ample debris in or near the channel that could be conveyed to the bridge during peak flows. Also there is a concern that slash placed on rehabed fire line directly upstream of the bridge on the Daze Canyon tributary may be conveyed to the bridge during extreme precipitation events.

Vegetation under Daze Canyon Bridge

Objective: Reduce risk of bridge damage or loss from scour and potential debris jam at FR504 and Daze Canyon.

Method: Remove existing pine and juniper species from under and in close proximity upstream of bridge to allow for free flow conditions preventing potential debris jam.
