Date of Report: 11/2/2012**BURNED-AREA REPORT**
(Reference FSH 2509.13)**PART I - TYPE OF REQUEST****A. Type of Report**

PART II - BURNED-AREA DESCRIPTION**A. Fire Name:** Powell SBW Complex**B. Fire Number:** ID-CWF-000545**C. State:** Idaho**D. County:** Idaho**E. Region:** R1**F. Forest:** Clearwater**G. District:** Powell**H. Fire Incident Job Code:** P1G69S 0105**I. Date Fire Started:** 7/20/2012**J. Date Fire Contained:** Not contained as of 10/29/12**K. Suppression Cost:** \$5,023,686**L. Fire Suppression Damages Repaired with Suppression Funds**

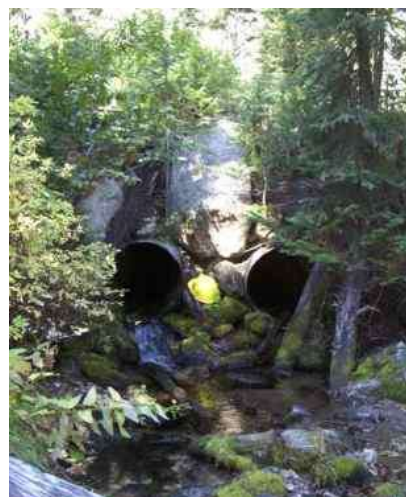
Road 359 MP 0.6 Culvert.

- Existing crossing is 2 24" culverts in a 9' BFW fisheries stream
- 1.5 miles of fish habitat above road.
- Watershed area = 1.19 square miles
- Apx ½ of watershed burned; apx 10% of watershed had mod severity
- Adjusted Design Flow = $110 \text{ cfsm}^6 = 130 \text{ cfs}$
- Predicted Q100 = 81 cfs (from StreamStats)
- Sizes to minimum of 6' culvert
- Fisheries stream, size for stream simulation.
- Bankfull width of stream is 9'. Use 11' wide low rise pipe-arch.
- Estimate \$15,000 for A & E design
- Estimate \$90,000 for installation
- Estimate 10 days of engineer time @ \$350/ day = \$ 3500 (contract prep and admin)

24" pipes in 9' stream. Picture taken prior to burn

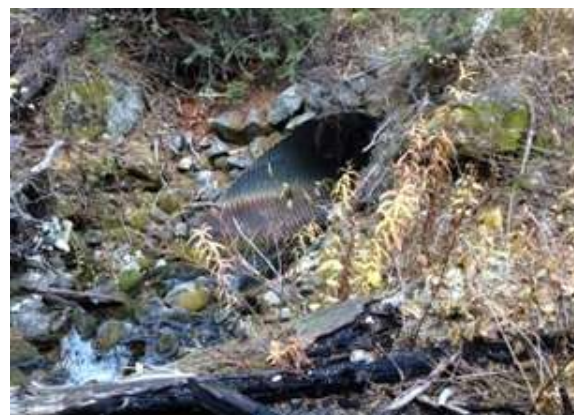
Road 359 MP 1.6 Culvert (Alkire Creek).

- Existing crossing is 48" culvert in a 9' stream
- Potentially fish-bearing-0.15 miles of marginal fish habitat
- Watershed area = 0.72 square miles
- 33% of watershed burned; apx 5% of watershed high severity

- The rust line on the culvert takes up half the volume. There is about a 300 foot unburned buffer above the culvert, but the slope leading into the culvert averages at greater than 15%. . There is high soil burn severity to the northwest. Peak discharge modeled to increase 3-5 times and to deliver up to 13 times the sediment to the area of the culvert (PRISM modeling in FS WEPP and RAWS station data from the Fenn Ranger Station)

- Use 8' culvert; stream simulation not necessary.
- Estimate \$35,000
- Estimate 10 days of engineer time @ \$350/ day = \$ 3500 (design, contract prep and admin)

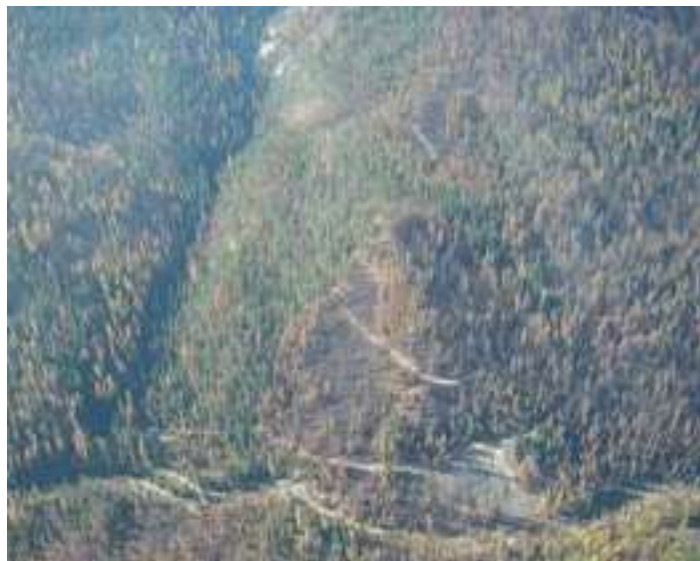
Road 359 MP 3.13 to MP 5.57

- Road accesses popular trailhead at confluence of Colt and Colt Killed Creeks
- Road grade varies from -5% to -15% +; 1 miles of over -8%
- Contributing area is 100% within the burn; nearly all low severity
- 0.2 miles burned moderate severity
- Literature suggests a 200' cross drain spacing on these grades
- Only three existing culverts (12" cross drains); upgrade to minimum of 18"
- Add 10 18" cmps and 20+ dips
- Estimate \$1000 per culvert (13 * \$1000 = \$13,000)
- Estimate 1 day with grader for dips (10 hours @ \$130/hr = \$1300)
- Estimate 4 days of engineer time @ \$350/ day = \$ 1050 (contract prep and admin)
- Total = \$15,350

Bottom of Road 359, where it switchbacks down to the confluence of Colt and Colt Killed Creeks to a popular portal to the Selway Bitterroot Wilderness.

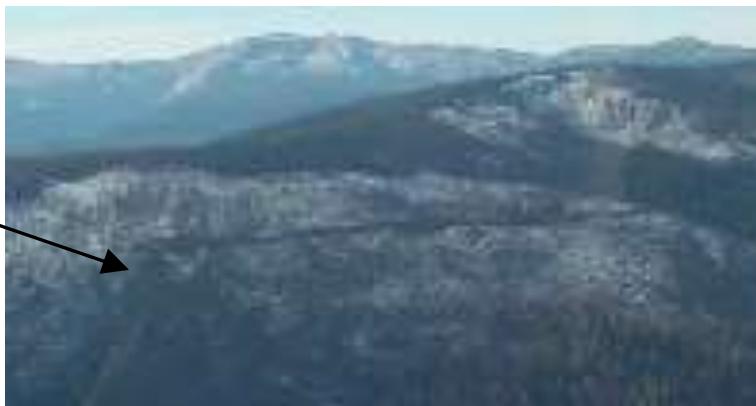
Road 111 MP 10.00 to MP 11.54

- Very low use, open road
- Fairly flat road grade
- Mostly high severity burn over the road and within the contributing area
- Apx 30 18"- 24" culverts, mostly in good shape
- Estimate 1 day with backhoe to clean culvert inlets (10 hours @ \$70/hr = \$700)
- Estimate 1 day of engineer time @ \$350/ day = \$ 350 (contract prep and admin)
- Total = \$1,050

End of Road 111 in high burn severity
(Fern Fire, Powell SBW Complex,
2012)

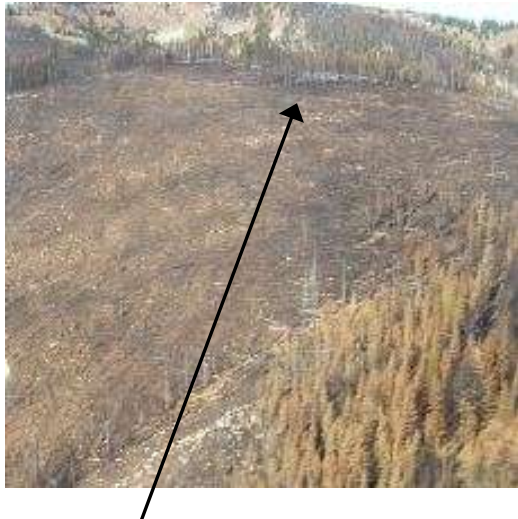
Trail Costs

In the Powell SBW complex 234.6 miles of trail were affected by fire. There are 10.25 miles that were impacted between moderate to high fire burn severity that are proposed for treatment to stabilize fire -affected trail tread at risk to damage from the additional runoff and erosion from the post fire conditions.

Trail 213 in high severity burn near Bear Mtn Lookout.

Utilize traditional tools to clean of drainage structures, replace damaged drainage structures (waterbars, dips), stabilize damaged areas, outslope trail tread, replace damaged retaining walls and post visitor warning signs.
