Date of Report:10/10/2010

FOURMILE EMERGENCY STABILIZATION BURNED AREA REPORT**PART I - TYPE OF REQUEST**

PART II - BURNED-AREA DESCRIPTION**A. Fire Name:** Fourmile Canyon Fire**B. Fire Number:** CO-BLX-000321 FUL0**C. State:** CO**D. County:** Boulder**E. Region:** Rocky Mtn (R2)**F. Forest:** Arapaho-Roosevelt**G. District:** Boulder**H. Fire Incident Job Code:** 1502 PNFUL0**I. Date Fire Started:** 9/6/2010**J. Date Fire Contained:** 9/13/2010**K. Suppression Cost:** \$9,500,000**L. Fire Suppression Damages Repaired with Suppression Funds**

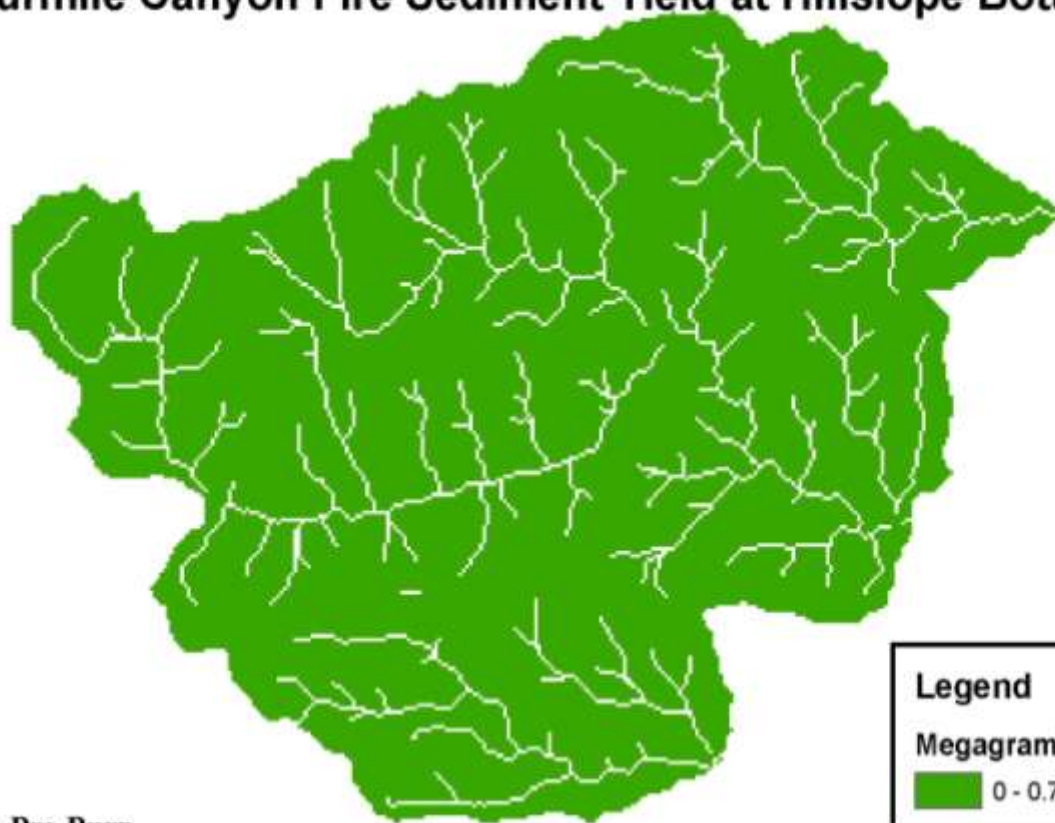
Figure #1 Pre-Burn

C. Soil Erosion: Overall, pre-burn conditions (Figure #1) had a sediment yield at the bottom of hillslopes in the range of 0-.7 Megagrams/Hectare (0 to 0.3 tons/acre). Post-burn sediment yields increased up to 14 Megagrams/Hectare (6 tons/acre) (Figure#2).

Fourmile Canyon Fire Sediment Yield at Hillslope Bottom
