Date of Report: August 30, 2012

BURNED-AREA REPORT
(Reference FSH 2509.13)**PART I - TYPE OF REQUEST****A. Type of Report**

- A. Fire Name: Antelope Fire 2012 B. Fire Number: CA-MDF-0521
C. State: California D. County: Modoc
E. Region: 5 F. Forest: Modoc
G. District: Devil's Garden RD
H. Date Fire Started: 21 August 2012 I. Date Fire Contained: 25 August 2012
J. Suppression Cost: \$1,600,000
K. Fire Suppression Damages Repaired with Suppression Funds
 1. Fireline waterbarred (miles): 3.0 miles handline
 2. Fireline seeded (miles): 0
 3. Other (identify): fence repair 0.64 mile
L. Watershed Numbers (HUC 6): 180200020801 (46 ac) and 180200020802 (576 ac)
M. Total Acres Burned: 622
 NFS Acres: 547 Other Federal (0) State (0) Private (75)
N. Vegetation Types: Juniper with bunch grasses and occurrences of medusahead.

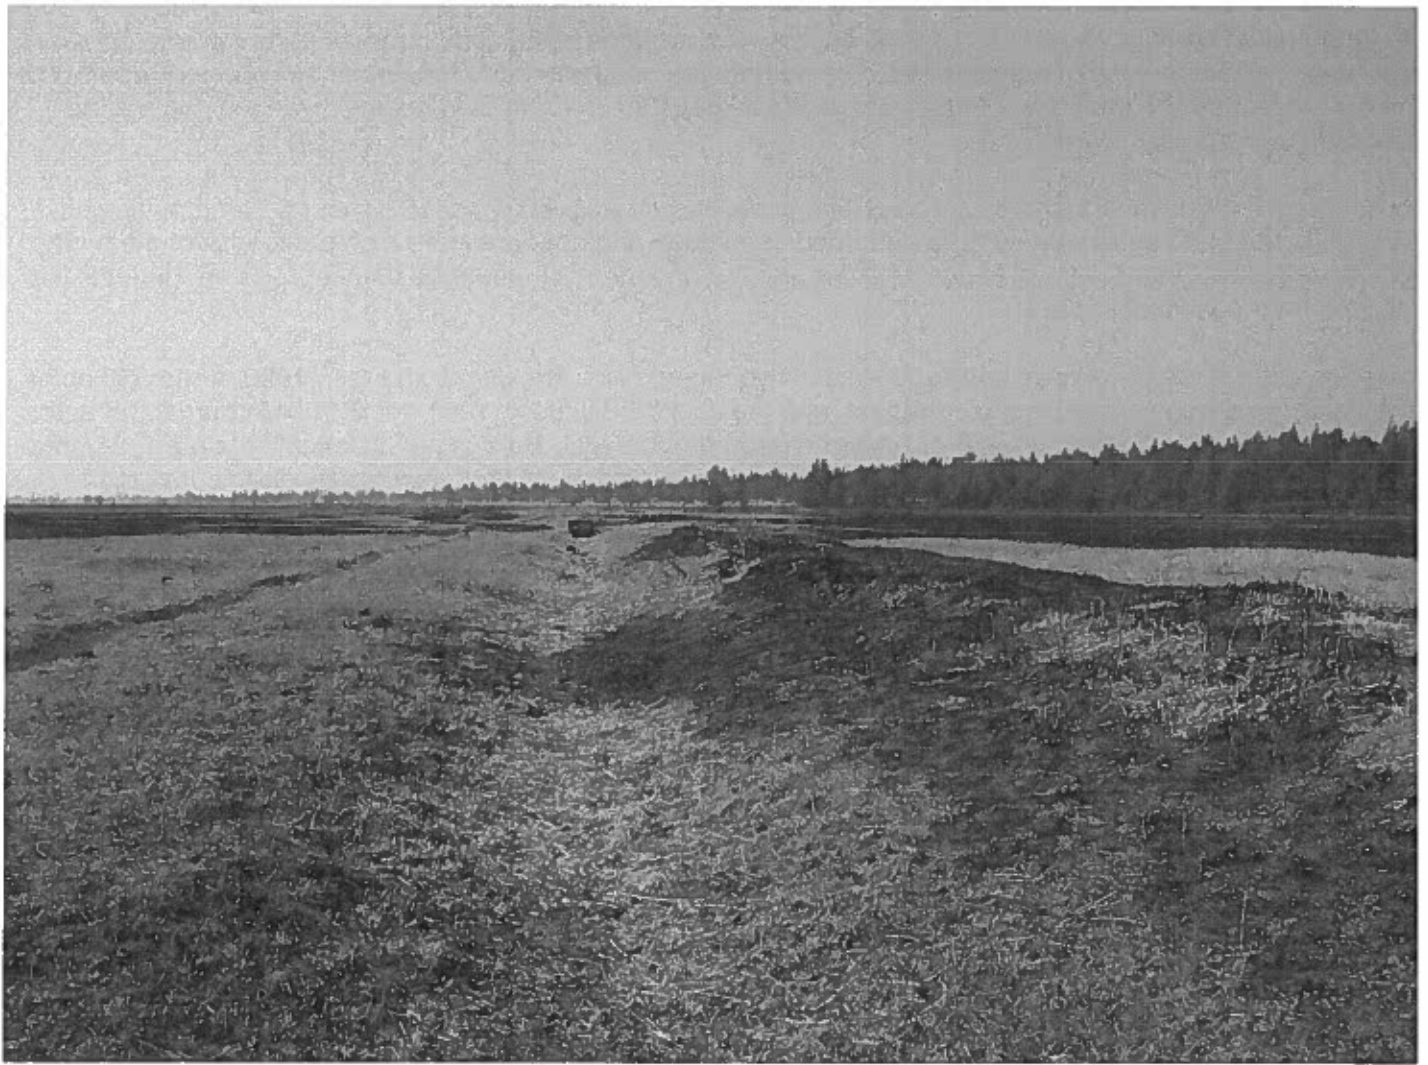
Figure 1. Jack's Swamp and fire perimeter intersection.

It is unknown if suppression equipment was weed-free; therefore noxious weeds may have been introduced into the burned area. The transportation system that suppression vehicles utilized to access the fire is adjacent to two vernal pools; these pools have potential habitat for a federally listed plant species, so noxious weed detection survey is warranted. However, there is not an emergency with regard to watershed response (erosion and increased runoff) due to: the overall low soil burn severity, the unburned vegetative buffer throughout the fire perimeter, the amount of rock, and the generally gentle slopes. No other unacceptable risks were identified (Figure 1).

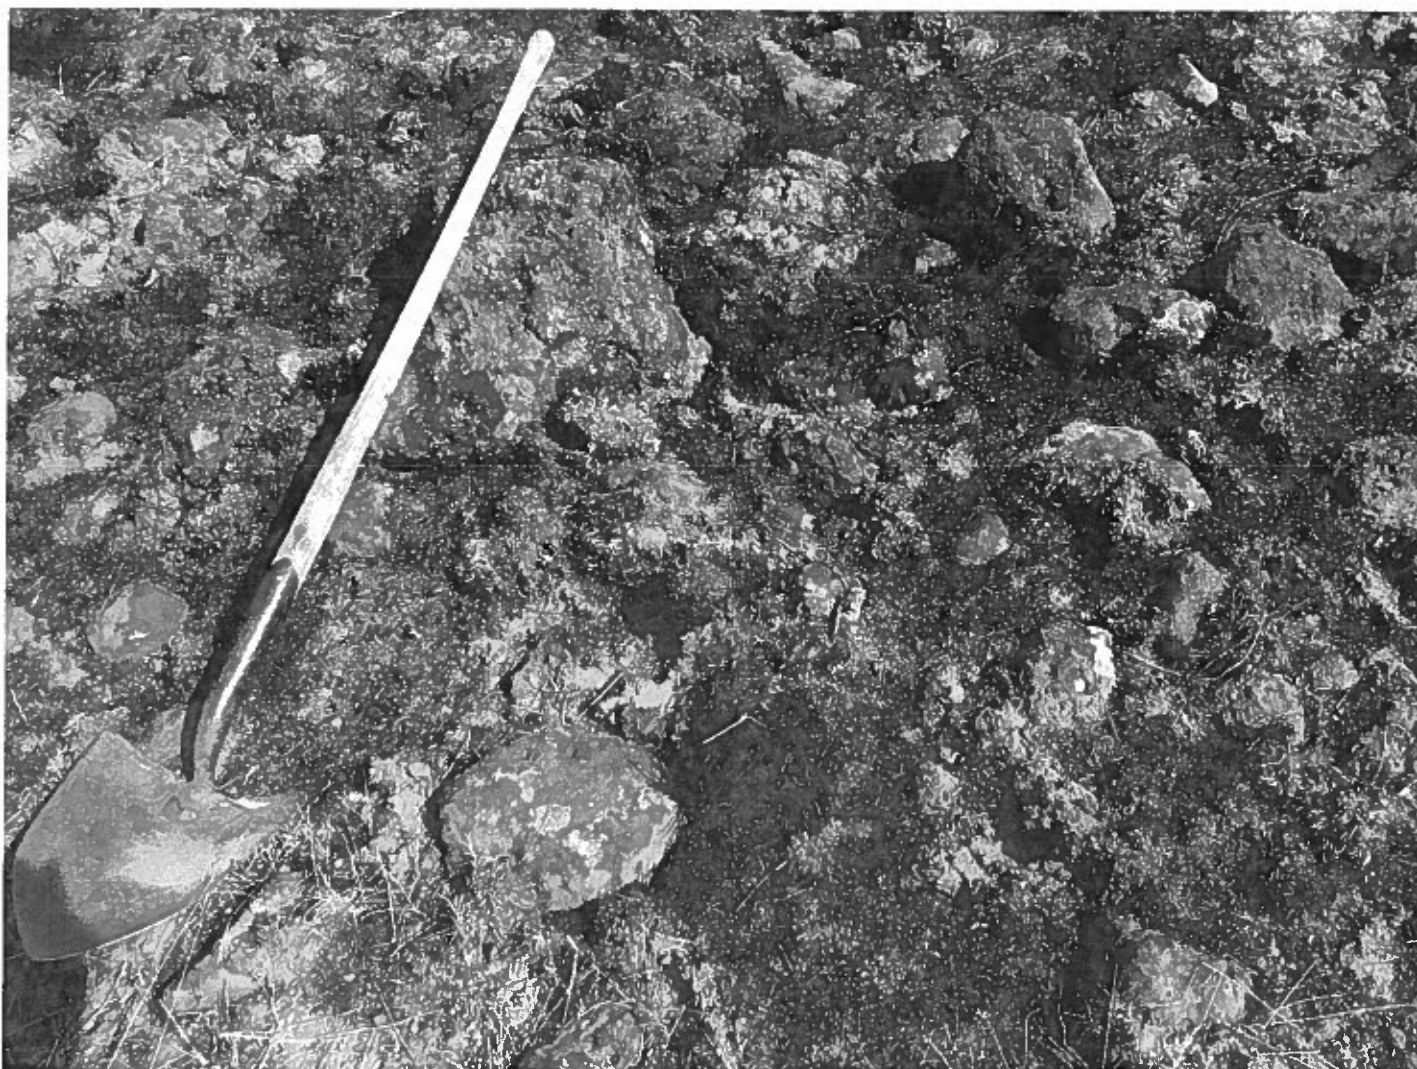
Figure 2. Low severity burn on Antelope Fire

Overall, soil burn severity was "low" with the exception areas directly under juniper trees. The fire burned the herbaceous material and duff, but in most cases did not totally consume either (Figure 2). The perennial bunch grass root masses seemed to be intact and it is anticipated that they will recover.

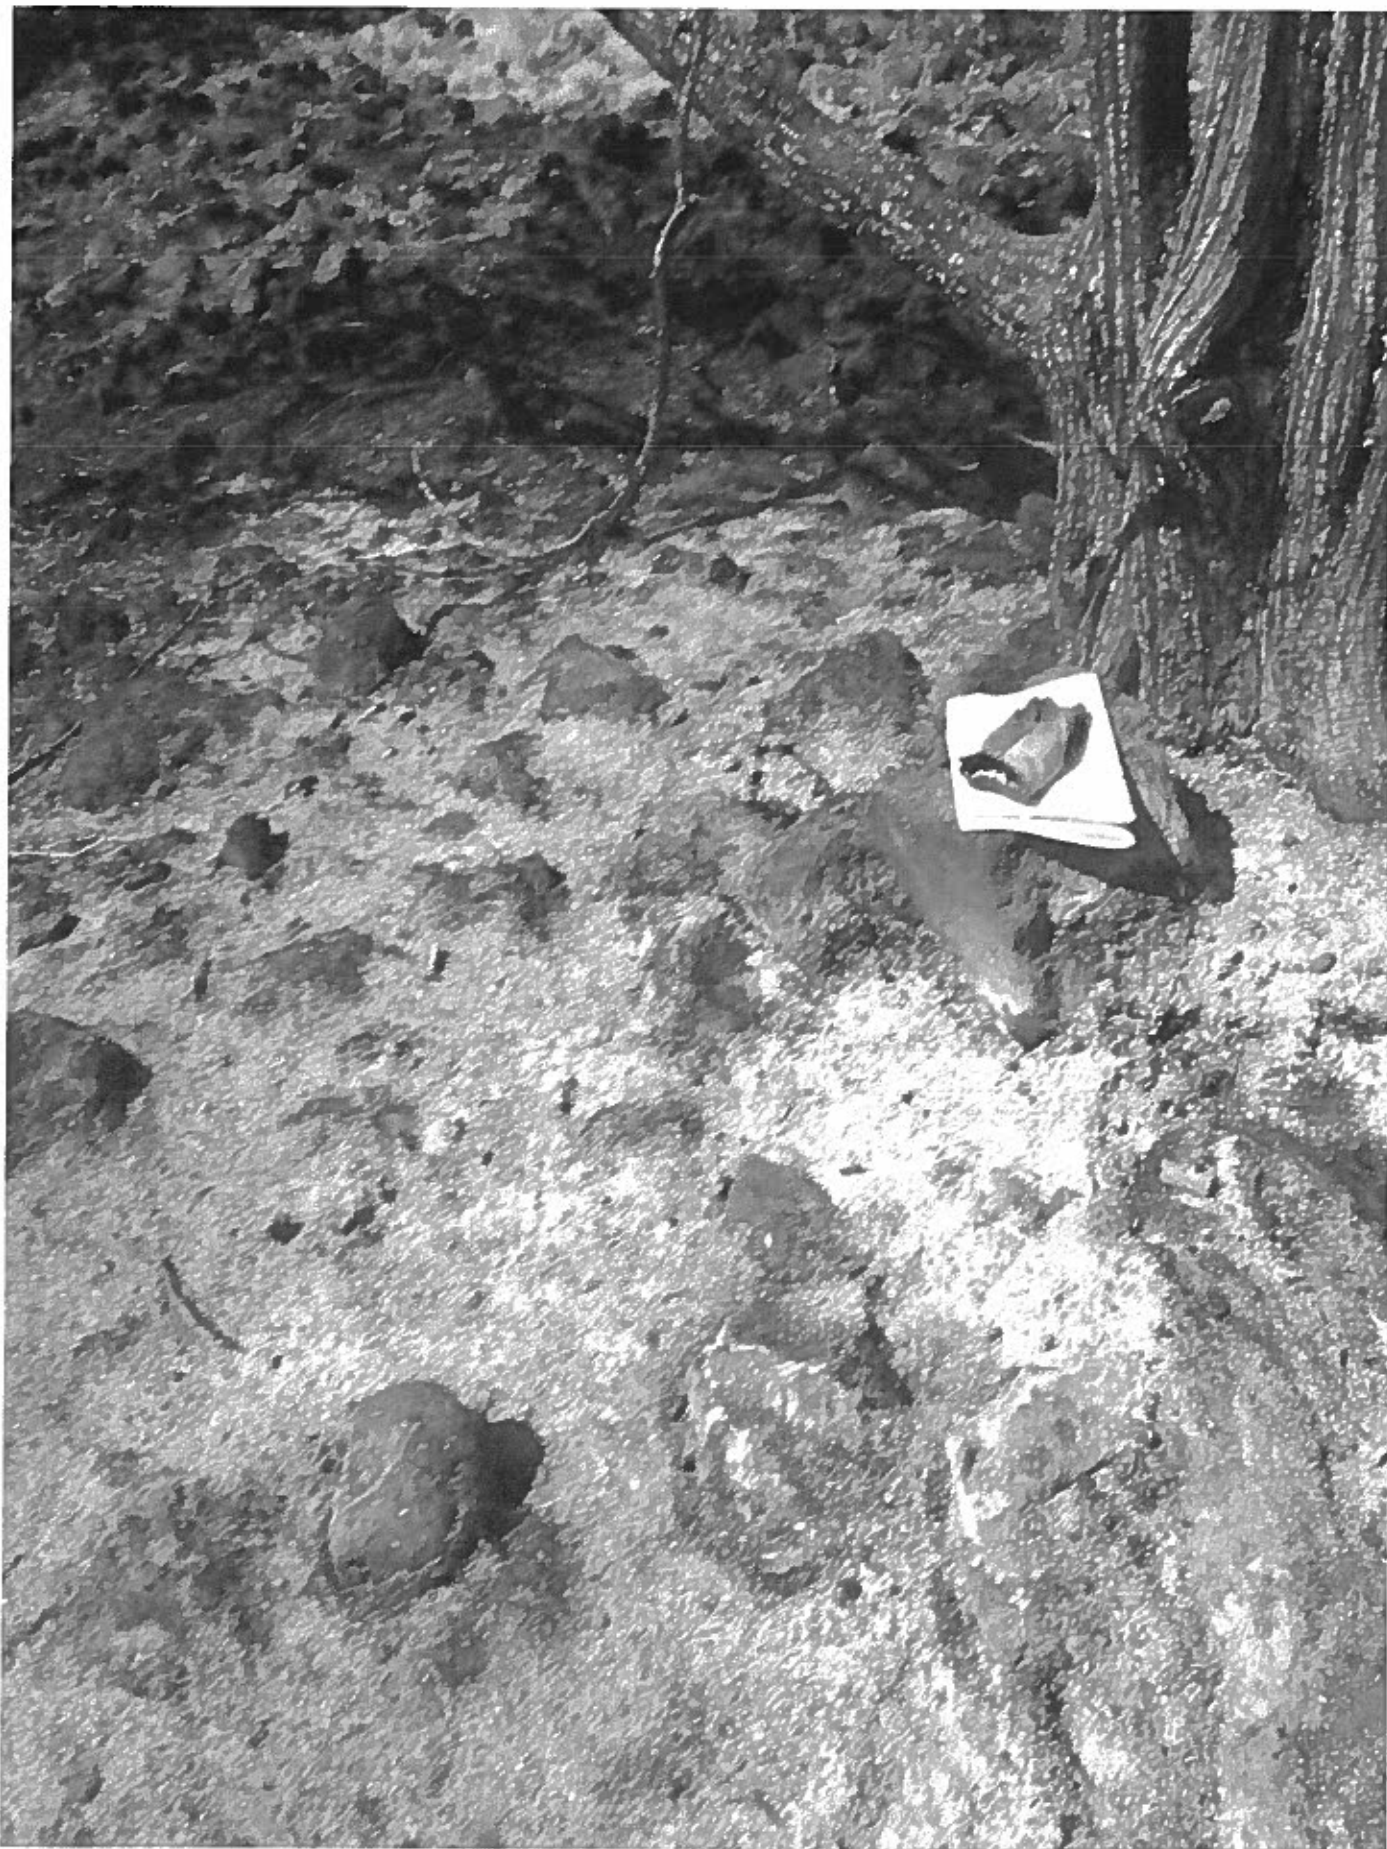
Figure 3. Soil with slight hydrophobicity under burned juniper tree.

Areas along a transect on the Forest System lands were checked for severity and the presence of hydrophobic soils. Grass root masses were intact; however, there were localized areas under juniper trees exhibiting slight hydrophobicity. In general, impacts to the soil appeared superficial throughout the fire, except in those areas of heavy duff concentrations under juniper trees (Figure 3).
