DETECTING BUILDING DEFECTS

A MINI PROJECT REPORT

COMPUTER SCIENCE ENGINEERING

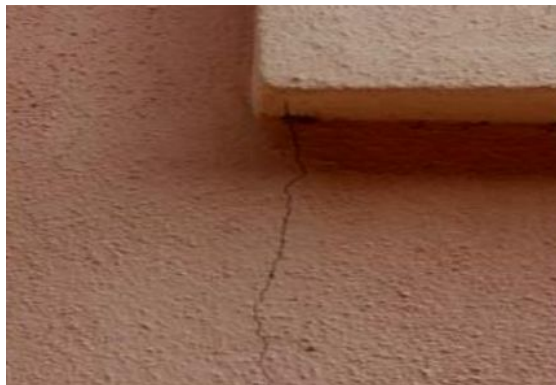
Fig 1.1

- ***Cracks*** - Often an effect of ageing of buildings, can be very dangerous if not dealt with at an early stage (Fig 1.1)

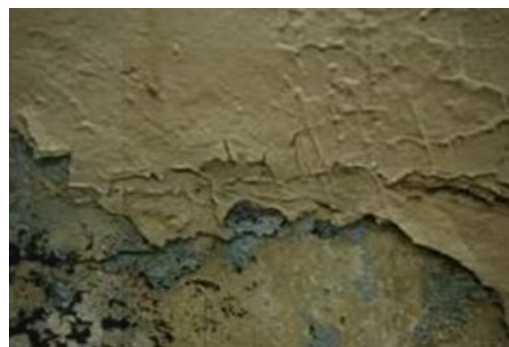
Fig 1.2

- ***Peeling of Paint*** - Occurs in areas that are exposed to excessive rain and great dampness, spoils the look of a structure (Fig 1.2)

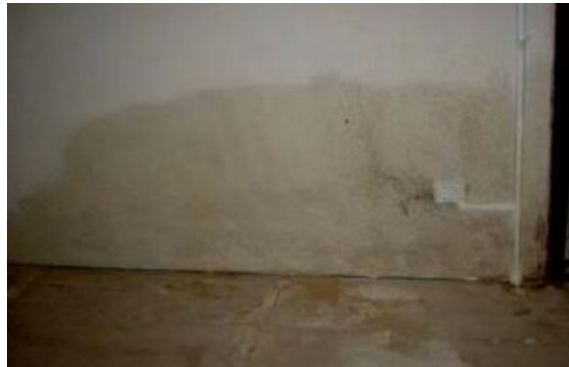
Fig 1.3

- ***Rising Dampness*** - Onset of unwanted and excessive moisture or water into a building, causes severe damage to brickwork (Fig 1.3)

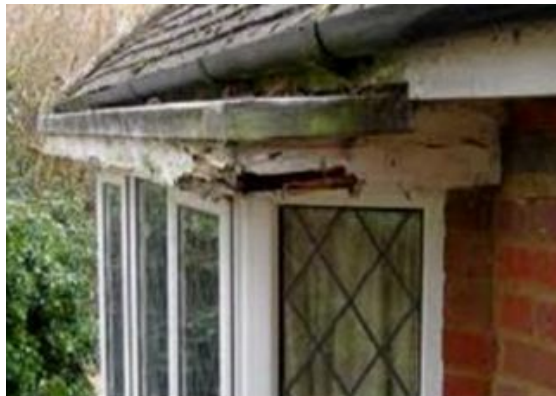
Fig 1.4

- ***Timber Decay*** - Decay of structures made of wood due to moisture, chemicals or insect activity (Fig 1.4)

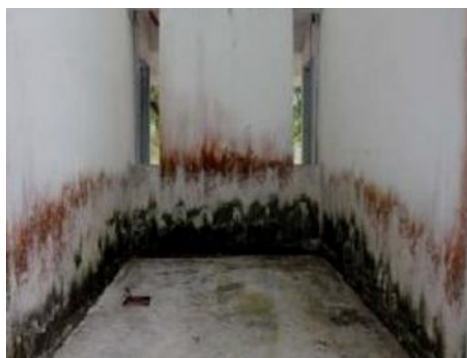
Fig 1.5

- ***Fungal Attack*** - Unwanted green growth on walls, distorts appearance (Fig 1.5)

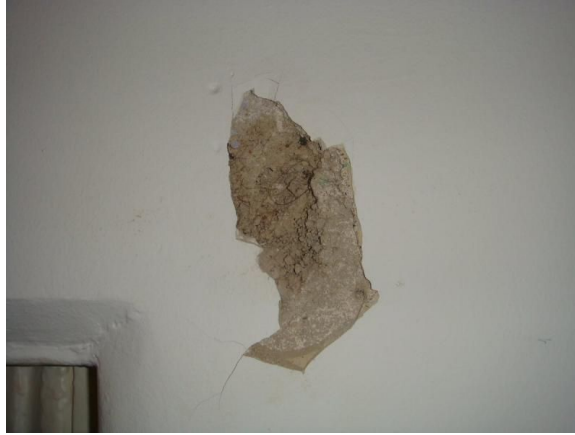
Fig 1.6

- ***Defective Plastering*** - Defects that are concerned with falling of plasters, holes in plaster walls etc. (Fig 1.6)

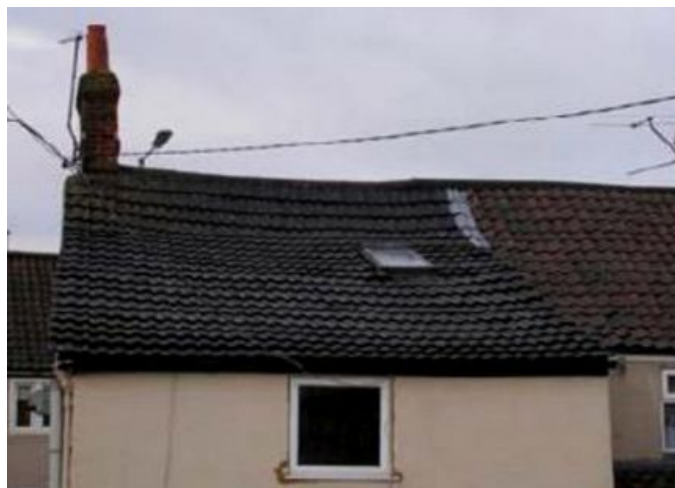
Fig 1.7

- ***Roof Sagging*** - Sagging roofs are dangerous and need to be identified early to prevent roof collapse (Fig 1.7)

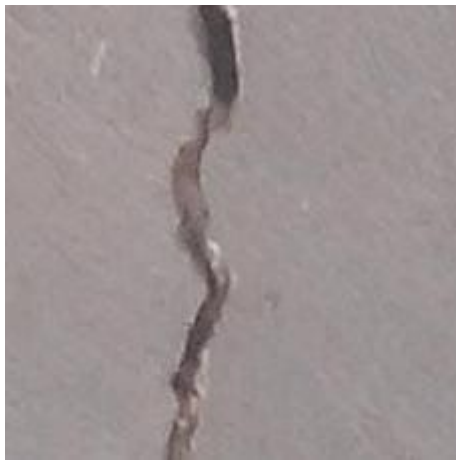
Thresholding is the process of converting an image into a form such that each pixel in the resulting image can have only one of the two possible values (white or black). It is a type of segmentation. In our project, we worked on 3 types of thresholding - Global, Adaptive and Otsu. We used thresholding to segment the cracks and noise in the images from the background.

Fig 4.1 a) Original Image

Fig 4.1 b) After Thresholding

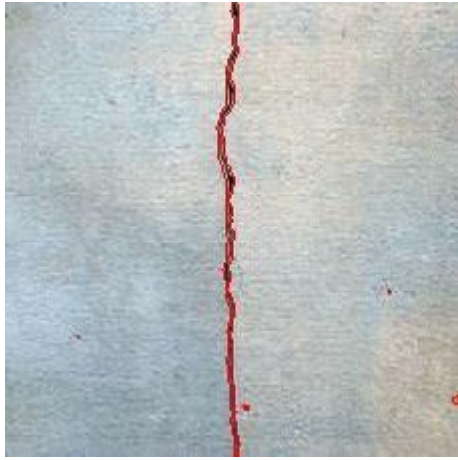
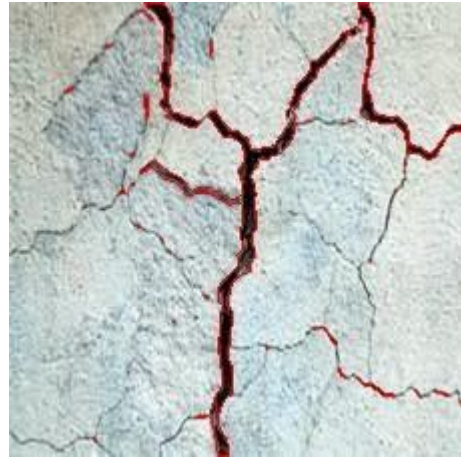
A contour is a region of continuous intensity of the same level. They are useful for object detection and in our project, we have used contours to localize and detect cracks(fig 4.2). *(Based on the assumption that most cracks have continuous edges. Even if they don't, we have tried preprocessing the images so that the boundaries of these cracks are of same intensity and so form a continuous contour)*

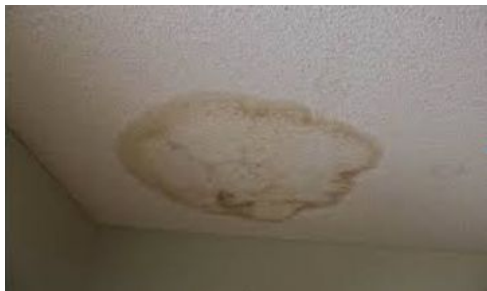
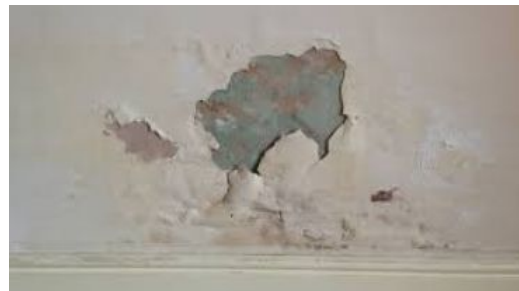
Gabor Filtering has been used to identify ROD.

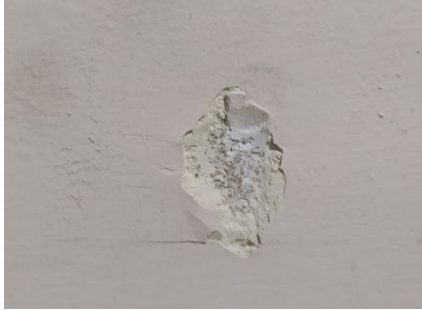
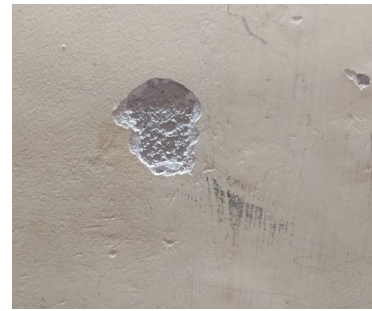
Regions of Defective Plastering (RODP) are areas on walls where the plaster has fallen off due to both natural as well as man-made causes. RODP like ROD is a defect that deeply affects the aesthetic look of a building and therefore, needs to be fixed. RODP are of varied shapes and most of the time, they can be

approximated to an elliptical geometry. Using this characteristic of RODP and gabor filtering , we have tried to detect RODP in an image of a wall.

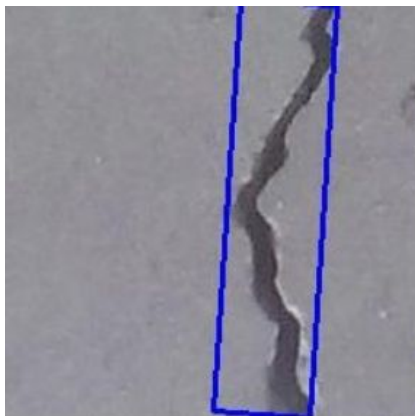
In fig 5.4 a) and b), our approach has perfectly detected the crack and classified them as cracks. In fig 5.4 c), our approach carefully bounds the largest crack in a frame with multiple cracks.

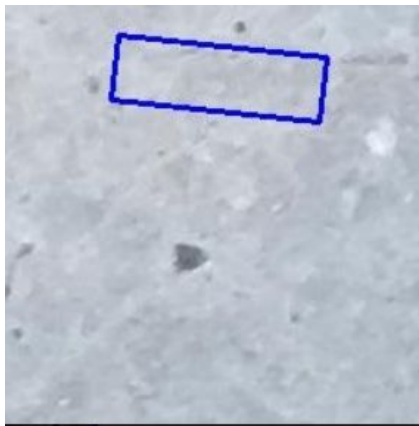
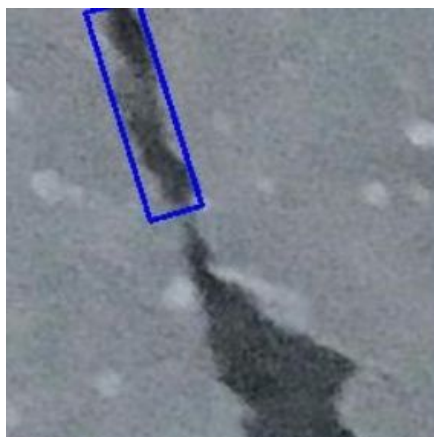
Fig 5.5 a), b) and c) are examples where the approach failed.

In fig 5.5 a), a region that has no crack has been bounded. In fig 5.5 b), noise has been bounded and in fig 5.5 c), the larger region of the crack has not been bounded due to the poor image.

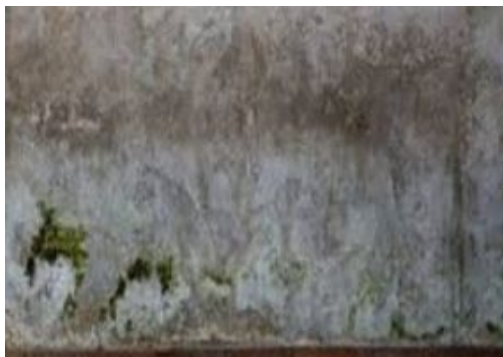
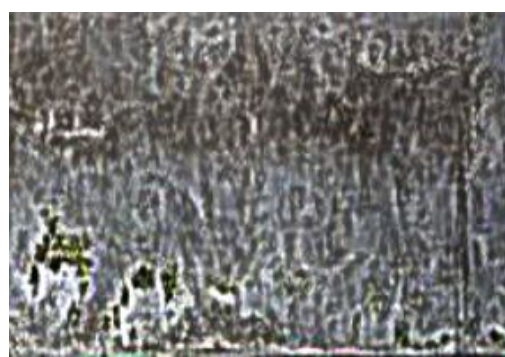
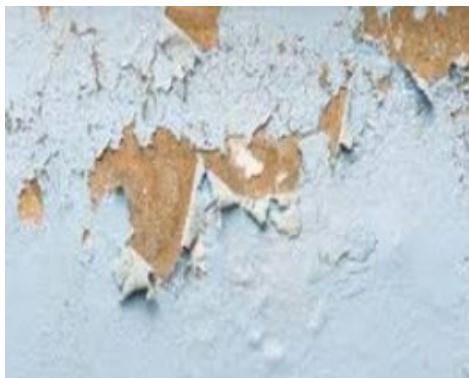
We have used Gabor filters as gabor filters help identify texture. And when there is a damping defect, the problem often is a new change in texture of the surface. We have made use of this very cause and worked on it.

Fig 5.12 a) Original Image

Fig 5.12 b) After Gabor Filtering

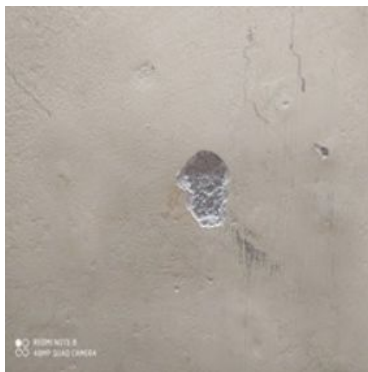
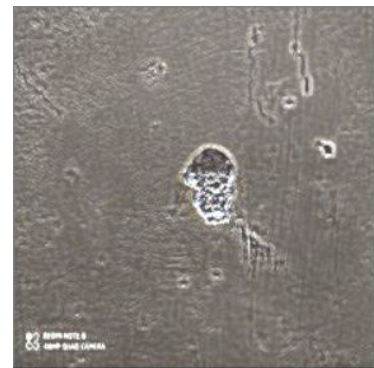
The work done in RODP has also been affected significantly by lack of data. Yet, we have tried to work with this constraint and have discovered that the gabor filter can help identify this too.

Fig 5.13 a) Defected Image

Fig 5.13 a) Defect Highlighted

Furthermore, “shape analysis” can be used to analyse the shape of the highlighted defect. And this can be used to calculate area. The approach in the empirical DIP-based method for crack detection will work well here too.

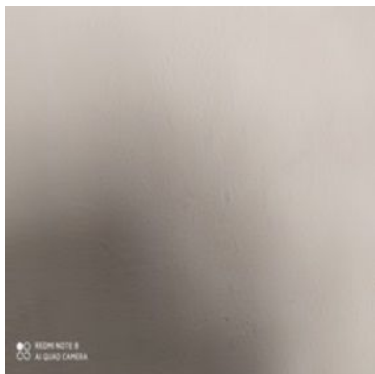
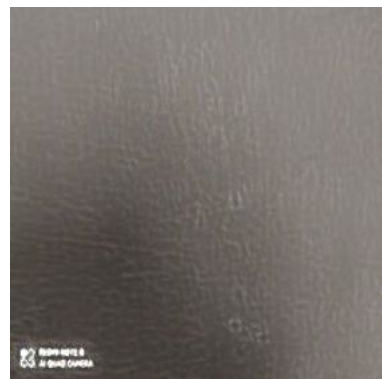
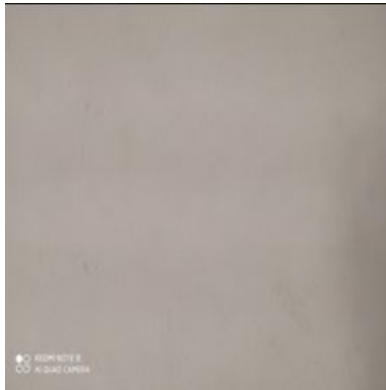
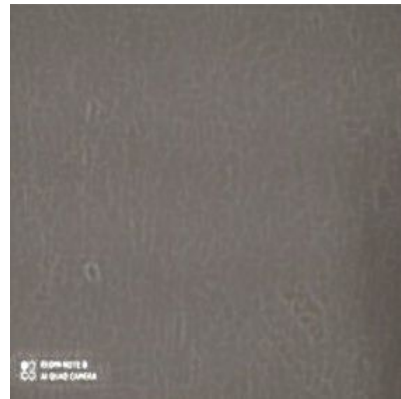
Fig 5.15 a) No-defect Image

Fig 5.15 a) Nothing is highlighted
