## MCE Case Study

**Customer:** International Paper, Eastover Mill

**Asset:** 75 HP AC Induction Motor (Critical Pump Application)

**Scope:** Critical motor evaluated with Baker AWA Tester during 2012 fall outage

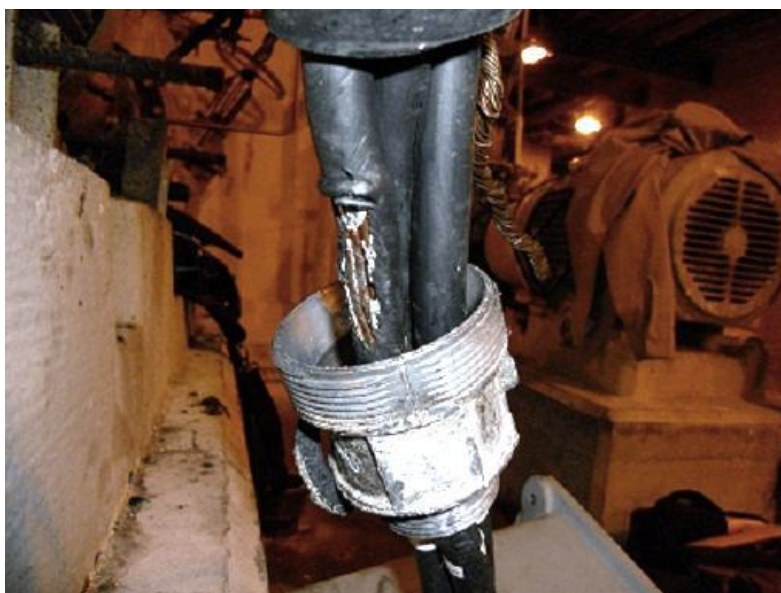
**Findings:** Test data recoded 10/1/12 indicated low insulation resistance & excessive leakage current. Investigation of motor connections in motor connection box revealed damaged cable insulation. Test data recorded 10/2/12 (post repairs) confirm successful repair and motor safe for operation.

Results Summary		Test Date/Time 10/1/2012 2:29:11 PM	
Test ID:	IP 480V < 100 HP StepV	Repair/Job #	
Tested By		Tested For	
Room #		MCC	
Location	2 Paper Machine-452	Legacy #	472005008
<b>Temp Status</b>	<b>Tested</b>	<b>PI Status</b>	<b>PASS</b>
Temp	35.0°C 95.0°F	Volts (V)	500
<b>Resist Status</b>	<b>PASS</b>	DA Ratio	1.0
L1-L2 (Ohms)	0.0755 Corr: 0.0727	PI Ratio	DA Only
L2-L3 (Ohms)	0.0755 Corr: 0.0727	<b>Step-Voltage</b>	<b>PASS</b>
L3-L1 (Ohms)	0.0755 Corr: 0.0727	Volts (V)	2000
Max Delta R %	0.005	I(μA)	0.15
Coil 1 (Ohms)	0.0378 Corr: 0.0364	Resist (Mohm)	13429 At 40°C 9495
Coil 2 (Ohms)	0.0378 Corr: 0.0364	<b>Surge Status</b>	<b>PASS</b>
Coil 3 (Ohms)	0.0378 Corr: 0.0364	Peak Volt(V) L1	2020
<b>Megohm Status</b>	<b>OVER CURRENT</b>	Peak Volt(V) L2	2020
Volts (V)	90	Peak Volt(V) L3	2020
I(μA)	930.00	Max P-P EAR(%)	1.6/1.8/1.8
Resist (Mohm)	0	EAR 1-2/2-3/3-1(%)	No Test
