Remote Sensing for Water Resources and Water Quality Modeling Applications

Vamsi Krishna Sridharan

May 18, 2025

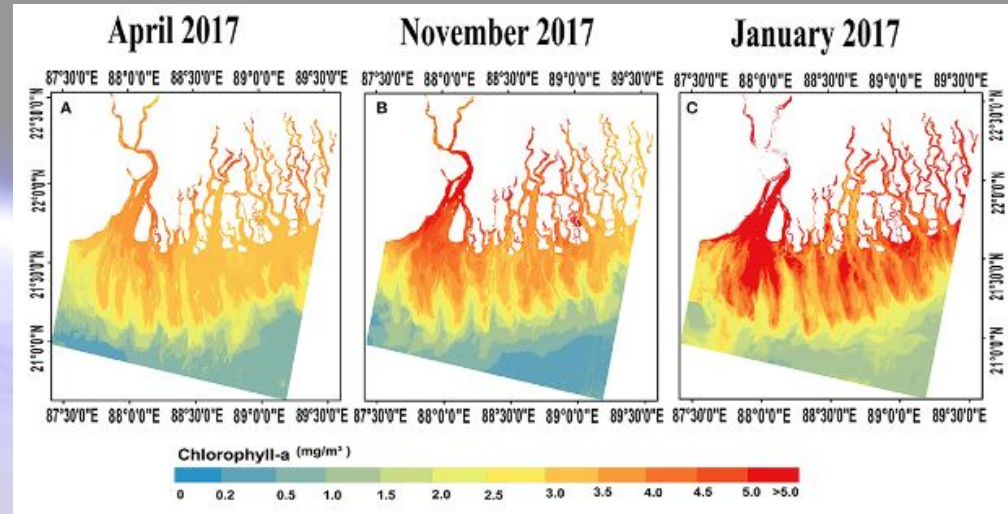
- In water-column impairments

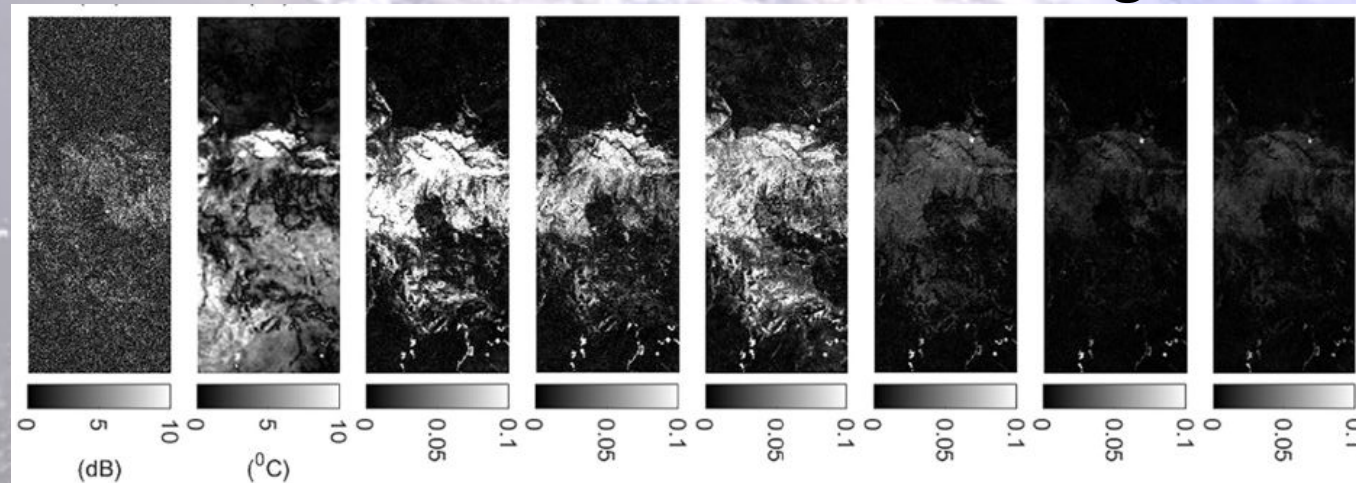
Source: Zhu et al. 2022

- Predicting impairments from land use land cover change

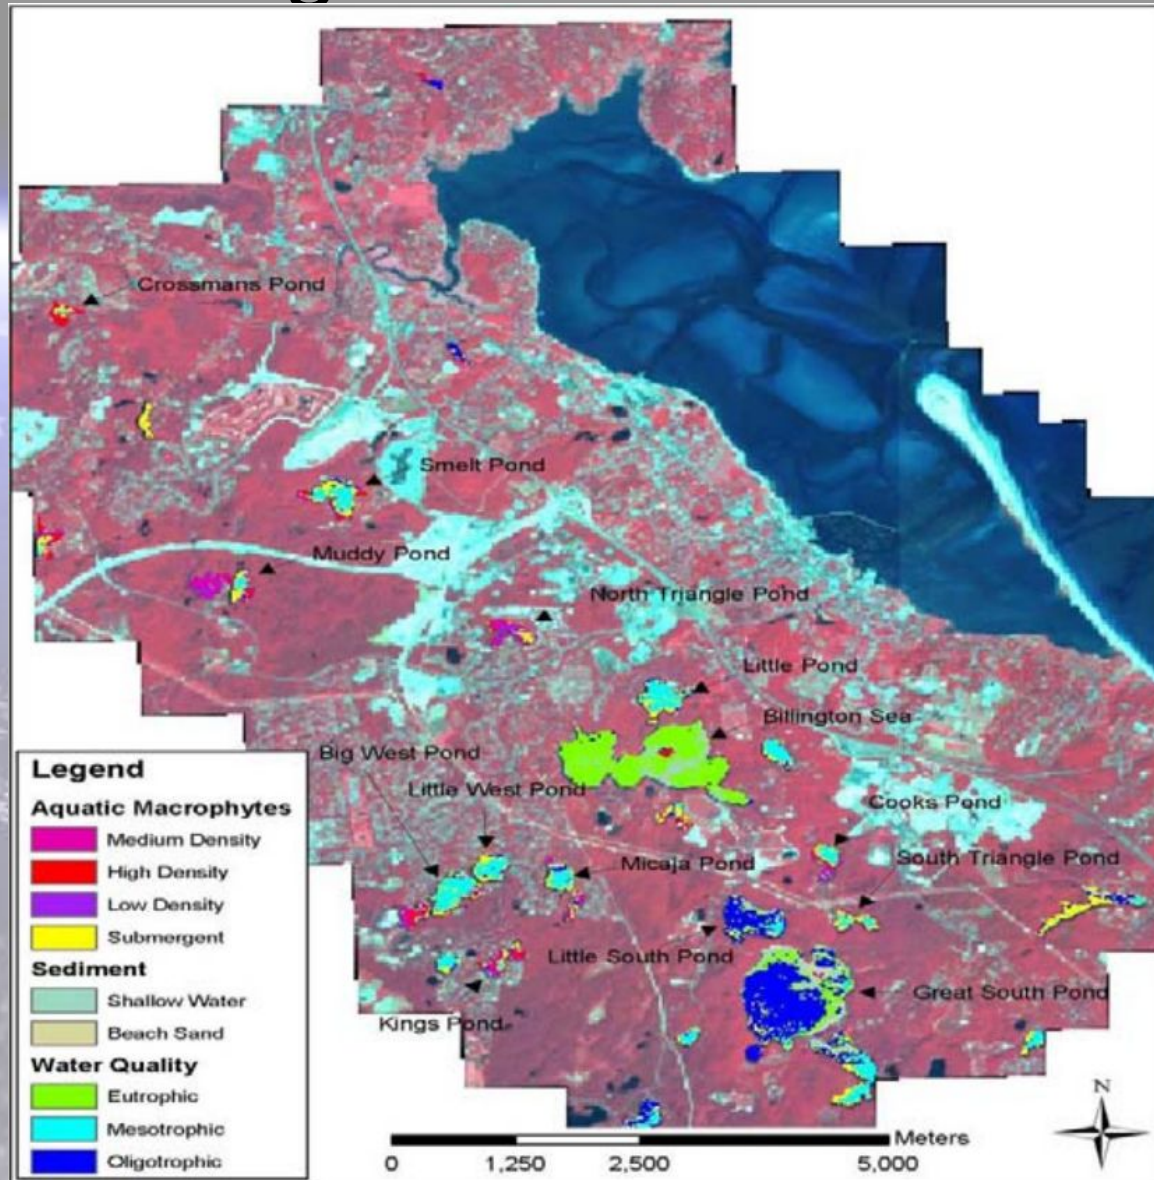
Source: Rogers and Thompson 2002

Remote sensing for initial assessment of eutrophication

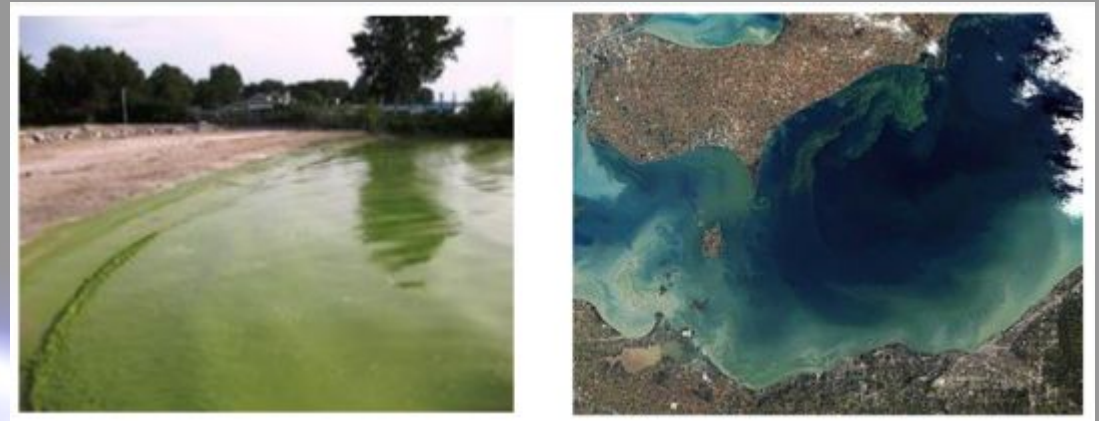
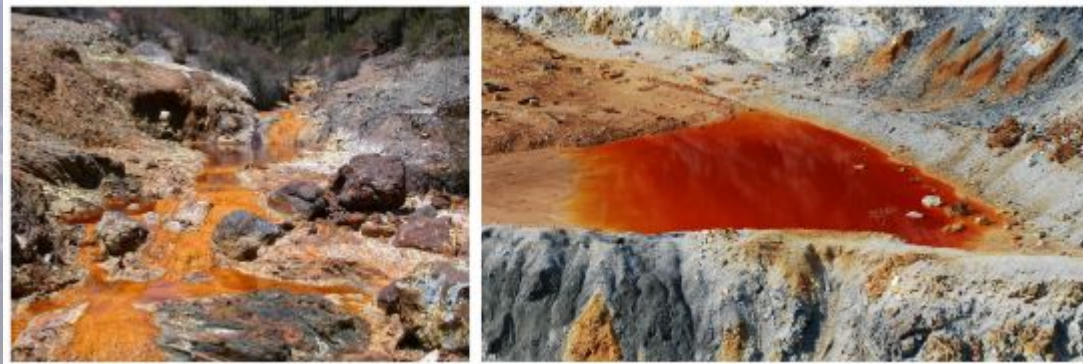
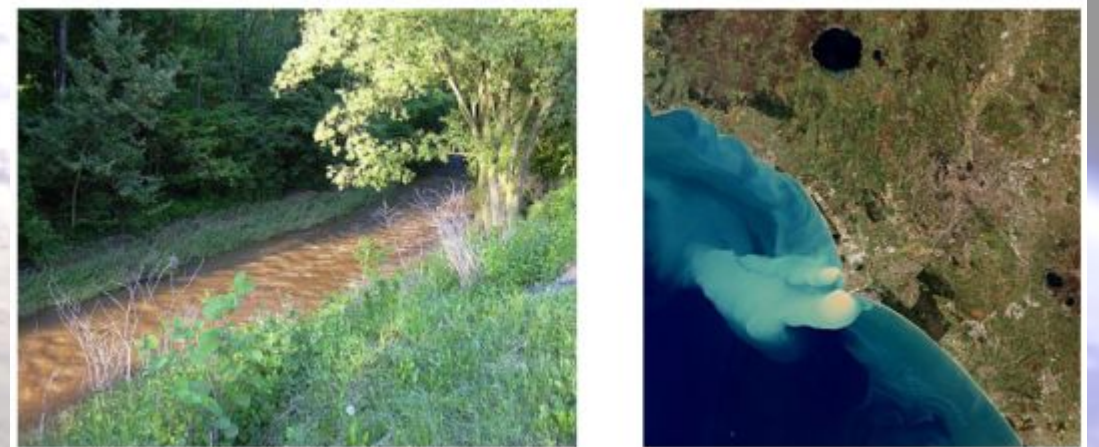
Source: Murray et al. et al. 2022

Remote sensing for HABs, acid mine drainage, and sediment plumes

- Quantities that affect the water column color
- Quantities that have a large spatial footprint
- Quantities that persist, or cycle over time

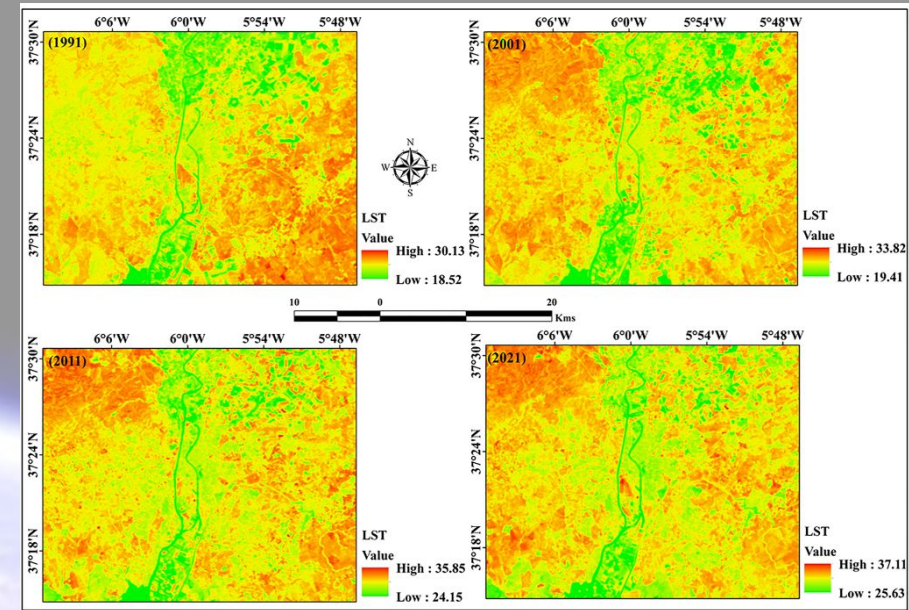
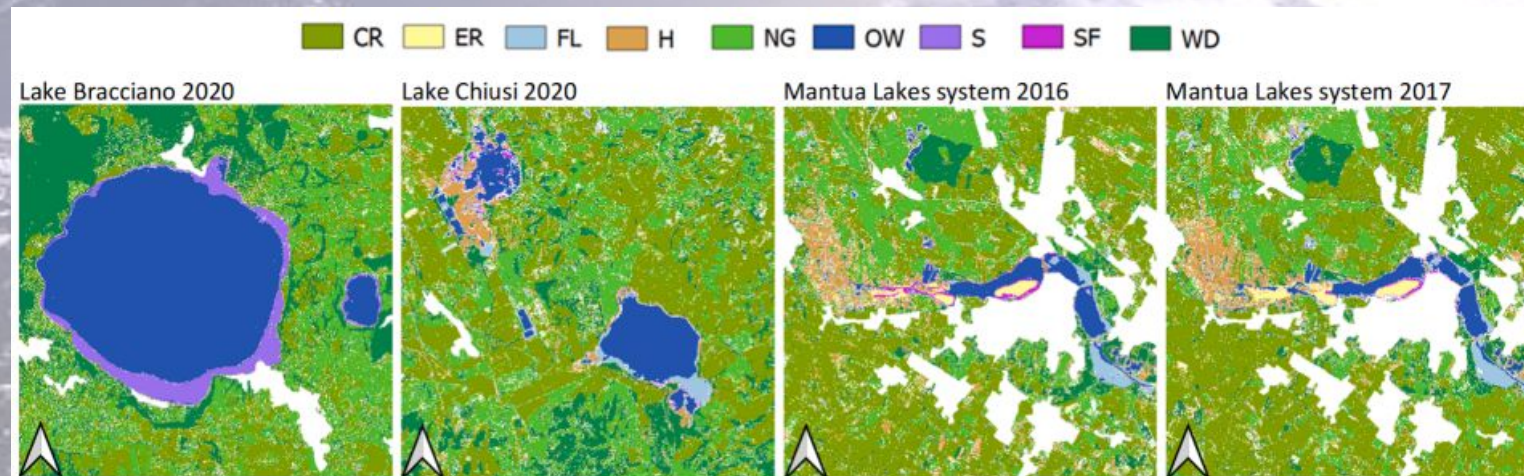
Sources: Halder et al. 2022;
Piaser and Villa 2023

Remote sensing for watersheds

- Linking sources to impairments
 - Urban heat islands and water temperature
 - Submerged aquatic vegetation and water quality

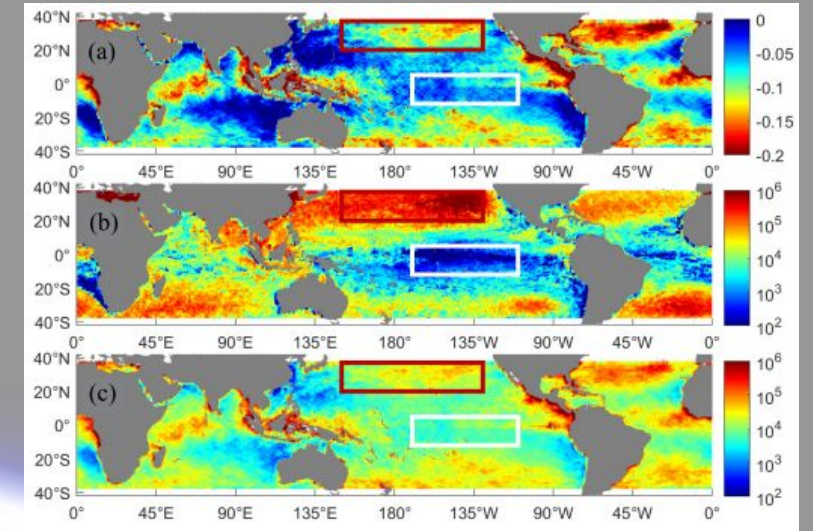
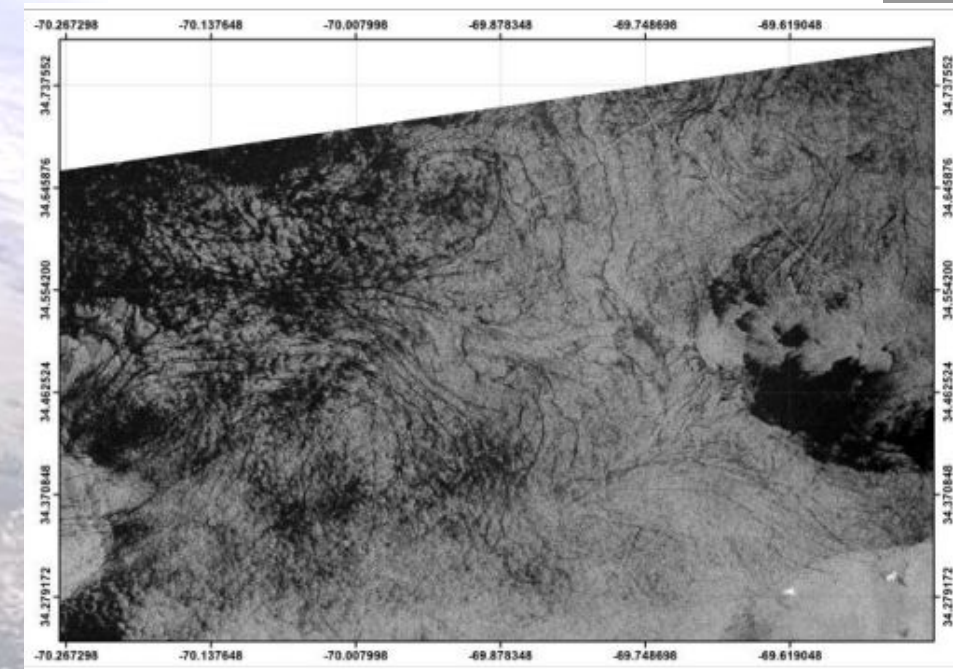
Sources: Davaasuren et al. 2018;
Evans and Ruf 2022

Remote sensing for non-traditional impairments

- Microplastics using RADAR wind field and ocean roughness deficit
- Microplastics using SAR coupled with striated ocean smoothness, no corresponding shipping, and bacterial activity
- Heavy metals using hyperspectral reflectance correlated with environmental factors

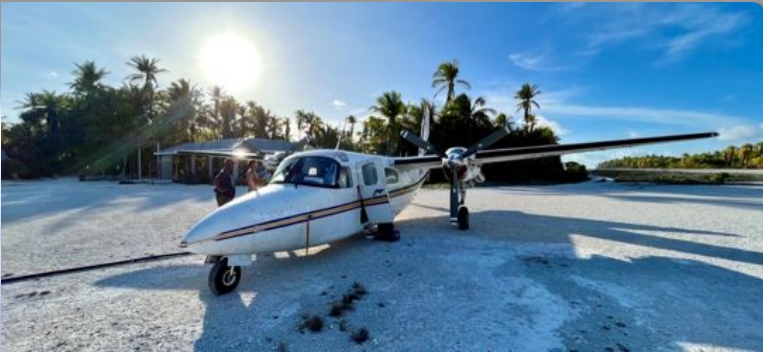
Coastal
Zone
Mapping
Imaging
Lidar
SuperNova

Remote sensing for coupled topobathymetry, and terrestrial ecosystem and benthic substrate mapping

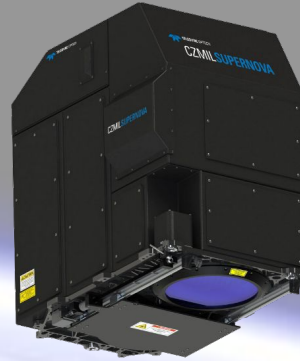
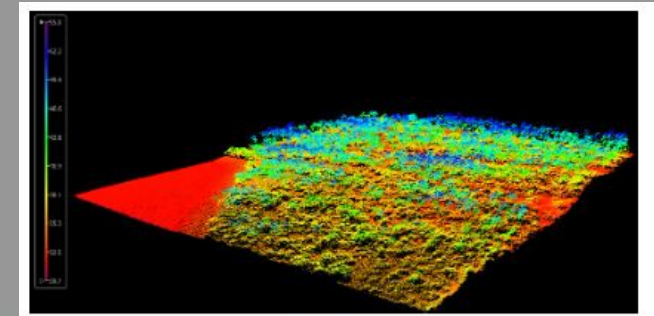
Kiribati

- Class 1: Unclassified
- Class 2: Topo Ground
- Class 40: Bathy Bottom
- Class 41: Water Surface
- Class 45: Water Column
