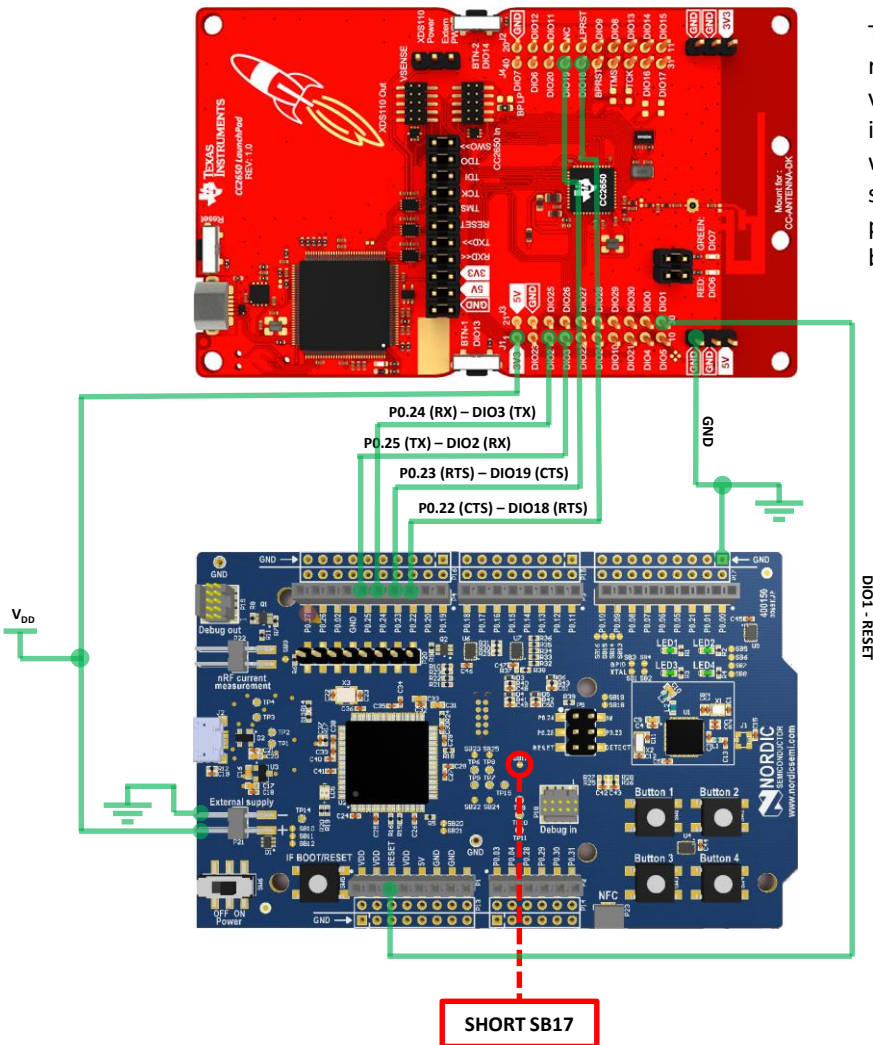
The Launchpad image refers to the revision 1.0 of the hardware. In that version the DIO2 and DIO3 pins were incorrectly labelled (labels are swapped with respect to actual pin location). This scheme refers to the actual wiring position, then discard any label on the board and just wire as shown.
