Toyota

U151E/F, U250E

sonnax®

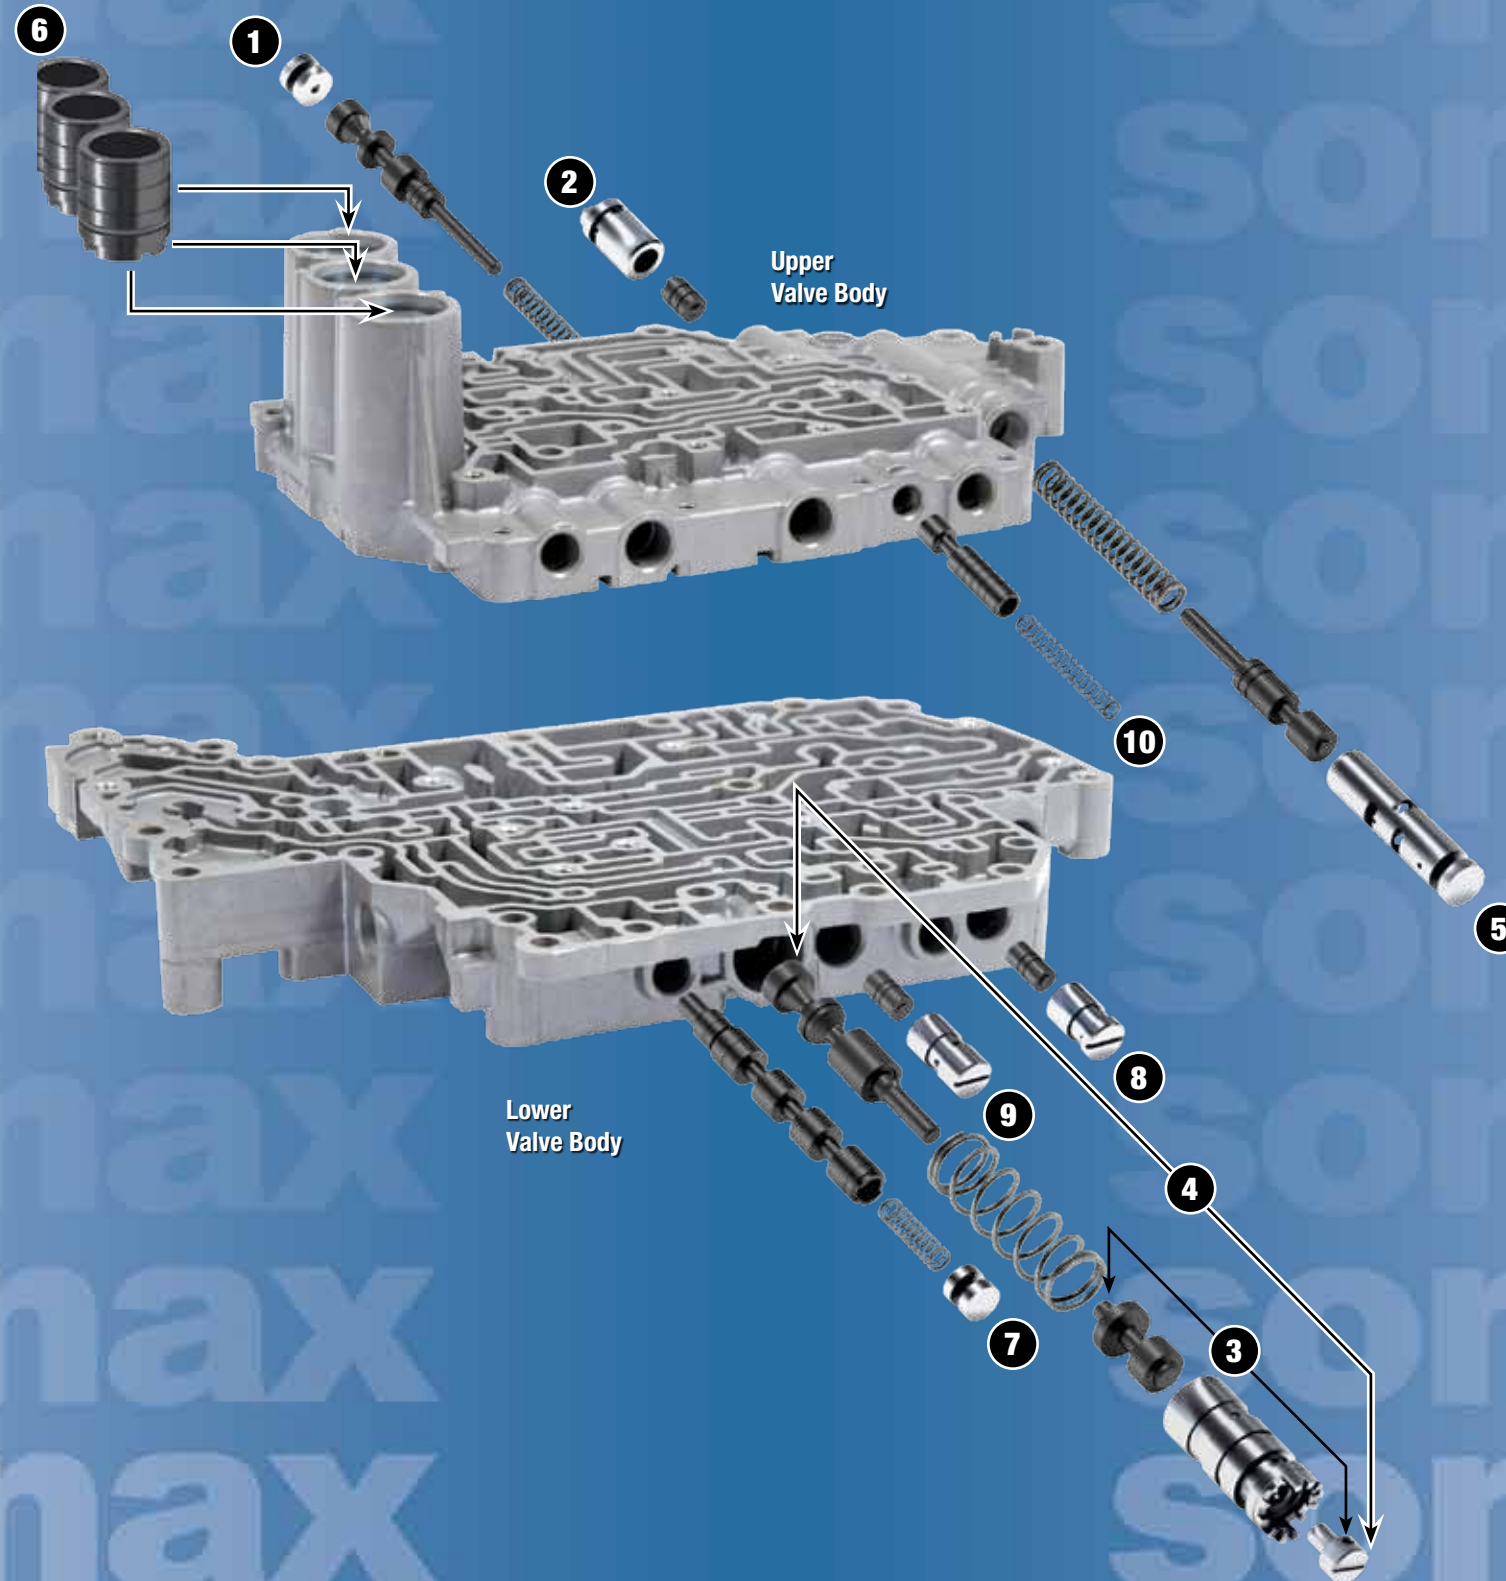
Oversized Secondary Pressure Regulator Valve Kit

Lockup Control Plunger Valve & Sleeve Kit

Boost Valve Kit

Oversized Pressure Regulator & Boost Valve Kit

Solenoid Modulator Valve Kit

Accumulator Piston Kit

Oversized Clutch Apply Control Valve Kit

B2 Apply Control Plunger Kit

B1 Apply Control Plunger Kit

Oversized B3 Orifice Control Valve Kit
