Sonnax testing has shown the new high-efficiency filter for the **E4OD, 4R100** removes post-rebuild contamination significantly more effectively than any other filter currently on the market

High-Efficiency Internal Filter

36423-BPF

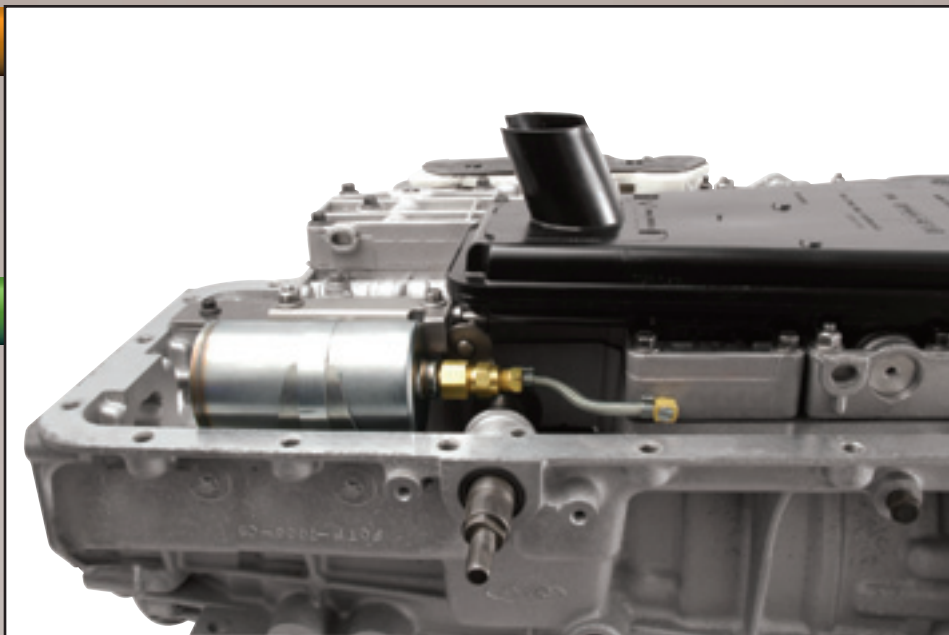
1 High Efficiency Internal Filter

- This 5-micron filter removes post-rebuild contamination 10 to 100 times more effectively than currently available cooler line filters.
- The filter continuously and efficiently removes residual contamination from prior failures.
- Fluid is pushed through the filter.
- Filter is in the pan.

The circuit design of the Sonnax filter ensures adequate oil pressure and flow to force fluid through the densely wound radial filter element. Sump filters and cooler line filters must balance flow and restriction, thus limiting their effectiveness. Sonnax has solved this problem by feeding the filter directly from internal transmission pressure in a “kidney loop bypass” configuration. By installing the filter inside the transmission at time of rebuild, all problems associated with external filters are eliminated. No more hassles, leaks, comebacks or filters “left off” by the installing shop.
