**Article No.:** TASC-TIP-11-09

## Thinking Outside the Box

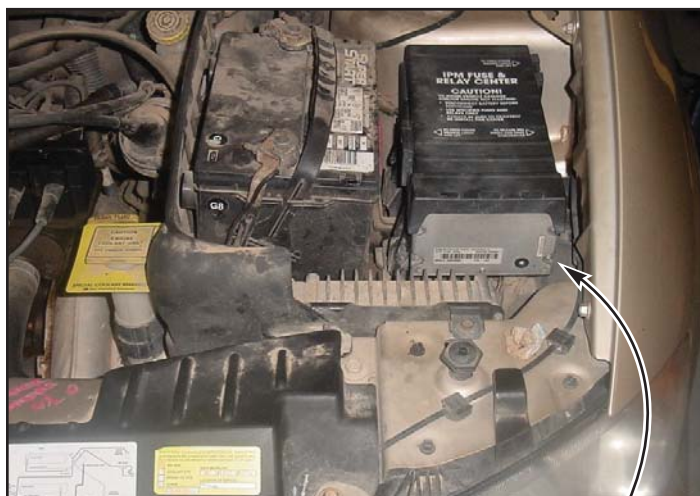
*Where the Front Control Module lives in the car.*

the vehicle's body circuits. Now, what does it have to do with the transmission? The FCM has the responsibility of sending 12 volts through the Integrated Power Module (IPM) to the TCM when the FCM detects that the driver has turned the key on. Sort of a long way around for getting the Ignition voltage to the TCM, but that is the way it was designed. We checked the IPM (what most of us think of as the fuse-relay box) and it tested

OK. We ordered an FCM and installed it, flipped the key on, and it sent 12 volts to pin 11 on the TCM. The TCM booted and the van was as good as new. This is an example of testing a system that is similar to those we have worked on many times before, only to find a completely different fix than we expected. As vehicles change and we see more Controller Area Network systems, we will continue to be forced to think outside the box.

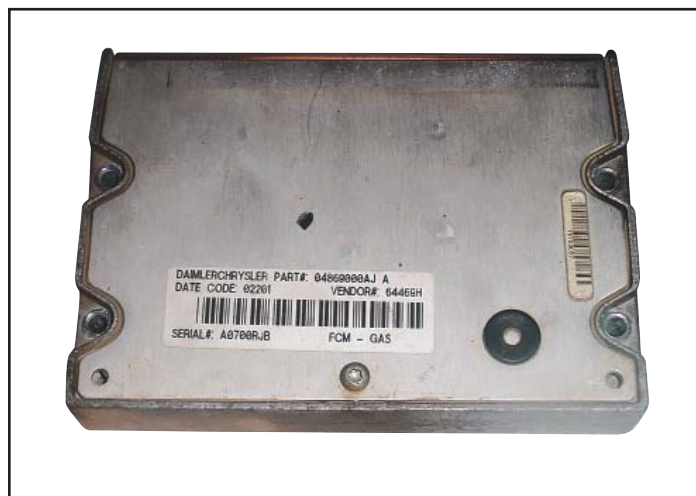
*The Front Control Module.*
