Torx® Plus Bit For Bell Housing Bolts

77000-HBK

'98 & later with
two-piece case

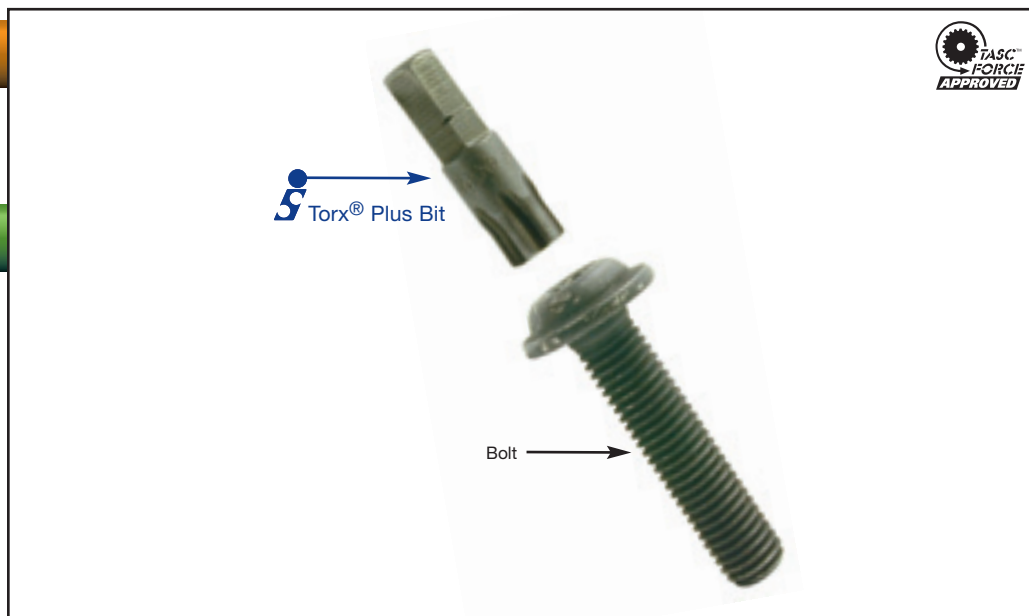
Torx® Plus Bit

Stripped bell housing bolts

Standard Torx® bits often fit loosely and damage the bell housing bolts during removal or installation of the bolts.

Use this Torx® Plus bit for removing bell housing screws.

Sonnax now offers a specially designed Torx Plus® bit **77000-HBK** for removing 4L60-E bell housing bolts. The bit has a tighter fit with the drive head of the bolt. This helps avoid rounding out the bolt head or the bit. It also helps prevent the bit from walking out of the bolt head. The Sonnax tool permits higher torque loads to be applied, which are often needed to remove these extra-tight bolts.
