## Oversized No-Walk Case Bushing

### 34006-OS

### Installation Instructions:

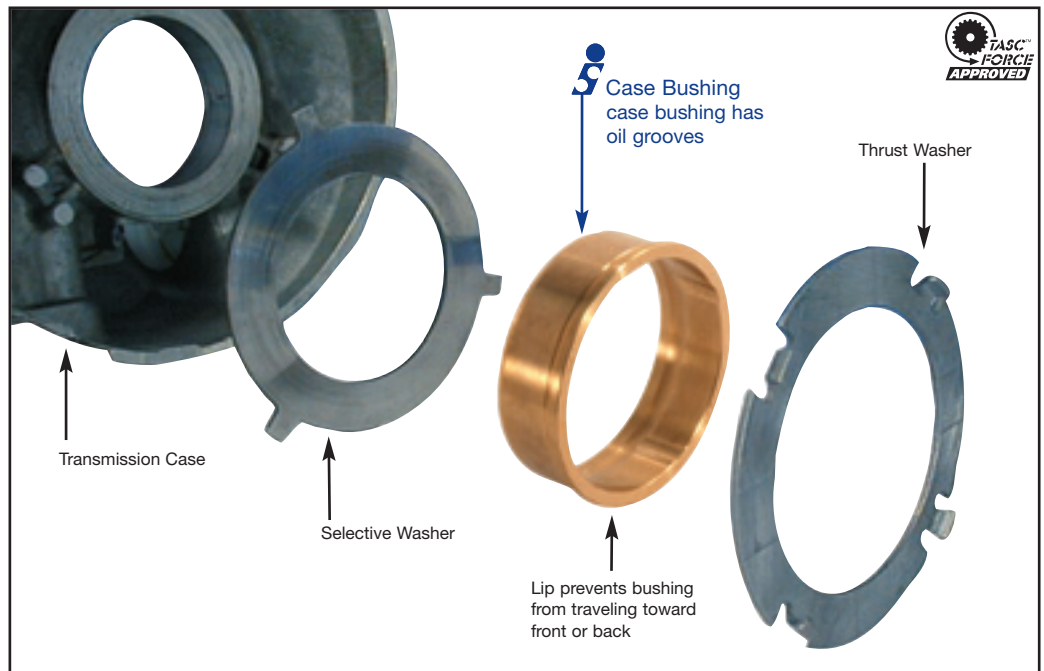
In some 1991 to 1996 models the output shaft lube holes may be partially restricted by the new bushing (see Figure 1). These two lube holes feed lube oil into the center of the output shaft and forward into the planetaries and rear section of the transmission. THM 400 and 4L80-E '97-up units do not have these lube holes.

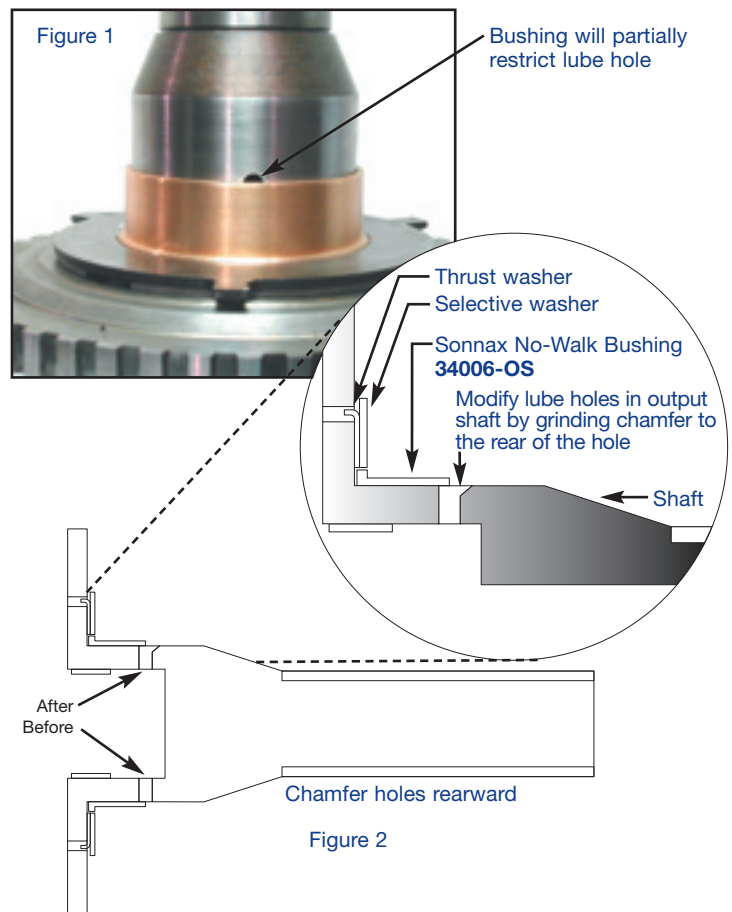
Using a die grinder, chamfer the lube holes as pictured in Figure 2.
