## Is It Safe to Drive?

The vehicle that opened our eyes was a 2001 Ford Explorer Sport Trac with a 5R55E in it (**Figure 1**).

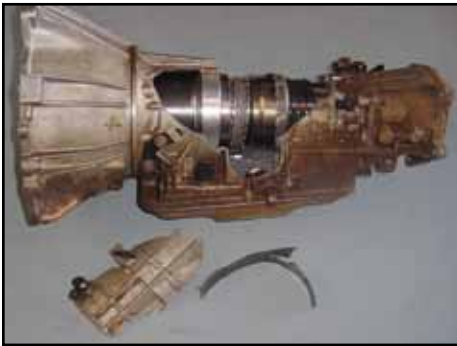
**Figure 2**

As you can see in **Figure 2**, the Explorer's transmission case was destroyed, with the damage appearing to originate in the area of the intermediate band. The next photo is a close-up of the direct drum...or should I say what is left of the direct drum (**Figure 3**).

Once in the shop, we did a scan on the Explorer and it had several codes, including several electrical circuit codes for the transmission. But a code that stuck out was a P0733, which is a ratio error in 3rd gear. On the 5R55E, the P0733 usually means a broken intermediate band. We also noticed that both air bags had been activated recently. We lifted the vehicle and were amazed when we saw how much damage there was. All the electrical circuit codes were showing up because the transmission main wiring harness had been severed by pieces of the transmission case. It had been flying pieces of the case which also broke the shifter cable, causing the disconnected feel we noticed earlier.

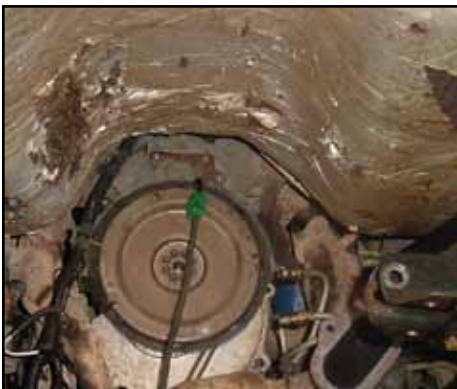
**Figure 4**

With the transmission out of the vehicle, you can see where the pieces of the transmission case hammered the firewall (**Figure 4**).

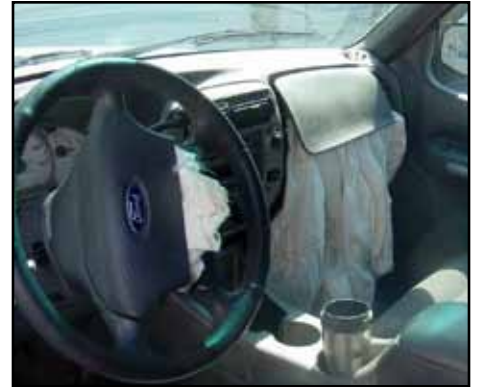
**Figure 5**

I will be first to admit I know very little about the air bag or Restraint Control System. I did a little research and found out that the Restraint Control Module is located inside the cab just above the bell housing. I have no idea why it discharged both air bags, but I can assure you they both went off (**Figure 5**). The Explorer was in great shape and nothing was damaged except the transmission, shifter cable, transmission wiring harness and, of course, the air bag system. With no signs of any other impact or accident related damage, I can only conclude that the self destructing transmission triggered the air bag deployment.
