# Sonnax Technical Bulletin

## Making the For Saving the CASE

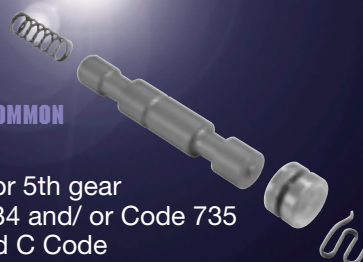
**56947J-S1**  
4-3 Pre-Stroke Valve Spring

The 4-3 pre-stroke valve spring in Ford 5R55N units controls the apply and release rate of the intermediate servo and direct clutch, which should be applied in 4th and 5th gears. A broken spring prevents proper valve function and can cause no 4th or 5th gear, Codes 734 and/or 735, or a Solenoid C Code.

made from chrome-silicon alloy, which allows for higher working stresses than typical spring material. The spring has been configured to reduce operating stresses by 8% at the critical regulating positions of the valve. This valve spring can save you hundreds in valve body replacement costs.

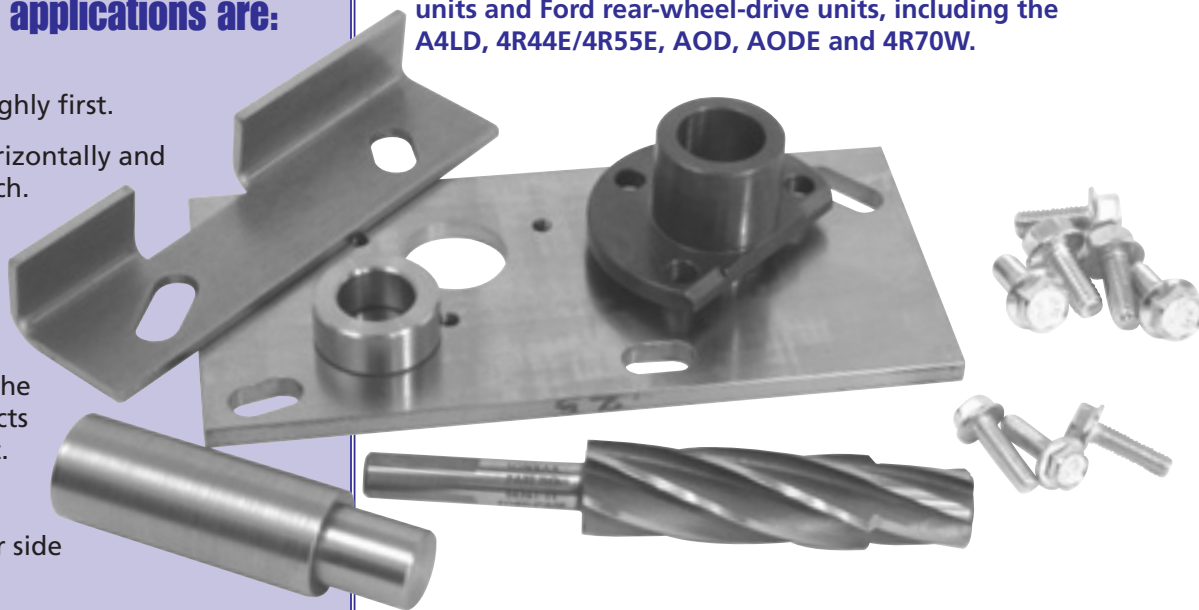
The tool kit consists of a reamer guide, plate, reamer, reamer alignment bushing, hex head cap screws, a sleeve installation tool and clamp bracket. You can correct the

The Sonnax 56361-TL tool kit includes everything you need to salvage worn cases in a wide variety of Chrysler units and Ford rear-wheel-drive units, including the A4LD, 4R44E/4R55E, AOD, AODE and 4R70W.

excessive movement of the manual shaft that allows oil to leak past the shaft seal by oversizing the manual shaft bore with the tool kit and installing Sonnax case repair bushing **22179-02** in your Chrysler rear-wheel-drive or, for the Ford A4LD, 4R44E/55E, AOD & E and 4R70W units, Sonnax part **56361-01K**.
