Axle/Side Leak Repair Plate

84995-01

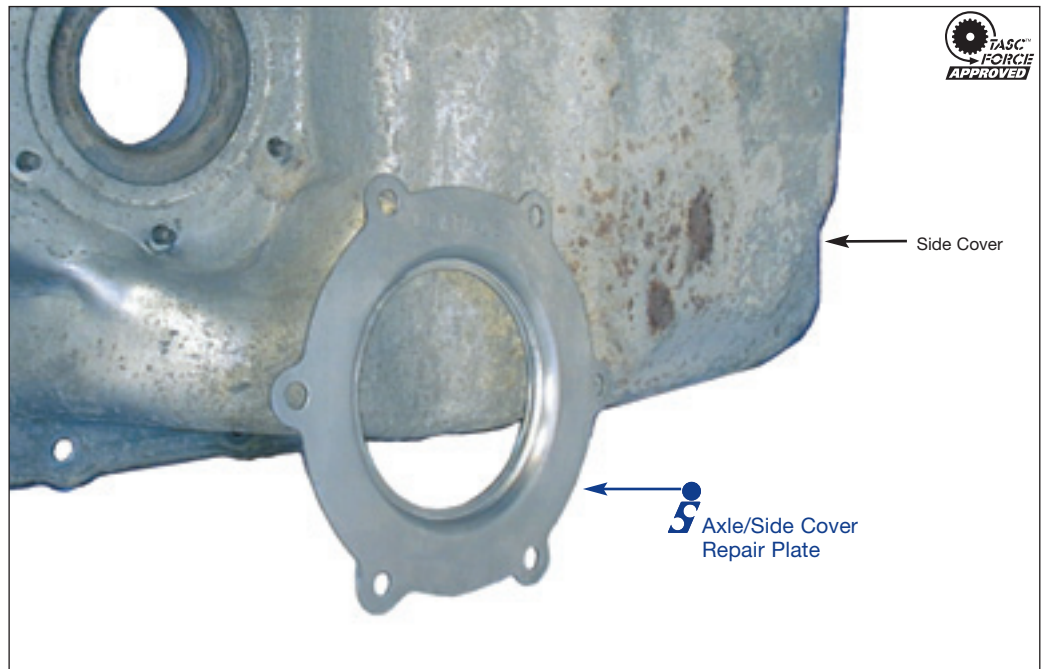
1 Leak Repair Plate

Note: For use with stamped steel side cover.

1. Remove the left axle.
2. Remove the six side pan nuts and washers. Discard the six washers (plate thickness eliminates the need for washers).
3. Clean the exposed channel plate area and side cover pan surfaces thoroughly.
4. Apply RTV silicone on the flat surfaces on the transmission side of the repair plate. Also apply silicone to the channel plate surface and side pan surface where the repair plate will touch.
5. Install the leak repair plate over the six threaded studs on the channel plate. Reinstall the six nuts to the studs and torque 6 to 10 ft. lbs.
6. Reinstall the left axle.
