4th Clutch Hub Bearing

Sonnax Part Summary

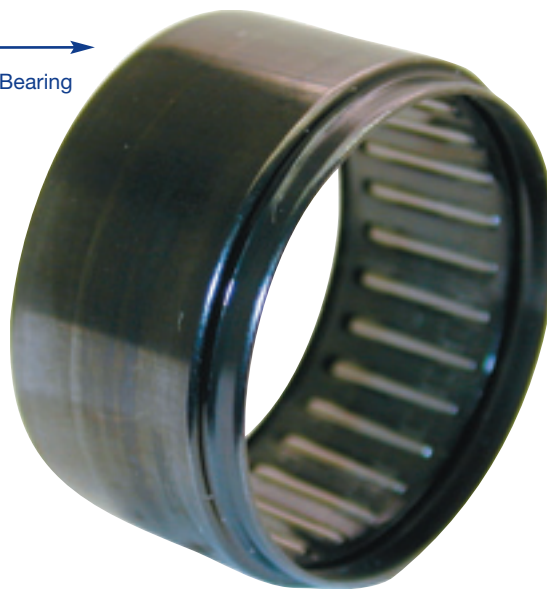
Worn-out bearing

Normal wear causes bearing to fail.

In 4T60 & E transmissions, the bearing in the 4th clutch hub shaft ("cookie cutter") often fails, making it necessary to purchase a new and expensive clutch hub. Sonnax now offers an OEM replacement clutch hub bearing **84450** that allows you to salvage the original clutch hub.

Replace the worn out bearing with this new 4th clutch hub bearing.

Note: Although the OEM applications are for '94 & '95, the shaft with this bearing and the external sleeve on the opposite end can be used back to '83.
